**FACILITY COMPLIANCE INSPECTION REPORT**  
**Division of Waste Management**  
**Solid Waste Section**

**Date of Site Inspection: April 1, 2015      Date of Last Inspection: April 3, 2014**

Jackson County MSW & C&D Transfer Facility  
 Scott Creek Transfer Station  
 48 Recycle Place  
 Sylva NC 28779  
 828-586-7509

Comprehensive Inspection

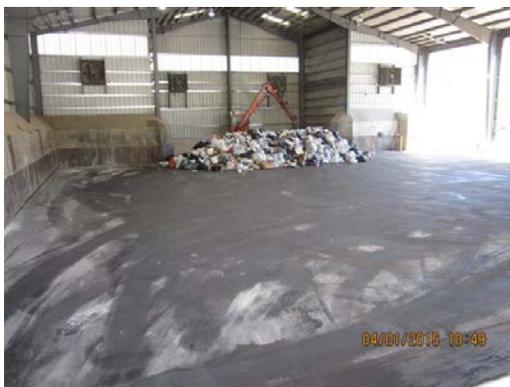
10. The transfer station was observed in operation. Smaller loads and private individuals have access to a separate area from large commercial haulers to place waste for transfer.
11. The tipping floor was observed and appeared to be in very good condition. The drainage system grate across the entrances also appeared to be in good condition. No noticeable vectors or objectionable odors were observed.

Tipping Floor

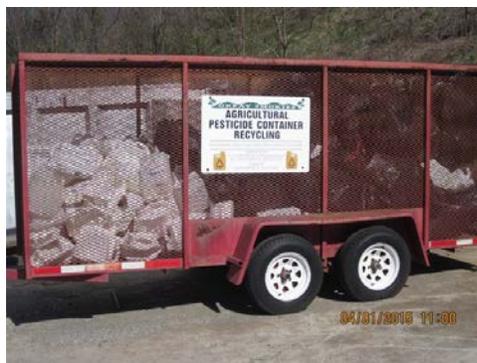
Agricultural Pesticide Container Recycling Bin

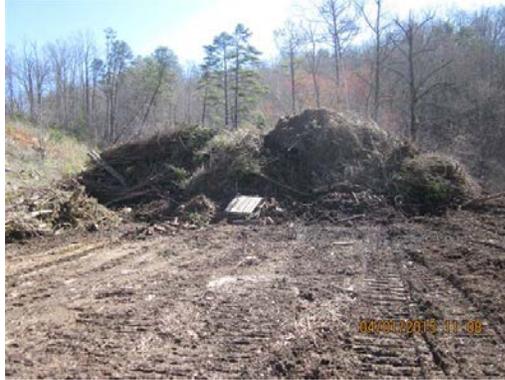
18. The facility is permitted to operate a wood grinding treatment and processing area. This area was observed with only unprocessed natural wood waste and pallets.

Wood grinding treatment and processing area
