**FACILITY COMPLIANCE INSPECTION REPORT**  
**Division of Waste Management**  
**Solid Waste Section**

**Date of Site Inspection:** April 21, 2014

Johnston County MSWLF  
 680 County Home Road  
 Smithfield, NC 27577

Comprehensive inspection

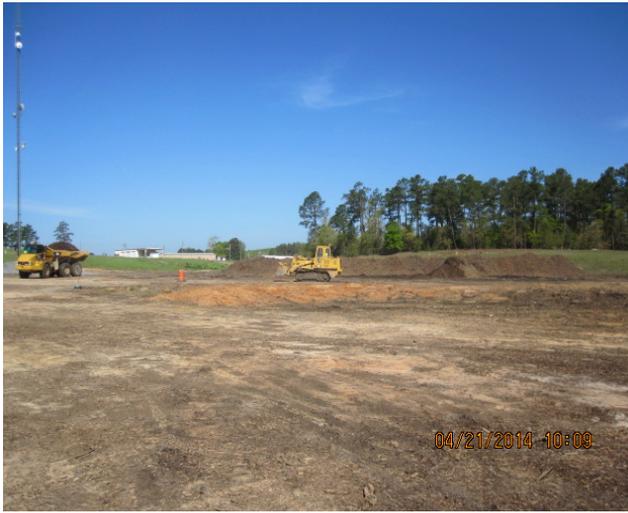
Windrowed ground yard waste

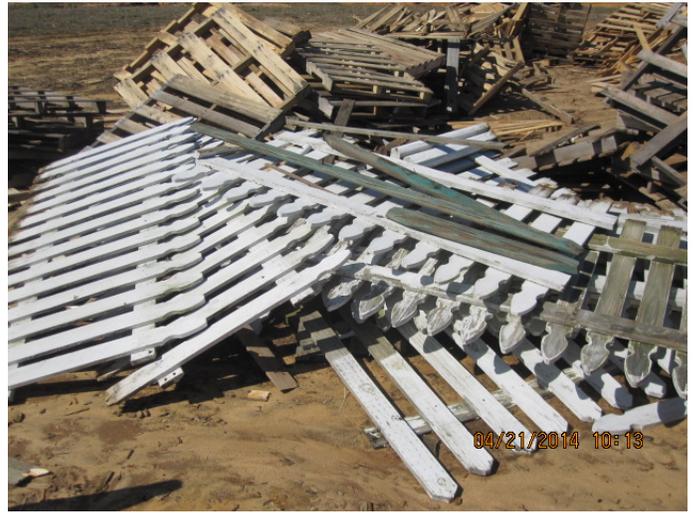
4. **There are some bare areas on perimeter side slopes and just a few areas of slight erosion were noted that need repair.**
5. The yard waste area appears to be very well run. There was no unacceptable waste observed in the yard waste or ground material. The compost temperature logs were reviewed. There were some white painted fences and some painted pallets in the pallet area that must be removed.

White fencing to be removed from pallet area

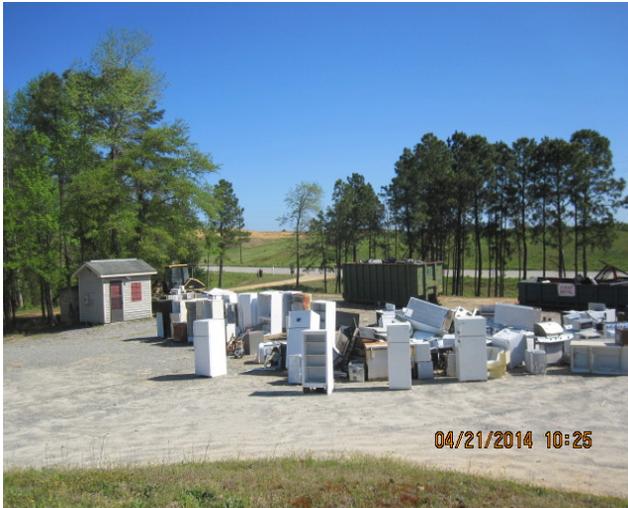
8. The recycling area appeared to be very clean and well maintained. CFC's are being removed from the white goods by the County. Records were checked and the number of units with and without (broken lines) CFC's, were noted- Very good. **The bulk unloading of the white goods from the convenience sites should be looked into so as not to break any refrigerant lines.**

White goods area

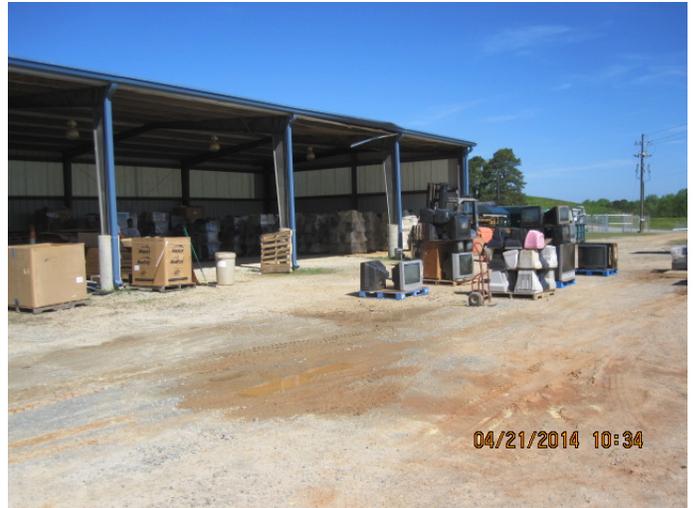
16. The electronics are palletized and shrink wrapped in the shed behind the office. Mr. Proctor stated that approximately \$65,000 was spent by the county on recycling electronics in 2013. It is estimated that this year the cost will be around \$55,000.

Electronics palletizing area

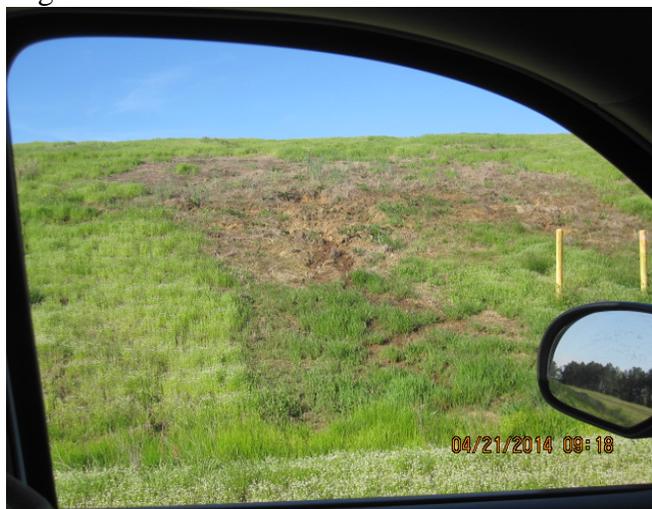
Slight erosion needing repair
