FACILITY COMPLIANCE INSPECTION REPORT
Division of Waste Management
Solid Waste Section

Date of Site Inspection: 16 December 2014 **Date of Last Inspection:** 9 December 2014

Maysville Construction and Demolition Debris Landfill
 11710 NC Highway 17
 Maysville, NC 28555

5203-20141216INSP

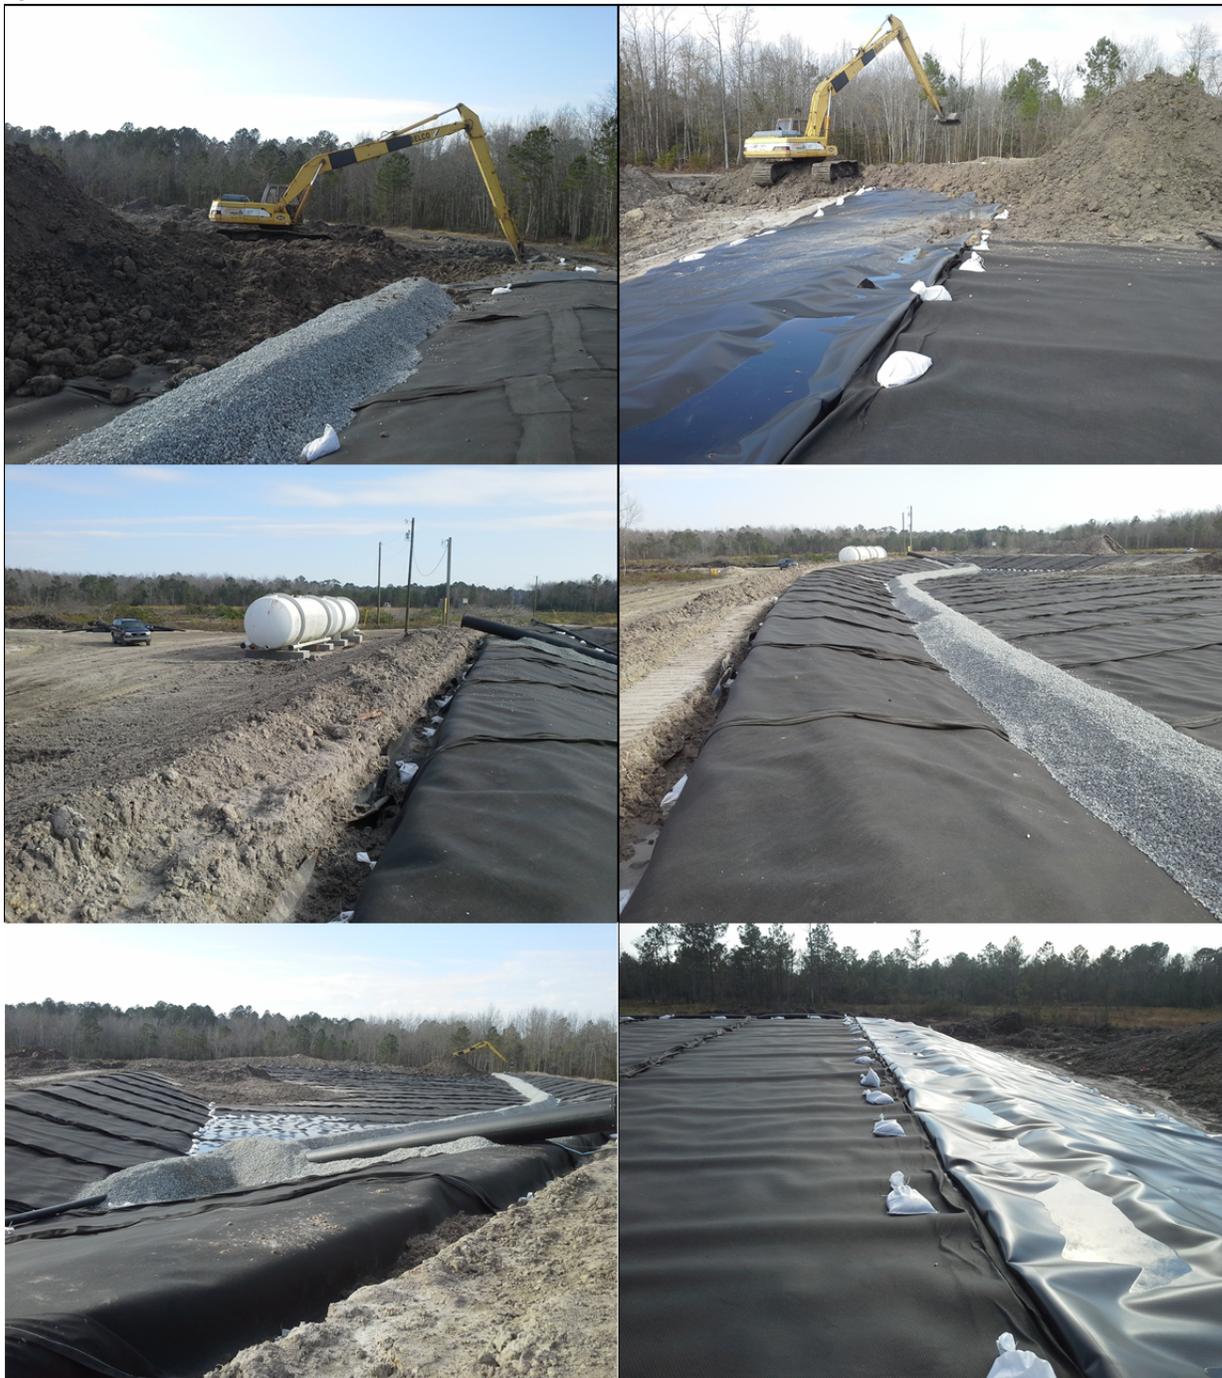
- 1) This Facility is a Construction and Demolition (C&D) waste Landfill.
- 2) The Facility access road is of all-weather construction and is being well maintained at this time.
- 3) It appears that unauthorized vehicles have been accessing the site via the old White Oak River Road Construction Access Road. *As per our conversation, as soon as possible, measures need to be taken to adequately secure the property and prevent all unauthorized access to the sight from this area.
- 4) Construction of Cell I of the C&D Landfill was underway during this Facility Compliance Inspection.

- 5) Installation of the synthetic liner system has been completed.
- 6) Facility monitoring wells were reviewed. All reviewed wells were properly labelled and secured with functioning locks.
- 7) The leachate collection line and sump installation has been completed.
- 8) The leachate storage tanks have been placed on-site on the concrete pads. The leachate collection system has not been plumbed to the leachate storage tanks.
- 9) Erosion control measures were in place and appeared to be functioning properly during this Facility Compliance Inspection.
- 10) No off-site erosion was observed during this Facility Compliance Inspection.
- 11) No violations were observed during this Facility Compliance Inspection.
- 12) *Corrective measures are required as a result of this Facility Compliance Inspection.
