**FACILITY COMPLIANCE INSPECTION REPORT**  
**Division of Waste Management**  
**Solid Waste Section**

**Date of Site Inspection: August 12, 2014**

Lincoln County Landfill MSW & C&D  
 5291 Crouse Rd. (SR-1169)  
 Crouse, NC 28033

Comprehensive Audit

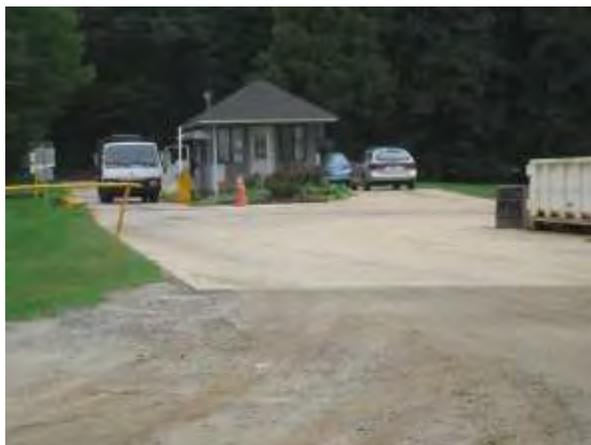
1. Scale house at the Entrance to the Lincoln County Landfill.

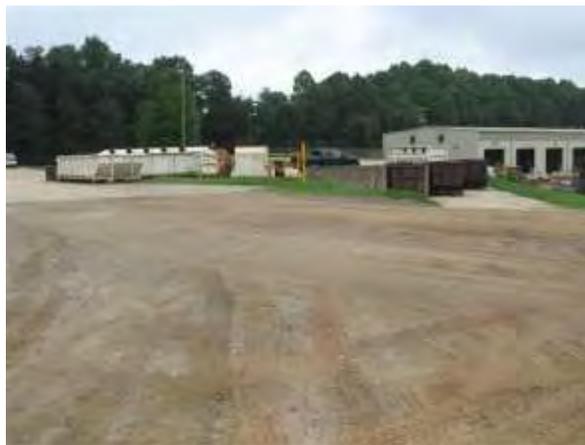
2. Roll-off boxes for segregating wastes and recyclables staged just inside of the entrance to the facility.

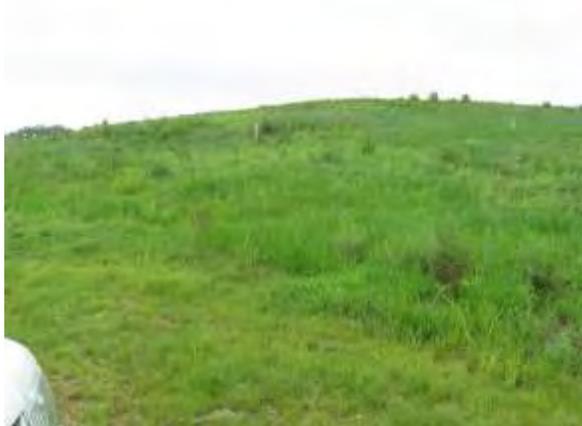
14. While the cap is showing some signs of differential settling that could allow water to pond on the landfill, no ponded water was observed.

3. Looking (S) down the eastern side of the closed MSW landfill.

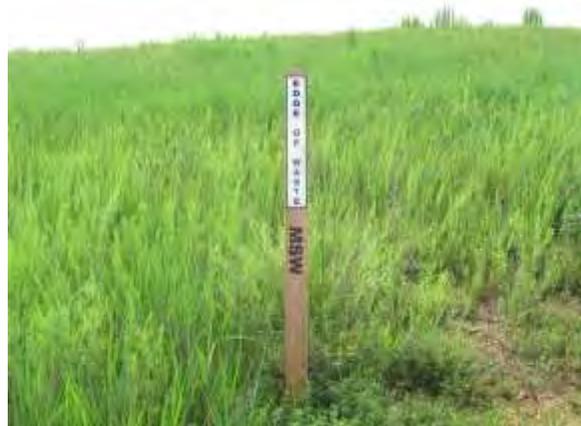
10. A review of the Solid Waste Section’s records failed to find any specific requirements for the closure of this landfill unit. Lincoln County does not have any records concerning specific requirements for the closure of this landfill unit. It is believed that this unit closed prior to 12/21/95.
11. The vegetative cover on the cap is well established and well maintained. (Photo #3)
12. Edge-of-waste markers are in place at this unit. (Photo #4)
13. There was no evidence of any excessive on-site erosion of the cap.

4. Edge-of-Waste marker (typical) for the closed MSW landfill

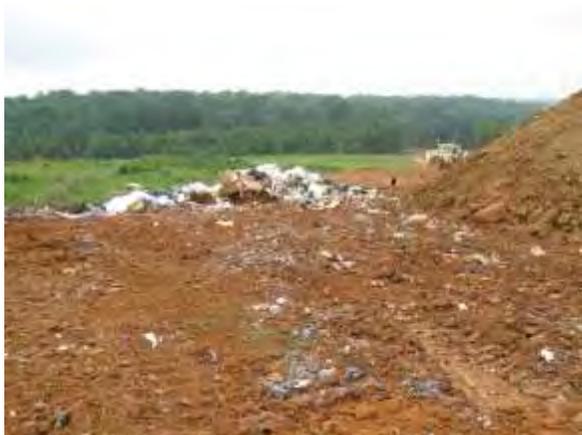
5. The working face of the C&D landfill.

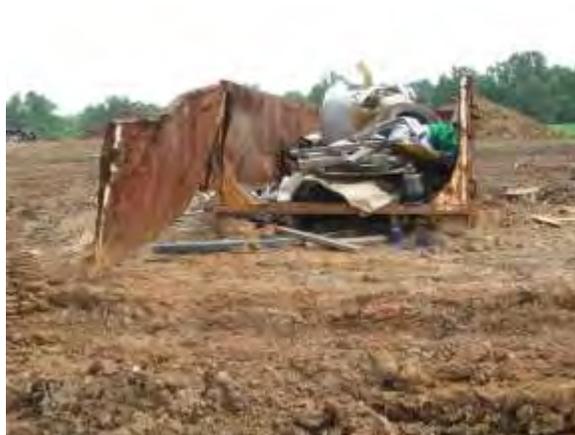
- 15. Tipping fees for the C&D landfill are currently \$30 per ton.
- 16. The C&D landfill is currently taking in approximately 500 tons of waste per month.
- 17. The landfill was actively receiving waste during the audit.
- 18. No prohibited wastes were observed during the inspection.
- 19. Approximately 1% of all incoming loads are screened.
- 20. Waste screening is done daily.
- 21. The active working face was well managed, and not too large. (Photo #5)
- 22. There was very little windblown waste.
- 23. An old “roll-off” box staged near the working face of the C&D landfill for the collection of scrap metal and prohibited wastes. (Photo #6)
- 24. The edge of waste was clearly identified with permanent markers.

6. “Roll-off” box staged near the working face of the C&D landfill for the collection of scrap metal and prohibited wastes.

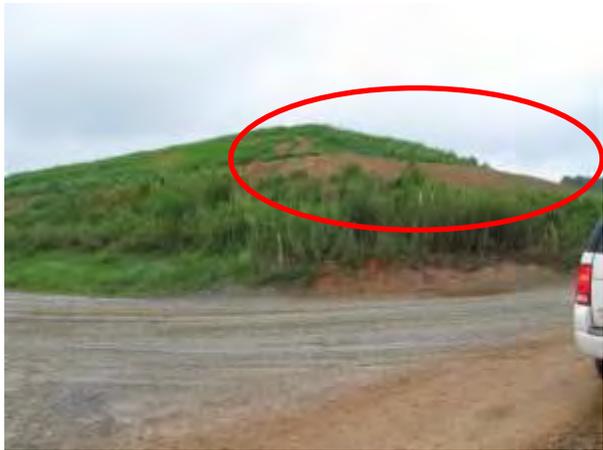
29. Approximately 1% of all incoming loads are screened.
30. Waste screening is done daily.
31. The working face was small and well managed. (Photo #8)
32. The southern slopes of the MSW landfill have several areas where the required vegetative cover is not adequate. (Photos #7 & #8) **Please take all necessary measures to ensure that all areas of sparse vegetative cover are addressed to prevent excessive on-site erosion. It is recommended that Lincoln County solid waste contact the local agricultural extension office for assistance with ensuring that all of the necessary nutrient requirements for the establishment and maintenance of the necessary vegetative cover are met.**

7. Looking at the (SW) corner of the MSW landfill. (Note the area without the required vegetative cover.)

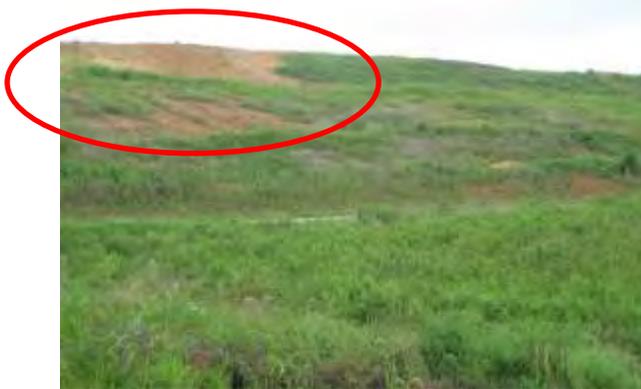
8. Looking at the (S) slopes of the MSW landfill. (Note the area without the required vegetative cover.)

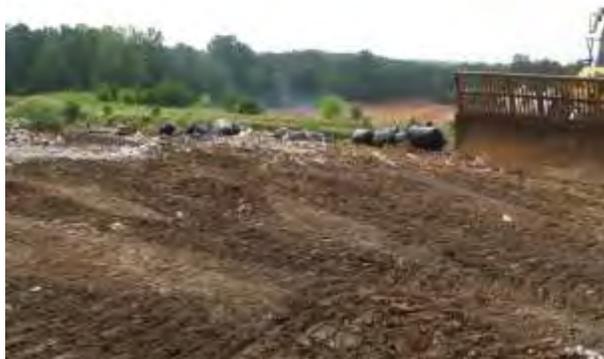
9. Working face of the MSW landfill.

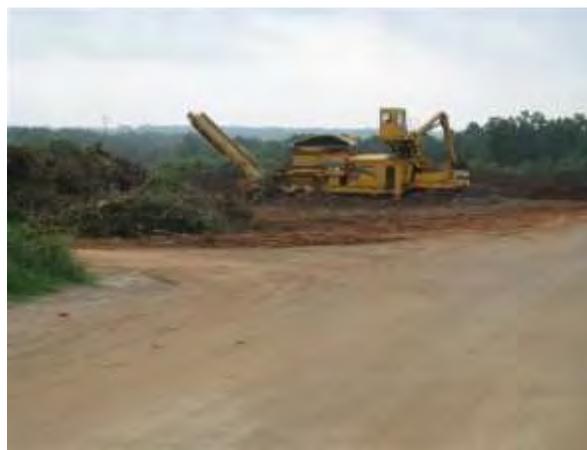
10. "Tub" grinder owned by Lincoln County.

36. Wooden pallets are ground into boiler fuel.
37. Lincoln County owns the grinder for processing the wooden pallets. (Photo #10)
38. Currently there is very little market for this boiler fuel.

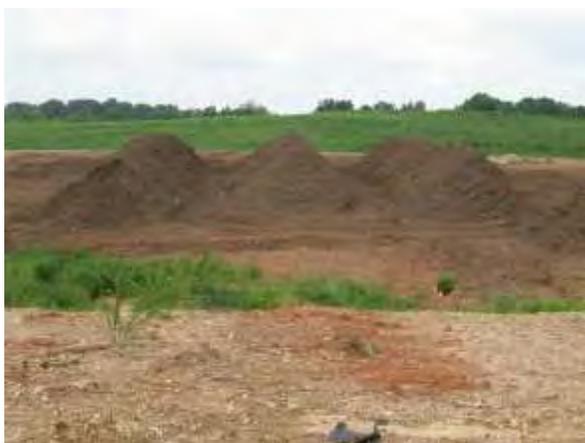
39. A Request for Acknowledgement Letter (RAL) – Small Type I Composting Unit has been approved for the grinding of yard waste into mulch.
40. Lincoln County owns the grinder for processing the yard waste.
41. The yard waste mulch was windrowed into windrows at the time of inspection. (Photo #11)
42. After composting (131°F for at least three days) the mulch is either distributed for use at Lincoln County facilities and properties or given away to Lincoln County residents.
43. Compost is given to Lincoln County residents at no cost.

11. Windrows of compost.

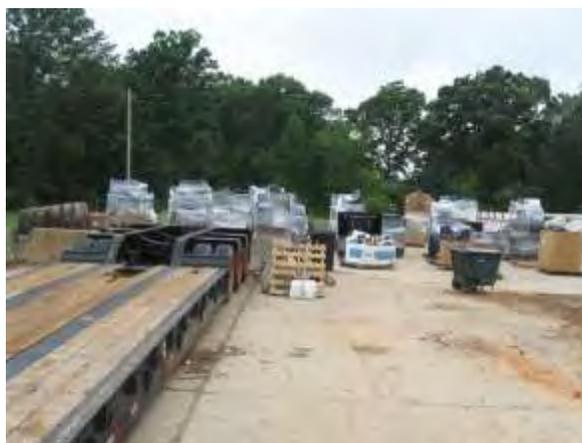
12. Electronics staged on concrete pad.

44. All electronics are collected and taken for recycling by *eCycleSecure* of Charlotte, NC.
45. Electronics are staged and shipped from the white goods concrete pad. (Photo #12)

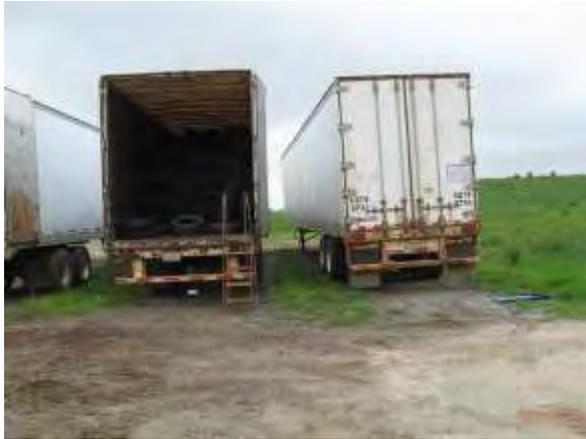
52. Scrap tires are stored in semi-trailers prior to being shipped to the *US Tire* facility in Concord, NC.
53. *US Tire* charges the landfill \$86 per ton for tire recycling and disposal.
54. Scrap tire records are maintained in the Scale House.
55. The scrap tire area was well managed. (Photo #13)
56. Scrap tire records are maintained in the scale house.

10. Three trailers used for the storage of scrap tires.

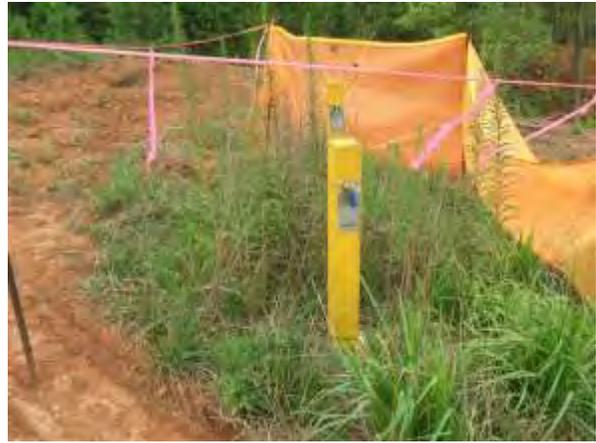
11. Typical groundwater monitoring wells – properly identified and locked.

57. Water quality monitoring records were reviewed.
58. Water quality samples are collected semi-annually by the landfill's consultant, S&ME. The most recent report of semi-annual water quality monitoring was for the sampling event that occurred April 14<sup>TH</sup> through April 16<sup>TH</sup> 2014.
59. The water quality monitoring plan consists of twenty-eight groundwater monitoring wells, six surface water monitoring points and one leachate sample.
60. A random inspection of groundwater monitoring wells found all wells to be in good repair, secured with padlocks and clearly marked with unique IDs / well tags that were correlated with maps provided by the facility. (Photo #11)

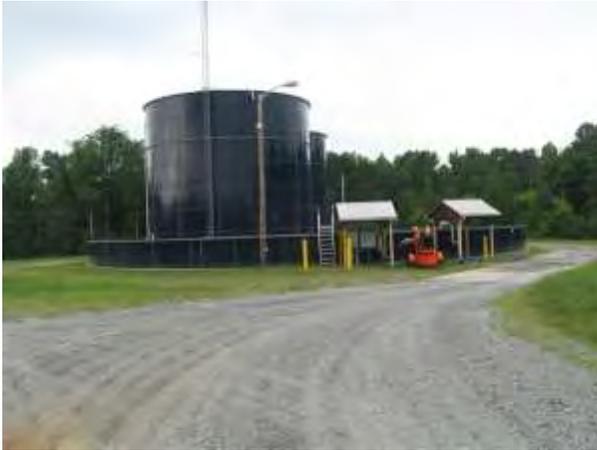
67. The leachate collection system consists of two 250,000-gallon aboveground storage tanks (ASTs). (Photo #12)
68. Leachate is gravity fed to a lift station which pumps the leachate up to the leachate ASTs.
69. Leachate is removed from the ASTs and hauled by landfill staff to the Lincolnton waste water treatment plant.
70. Leachate is routinely removed from the ASTs whenever the level exceeds 50% capacity of any one tank.

12. Two 250,000-gallon above ground leachate storage tanks located in the (SW) corner of the facility.
