FACILITY COMPLIANCE AUDIT REPORT
Division of Waste Management
Solid Waste Section

Date of Audit: August 13, 2014

Owls Den MSW Landfill - Closed
 701 Owls Den Road (SR-1203)
 Howards Creek, NC

Comprehensive compliance inspection.

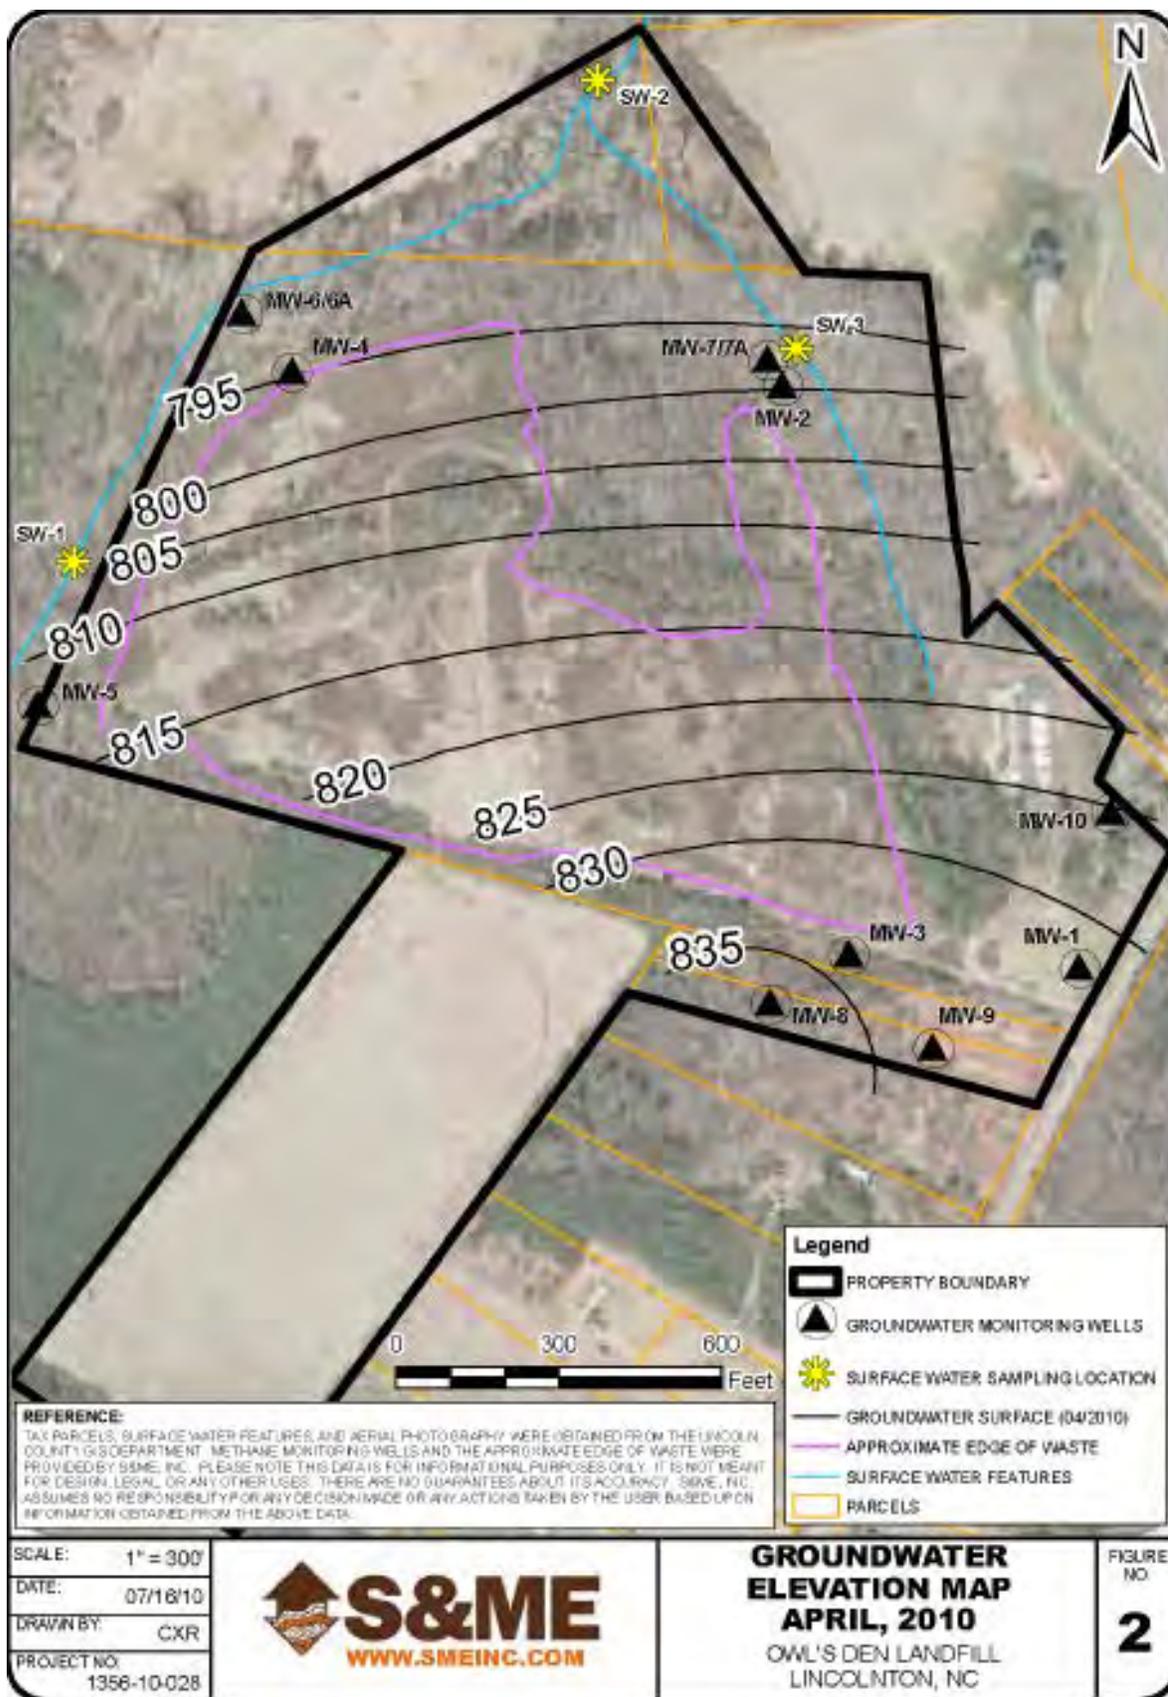
Figure 1: Lincoln Co. GIS Aerial: Owl's Den Closed MSW Landfill 55-02
 (With the Approximate Groundwater Monitoring Well Locations)

10. Required semi-annual analysis of water samples of one background monitoring well (MW-1) and ten existing groundwater monitoring wells (MW-2,4,5,6,6A,7,7A,8,9, and 10) and surface water monitoring from three locations (SW-1,2, and 3) was last completed on April 17 & 18, 2014, by S&ME, Inc. (Figure 1)
11. Three surface water points (SW-1, 2, and 3) are monitored semi-annually. SW-1 is the background surface water sampling point.
12. All of the groundwater and surface water samples were analyzed for the Federal Appendix I list of volatile organic constituents and for the eight RCRA metals.
13. A random inspection of the groundwater methane monitoring wells found all inspected to be properly labeled and secured. (Photos #7 & #8)

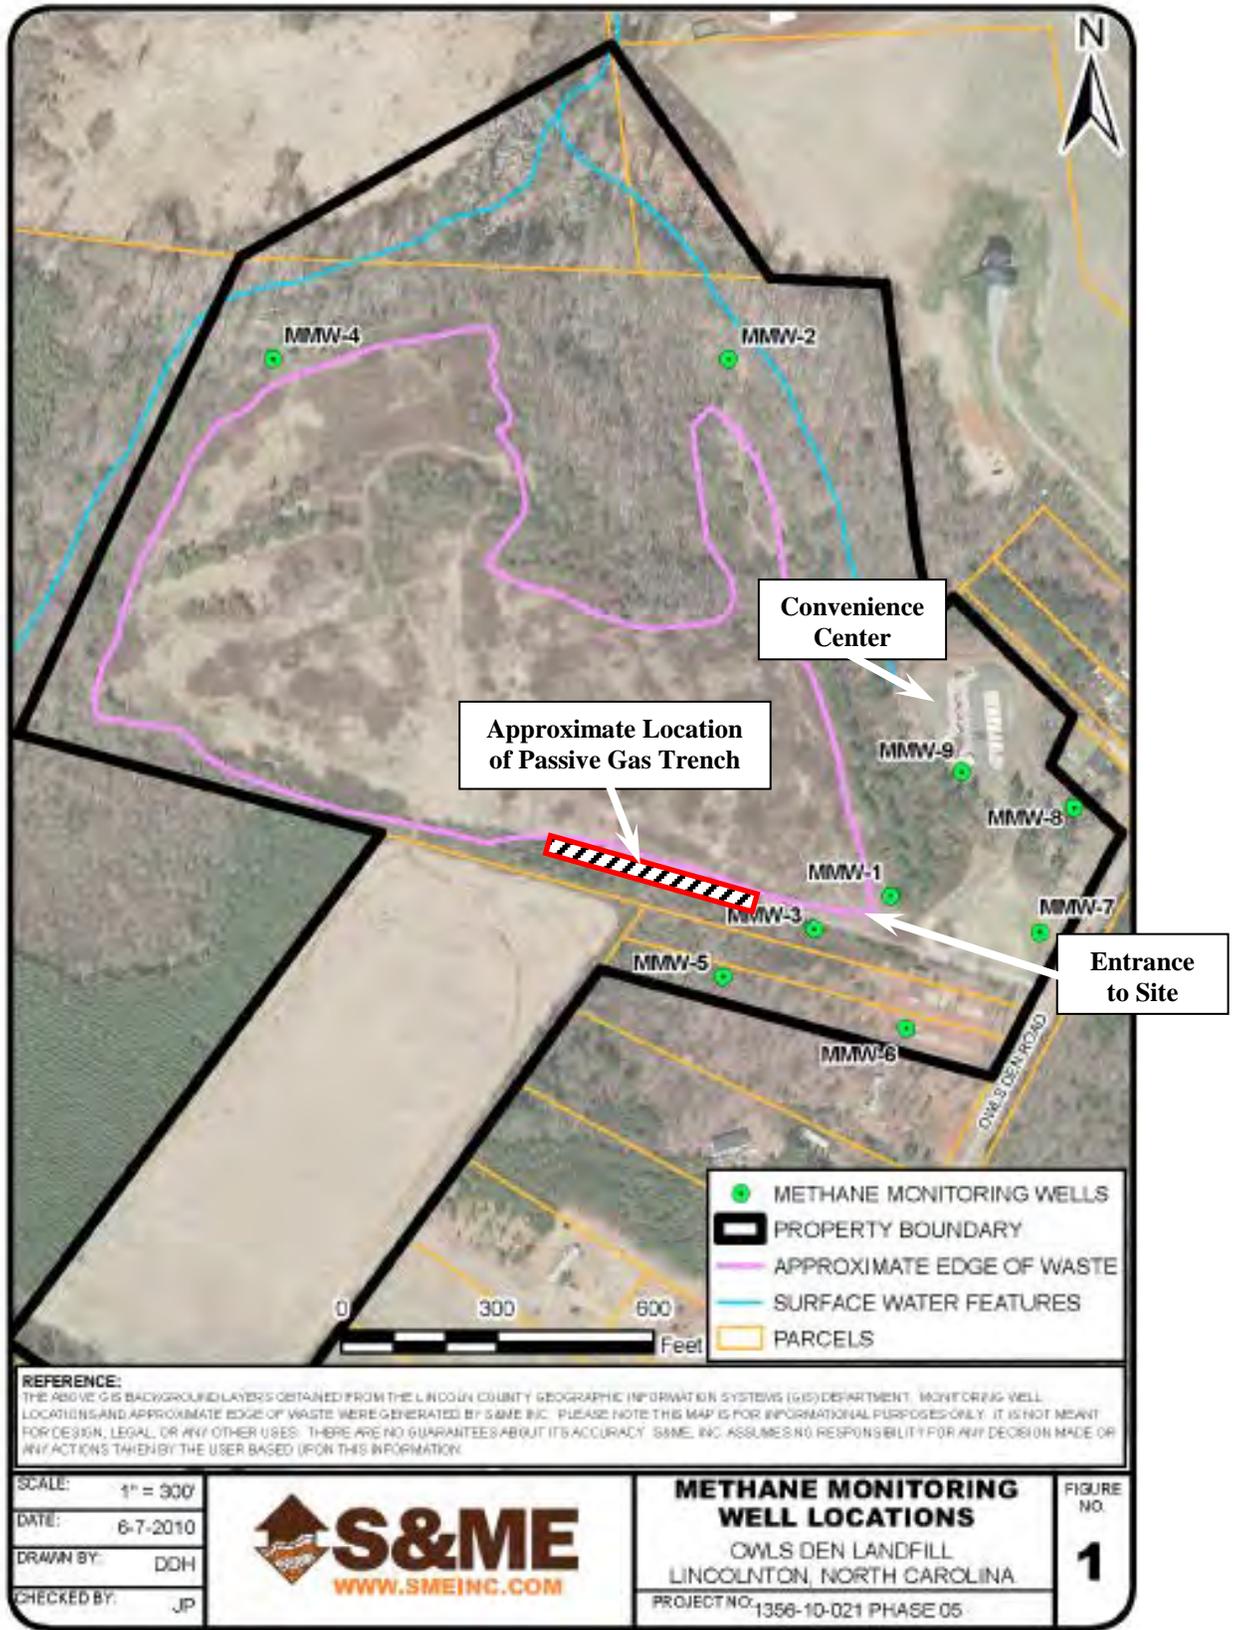
Figure 2: Lincoln Co. GIS Aerial: Owls Den Closed MSW Landfill 55-02
 (With the Approximate Methane Monitoring Well Locations)

14. As required by the approved CAP, a 400-foot long passive gas trench with five positive gas vents (T-1 through T-5 installed at 100-foot intervals along the trench) was installed along the edge of waste on the southern boundary. (Figure #2 and Photos #7 & #9)
15. Landfill gas monitoring wells has been conducted since June 2010.
16. Monthly landfill gas monitoring of MMW-2,4,5,6,7,8, and 9 (Figure 2) is done by Lincoln County Landfill staff using a *GEM 2000* combustible gas meter. (Landfill gas monitoring wells MMW-1 and MMW-3 have been removed from the monitoring plan.) The most recent monitoring occurred was conducted on April 18, 2014. (Figure 1)
17. Landfill gas monitoring is also done of the residence at 659 Owl's Den Road whenever the County can get permission from the occupant.

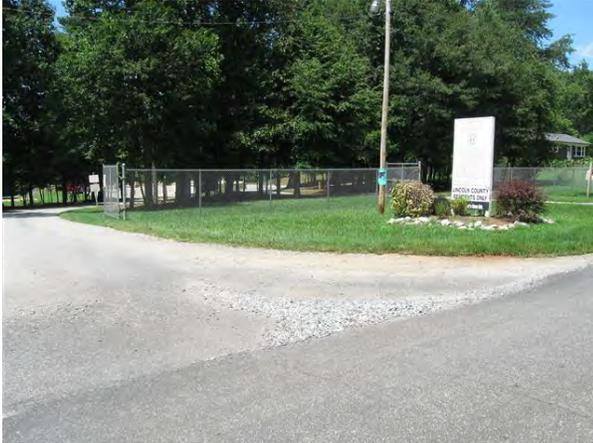
1. While the entrance to the site is controlled by a locked gate, access to the site can be made through the “convenience center” on Owls Den Road. (Photo #1)

1. Entrance to the convenience on Owls Den Road.

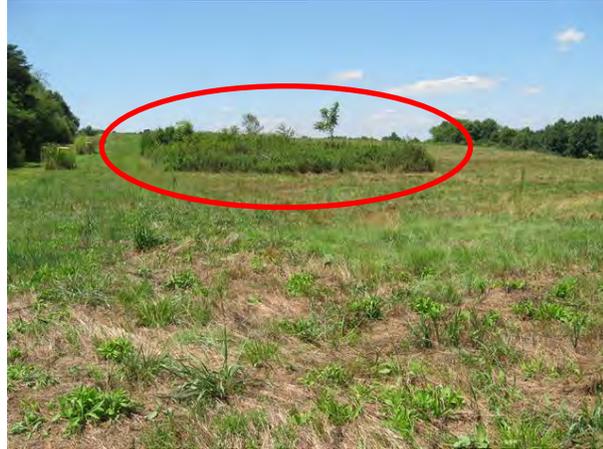
2. While most of the landfill had recently been mowed, some areas are still in need of mowing. (Photo #2 and #4-#6)
3. While edge-of-waste markers clearly delineated most of the landfill (Photo #3), some of the markers were located in areas that were in need of mowing (Photo #4).

2. Looking (SSW) down the SSW side of the landfill from just inside of the entrance. (Note the "island" of un-cut vegetation that needs to be mowed.)

18. The integrity of the cap of the landfill must be properly maintained. Proper and necessary maintenance of the cap includes, at a minimum:

- Mowing the cap as needed to prevent the establishment of trees and woody vegetation;
- Repairing the effects of any surface erosion or subsidence;
- Maintaining the slope of the cap to ensure the controlled shedding of surface water;
- Maintaining the slope of the cap to prevent the ponding of water over waste;
- Establishing and maintain native grasses to stabilize the cap;
- Initiate adequate erosion control measures to prevent excessive on-site erosion; and to prevent silt from leaving the site.

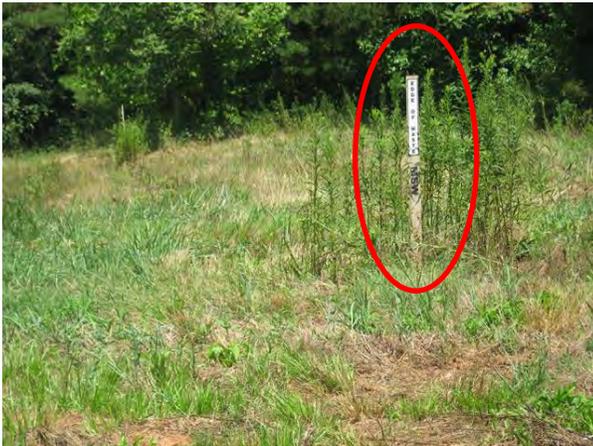
3. Edge-of-waste marker in an area that has recently been mowed.

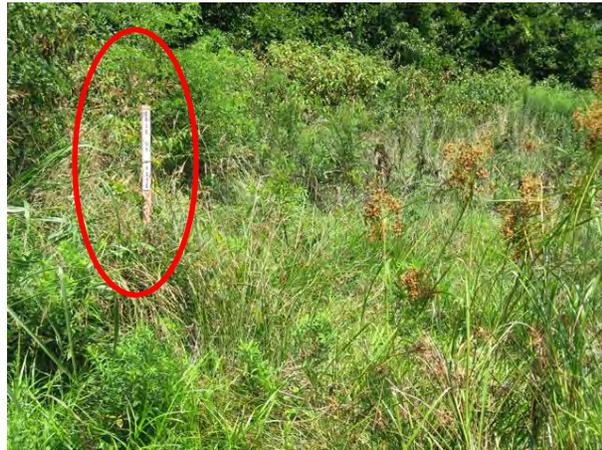
4. Edge-of-waste marker in an area that needs to be mowed.

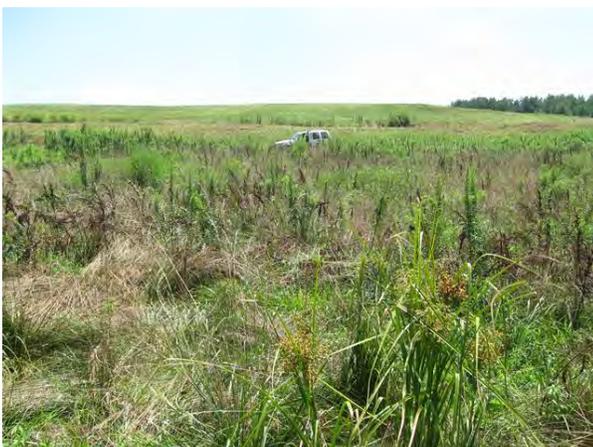
5. Looking (E) from near MW-4, across the landfill. Note the vegetation in the foreground needs to be cut.

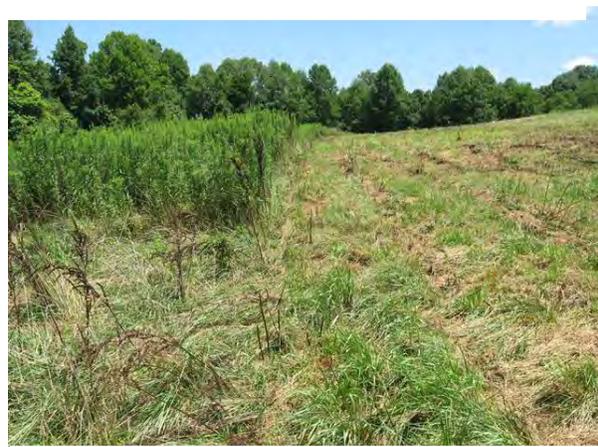
6. Looking (NNE) along the western edge of waste, in the area of MW-4. Note the vegetation on the left that needs to be cut.

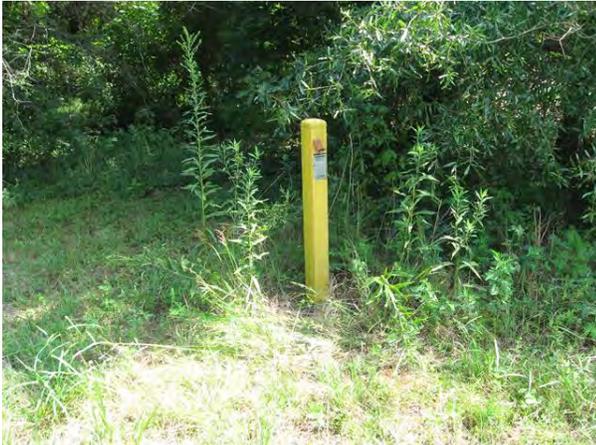
7. Ground water monitoring well (typical) properly locked and labeled.

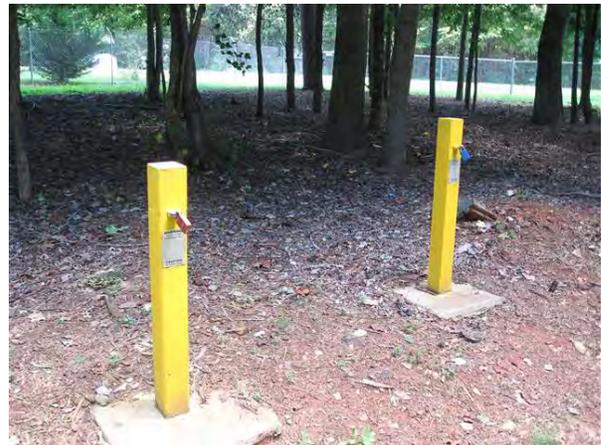
8. Ground water monitoring well MW-10 on the right and methane monitoring well MMW-8 on the left, properly locked and labeled.

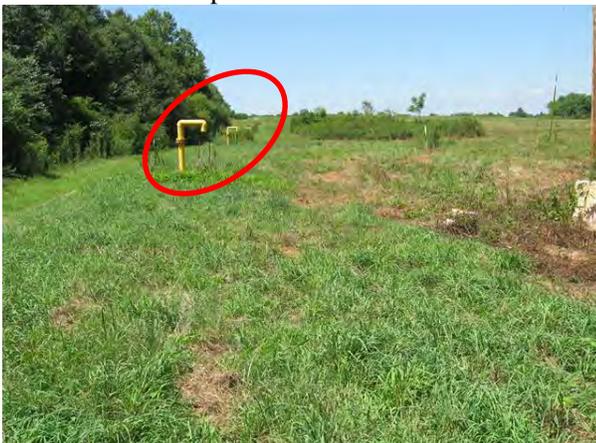
9. Looking (SSW) down the SSW side of the landfill from just inside of the entrance. Note the "line" of five positive gas vents on the left.
