**FACILITY COMPLIANCE AUDIT REPORT**  
**Division of Waste Management**  
**Solid Waste Section**

**Date of Audit:** 9/22/14**Date of Last Audit:** 3/05/14**FACILITY NAME AND ADDRESS:**

McDowell MSW – Closed October 7, 1994  
 2849 NC Hwy 226 S.  
 Marion, NC 28752

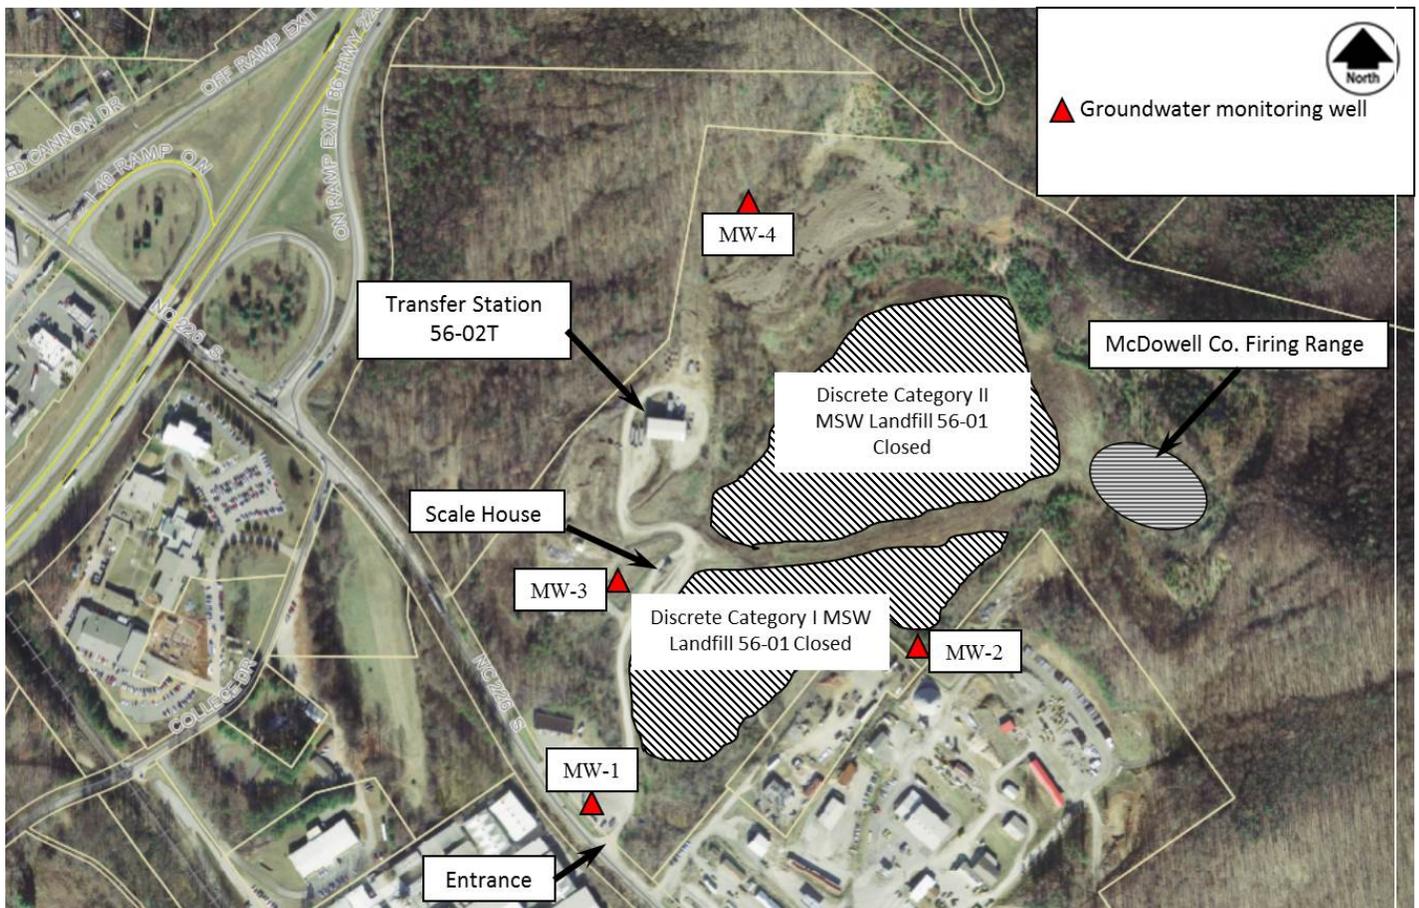
- The closed McDowell County municipal solid waste (MSW) landfill consists of two separate areas: “Discrete Category I Landfill” and “Discrete Category II Landfill”. (Figure 1)
- Category I landfills are MSW landfills that did not receive solid waste after 10/9/93, and were closed in accordance with their Permit, the Conditions of their Permit, and 15A NCAC 13B .0510.
- Category II landfills are MSW landfills that continued to receive solid waste after 10/9/91, but stopped receiving waste before 10/9/93, and were closed in accordance with their Permit, the Conditions of their Permit, and 15A NCAC 13B .0510; and the cap system had to be installed within 6-months of the last receipt of wastes and meet the criteria of set forth in 15A NCAC 13B .1627(c)(1).

Figure 1: McDowell Co. GIS Site Map – Approximate Location of Closed MSW Landfill 56-01

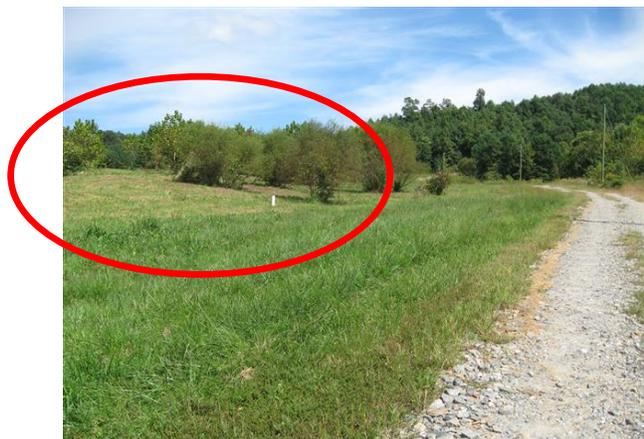
McDowell County has failed to maintain the final cover system in accordance with the December 13, 1995 letter, titled “*Closure of the McDowell County Landfill, Permit #56-01*”. Specifically, trees and woody vegetation have become established on both the *Discrete Category I* and the *Discrete Category II*, closed landfill units. The root systems of this vegetation can compromise the integrity of the cap systems which can lead to increased erosion of the cap as well as increased surface water infiltration.

1. Looking (E) down the access road to the gun range at multiple trees near the northeast edge of the "Discrete Category II" landfill.

**It is recommended that McDowell County develop and implement a written maintenance plan for the landfill. At a minimum this plan should include a schedule for routine inspections and implementation of the following actions:**

- Ensure that vegetation on the cap is mowed sufficiently to allow for inspection of the cap;
- Ensure that trees and woody vegetation are prevented from becoming established on the cap;
- Ensure that any surface erosion is repaired and re-seeded as necessary;
- Ensure that erosion is controlled and repaired to so that no silt or sediment leaves the site;
- Ensure that any leachate seeps in the cap are repaired;
- Ensure that any areas of bare soil are reseeded to establish a vegetative cover;
- Ensure that any areas of subsidence of the cap are repaired, re-sloped and reseeded as necessary to ensure the controlled shedding of surface water from the cap;
- Ensure that “edge-of-waste” markers are maintained in good repair;
- Ensure that property line markers are installed and maintained in good repair; and
- Ensure that the groundwater monitoring wells are maintained in good repair.

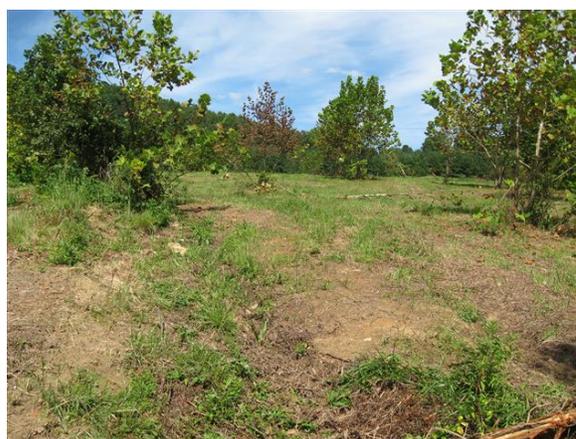
2. Multiple trees on the northeast segment of the cap of the "Discrete Category II" landfill.

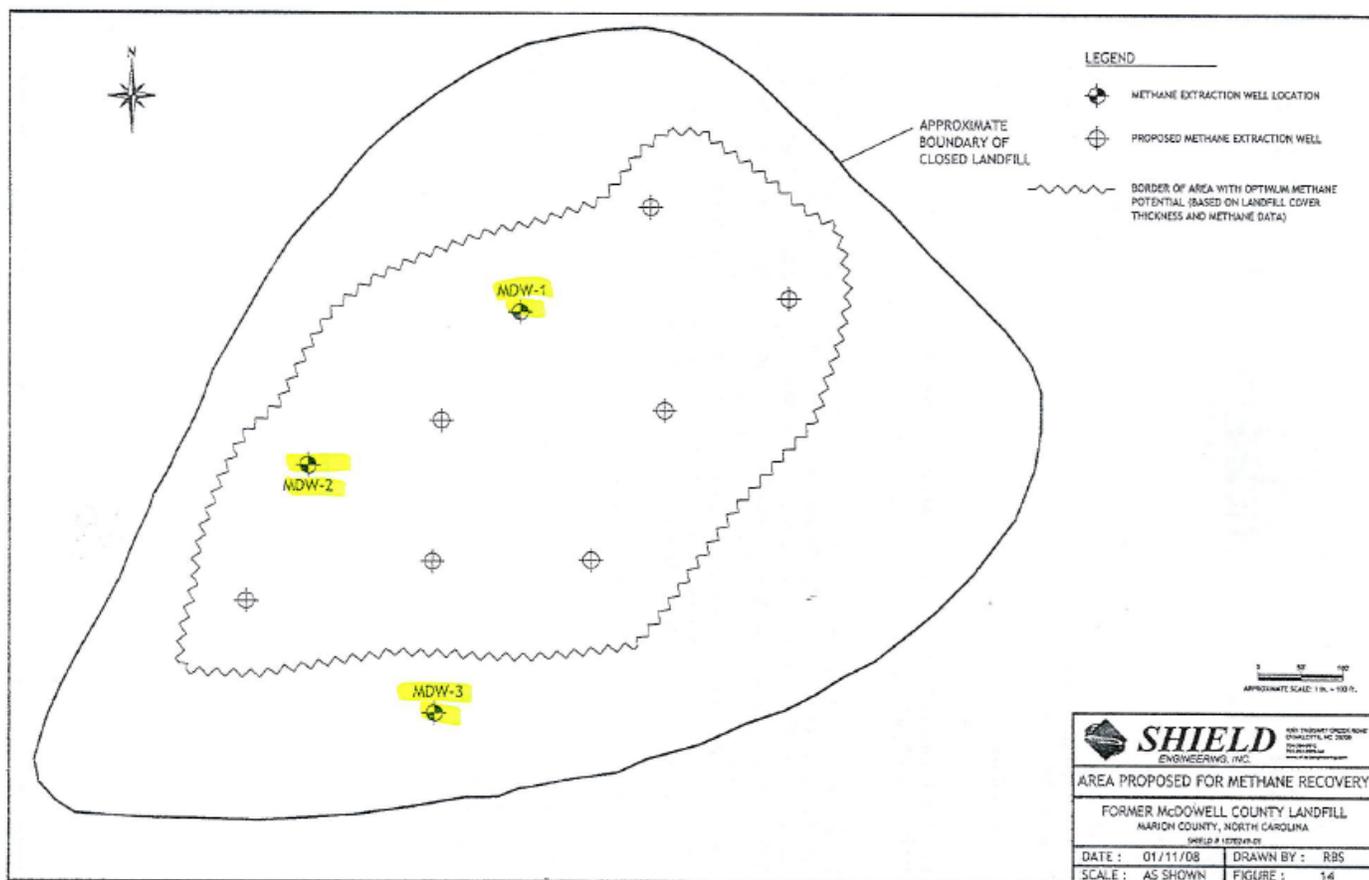
- On 10/20/07 McDowell County's consultant (Shield Engineering) requested that NCDER approve the installation of three methane extraction wells at the McDowell County MSW Landfill. (Figure 2)

- On 12/06/07, the Permitting Branch Supervisor (Ed Mussler) of the Solid Waste Section (SWS) approved the Shield Engineering's request to install three methane extraction wells on the "Discrete Category II Landfill". (Figure 2)

- There are no records of the installation of the three proposed methane extraction wells on the "Discrete Category II Landfill".
- Only one of the three proposed methane extraction wells, believed to be MDW-3, was observed during this inspection. (Figure #2 and Photo #13). It is believed that proposed methane extraction wells MDW-1 and 2 were never installed. The odor of landfill gas was present in the area of MDW-3, suggesting that this well was passively venting landfill gas.

Figure 2: Proposed Location of Three Landfill Gas Recovery Wells on Discrete Category II Closed MSW Landfill (1-11-08)

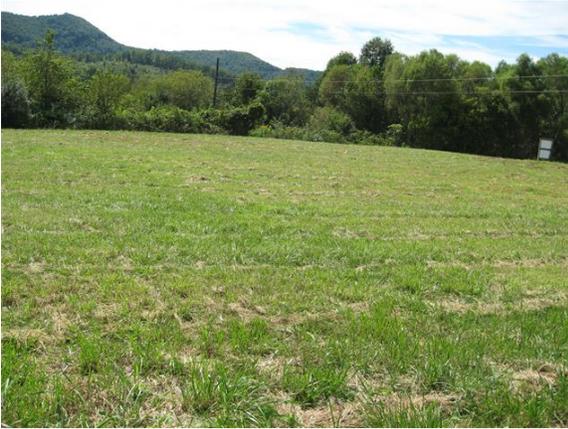
1. The “Discrete Category I” landfill was well maintained – mowed and free of surface erosion and subsidence. However, as the limits of waste are not marked, it appears that the northeast quadrant of this landfill may be covered with mature trees. (Photo #7) **The waste boundaries must be determined and marked** to confirm that the cap is free of trees and woody vegetation to ensure that the integrity and effectiveness of the final cover system is not compromised. (See the enclosed May 29, 2009 Memorandum “*Permanent Edge-of-Waste Markers at Construction and Demolition Debris Landfills, Industrial Solid Waste Landfills and Municipal Solid Waste Landfills*”)

7. Looking NE across the “Discrete Category I” landfill.

3. Permanent waste boundary and property line markers must be installed at both the “*Discrete Category I*” landfill and the “*Discrete Category II*” landfill. (See the attached May 29, 2009 Memo: *Permanent Edge-of-Waste Markers at Construction and Demolition Debris Landfills, Industrial Solid Waste Landfills and Municipal Solid Waste Landfills*)

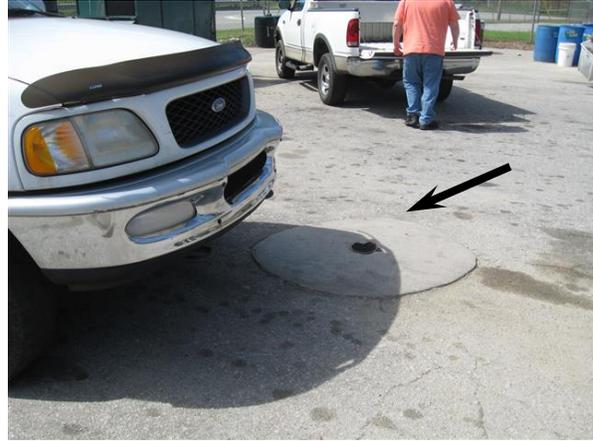
2. Inspection of the four groundwater monitoring wells (Figure 1, and photos #8 through #12) found multiple instances where the wells failed to comply with the North Carolina *Well Construction Standards* (15A NCAC 2C). These possible violations have been referred to the Division of Water Resources’ Asheville Regional Office (828-296-4500).

8. “Flush mount” ground water monitoring well (MW-1) without a cover. (Located in the convenience center collection area at the entrance.)

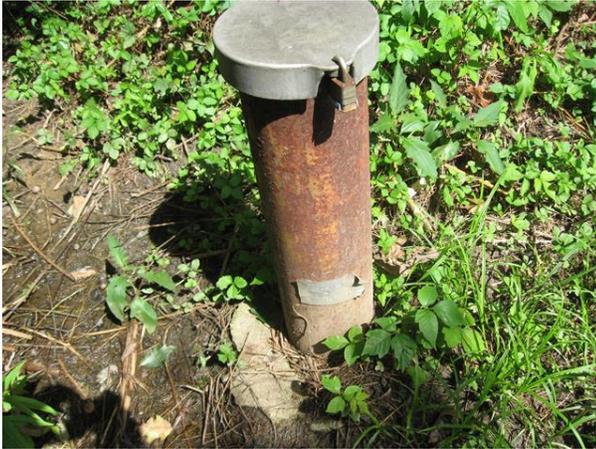
9. Ground water monitoring well MW-2 located off the SE quadrant of “Discrete Category I”

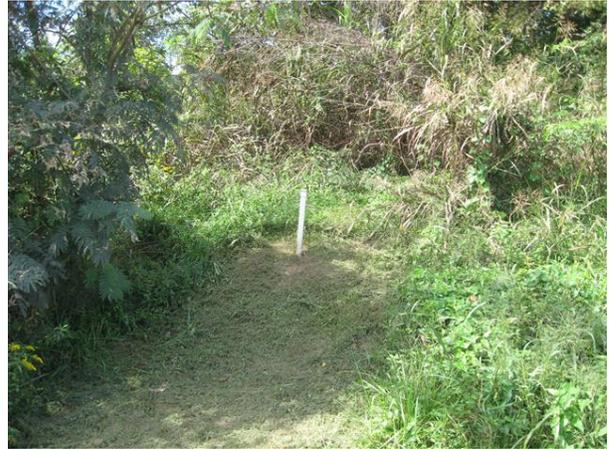
10. Ground water monitoring well MW-3. (Note the well is does not have the required steel outer casing.)

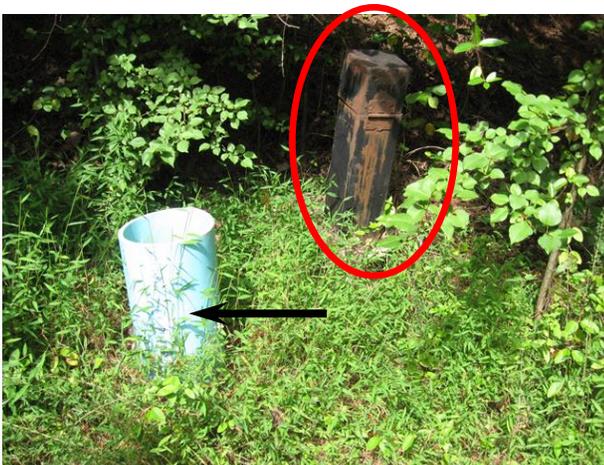
11. Ground water monitoring well MW-4 (white PVC casing) located north of the transfer station. (Note the original steel out casing to the well in the background that has broken off.)

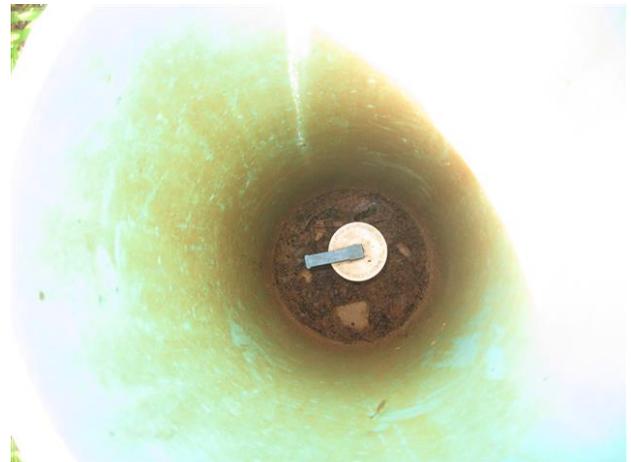
12. Looking down the PVC outer casing to MW-4 located north of the transfer station at the cap to the well. (Note that the well is not properly secured with a lock.)

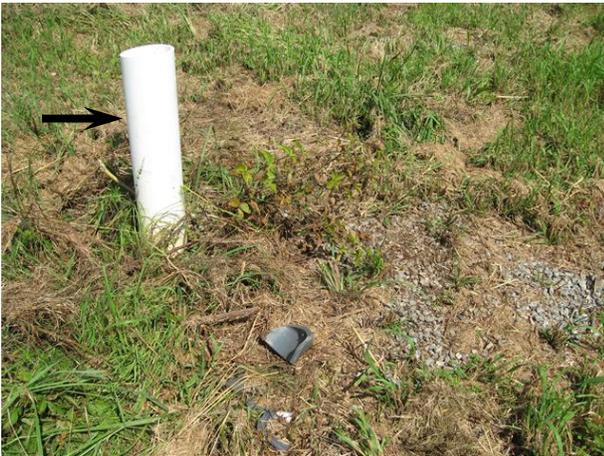
13. Six inch diameter white PVC methane extraction well (believed to be MDW-3) located near the center of “Discrete Category II Landfill”. Note that the well is not capped.

5. During the inspection, what appeared to be one of the three methane extraction wells that were approved for installation by the SWS on 12/06/07 was located. These wells are not, and never have been put into use. (Photo #13)
6. There was no evidence of any leachate breakouts or seeps on the landfill.
7. Groundwater sampling of four monitoring wells (MW-1 through MW-4) last conducted on 8/21/14 by *Pace Analytical*.
  - The analytical results of the samples collected from MW-2 showed multiple constituents in exceedance of the groundwater (2L) standards.
  - The analytical results of the samples collected from MW-3 showed constituents that are indicative of possible landfill gas migration.
8. While access roads to the groundwater monitoring wells, the road to MW-4 is badly rutted and in need of grading.
