RJN Project: 010057.01

Re: Submission of Old Fort Landfill Closure Report
Old Fort Landfill - 1240 Parker Padgett Road, Old Fort, North Carolina
Permit 56-03

OLD FORT LANDFILL CONSTRUCTION CLOSURE REPORT

**PERMIT #56-03
1240 PARKER-PADGETT ROAD
OLD FORT,
MCDOWELL COUNTY,
NORTH CAROLINA**

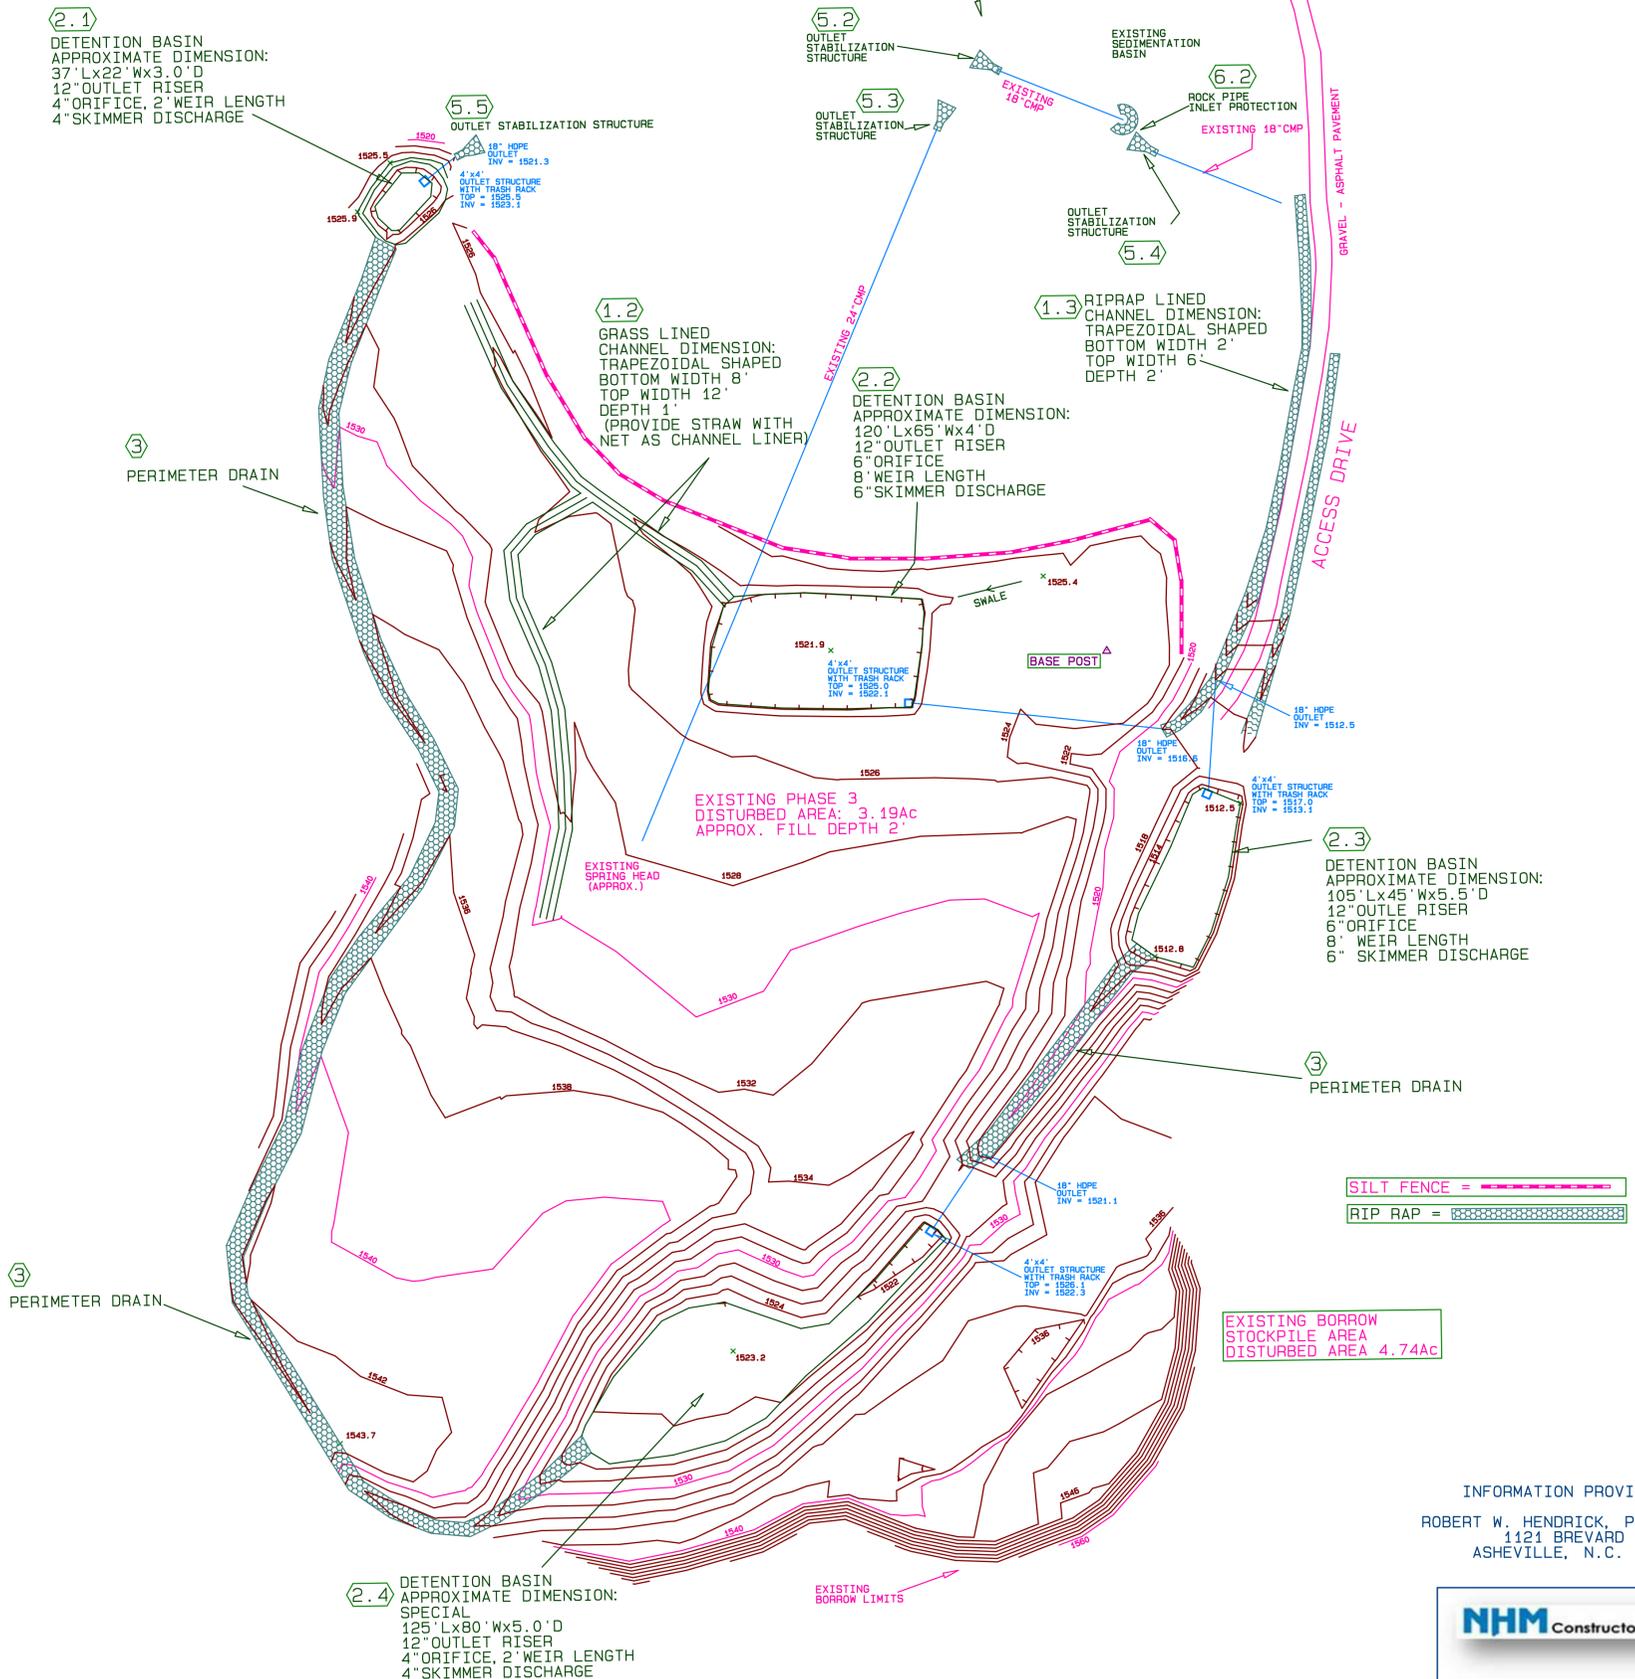
SOIL EROSION & SEDIMENT CONTROL OF OLD FORT LANDFILL

Erosion control measures were installed beginning on April 16, 2014 and completed on May 7, 2014. Erosion control measures consisted of installation of rock dams, outlet stabilization structures, sedimentation basins, perimeter drainage channels Refer to Table 1 for a complete list of countermeasures. In addition, refer to Figure 2 and 3 for the plan view of the countermeasures.

COUNTERMEASURE FEATURE	LOCATION	DESCRIPTION	DATE INSTALLED
1.2 Grass Lined Channel	Drains the grade between Phase 2 and Phase 3	Trapezoidal Channel lined with straw matting	4/30/14 - 5/5/14

1.3 RipRap Lined Channel	South side of landfill access road	Trapezoidal Channel lined with geofabric and granite rip rap, with check dams	4/30/14 - 5/7/14

2.1 Detention Basin	West end of Phase 2, collects from 3.0 perimeter drain	37'x 22' x 3' deep with 12" outlet riser	4/23/14 - 5/5/14
2.2 Detention Basin	West end of Phase 3	120'x 65' x 4' deep with 12" outlet riser	4/16/14 - 5/5/14

2.3 Detention Basin	Northwest end of Phase 3, collects from 3.0 perimeter drain	105' x 45' x 5.5' deep with 12" outlet riser	4/16/14 - 5/5/14
2.4 Detention Basin	East end of Phase 2 and Phase 3	125' x 80' x 5' deep with 12" outlet riser	5/2/14 - 5/8/14

3.0 Perimeter Drain	Drains to west in two directions from 2.4 Detention Basin. Outlets to 2.1 Detention basin and 2.3 Detention basin.	Trapezoidal Channel lined with geofabric and granite rip rap and check dams	4/30/14 - 5/7/14

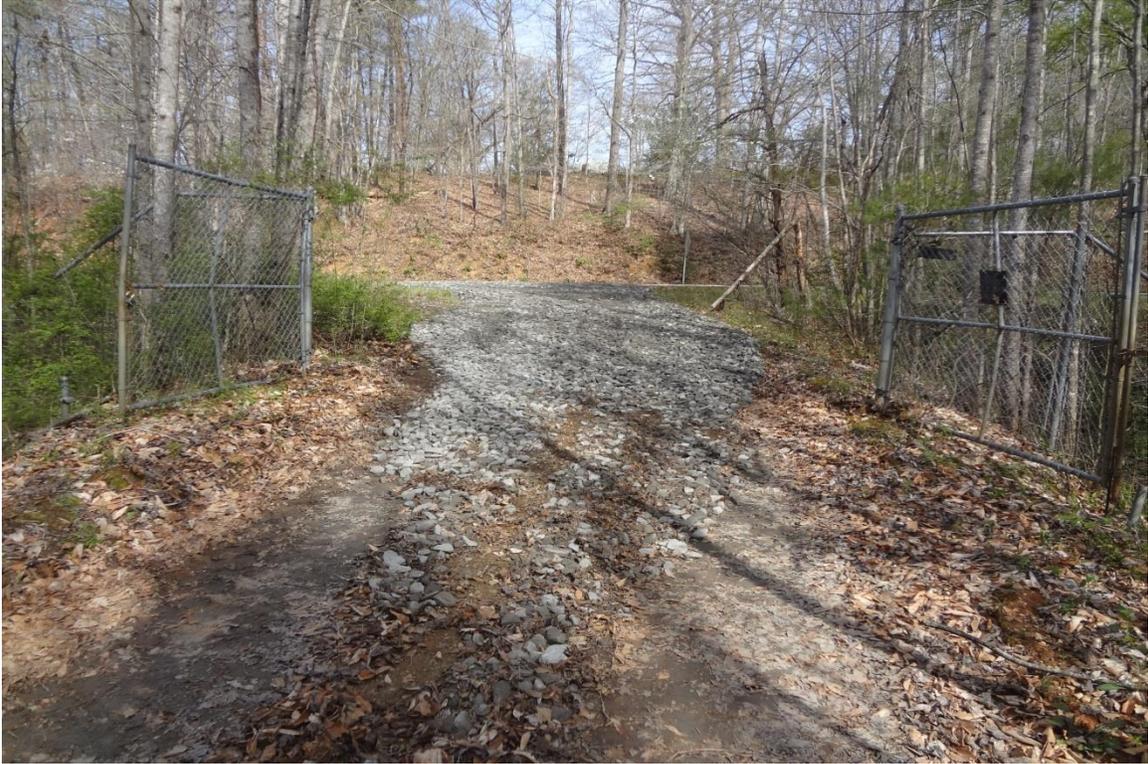
4/17/14 – Entrance of Access Road lined with stone

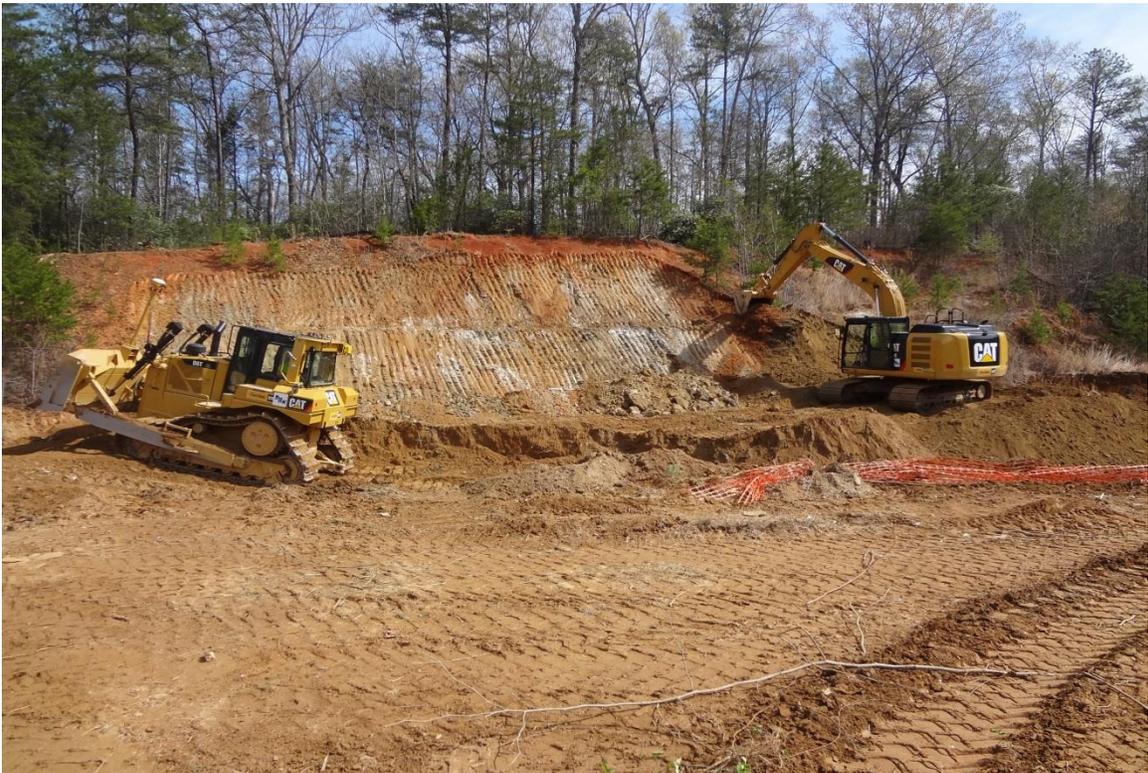
4/17/14 – Excavating 2.3-Detention Basin

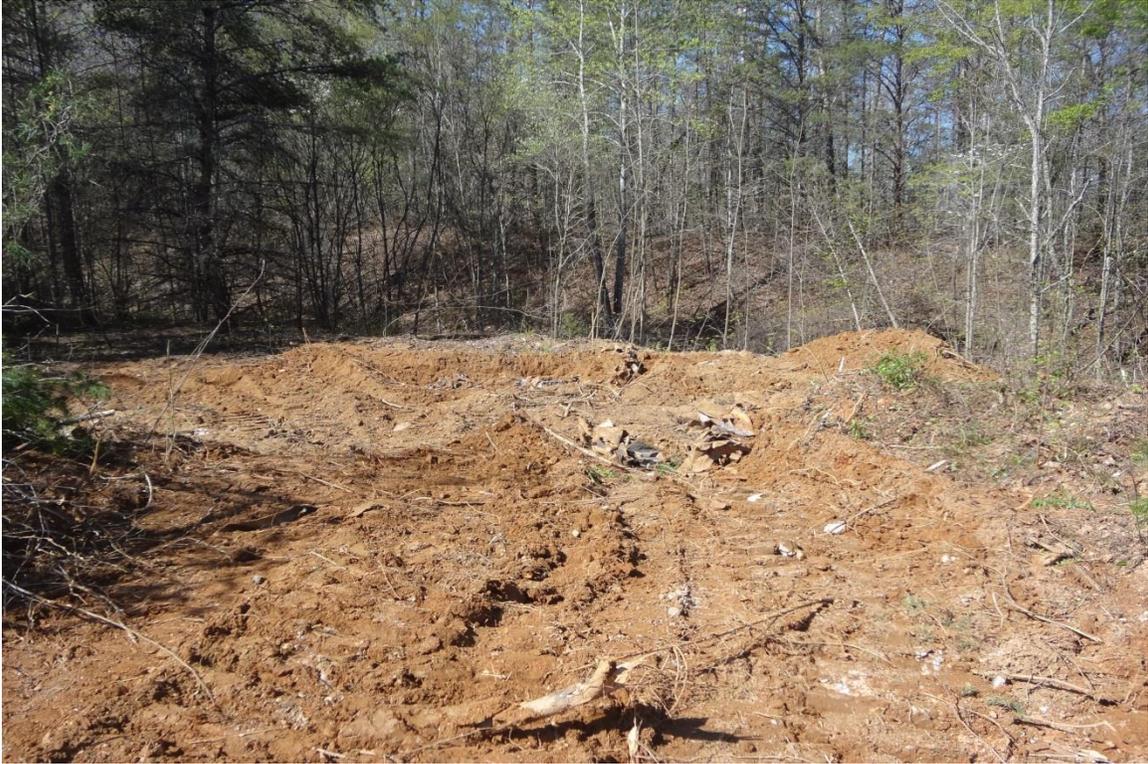
4/23/14 – Excavating 2.1-Detention Basin

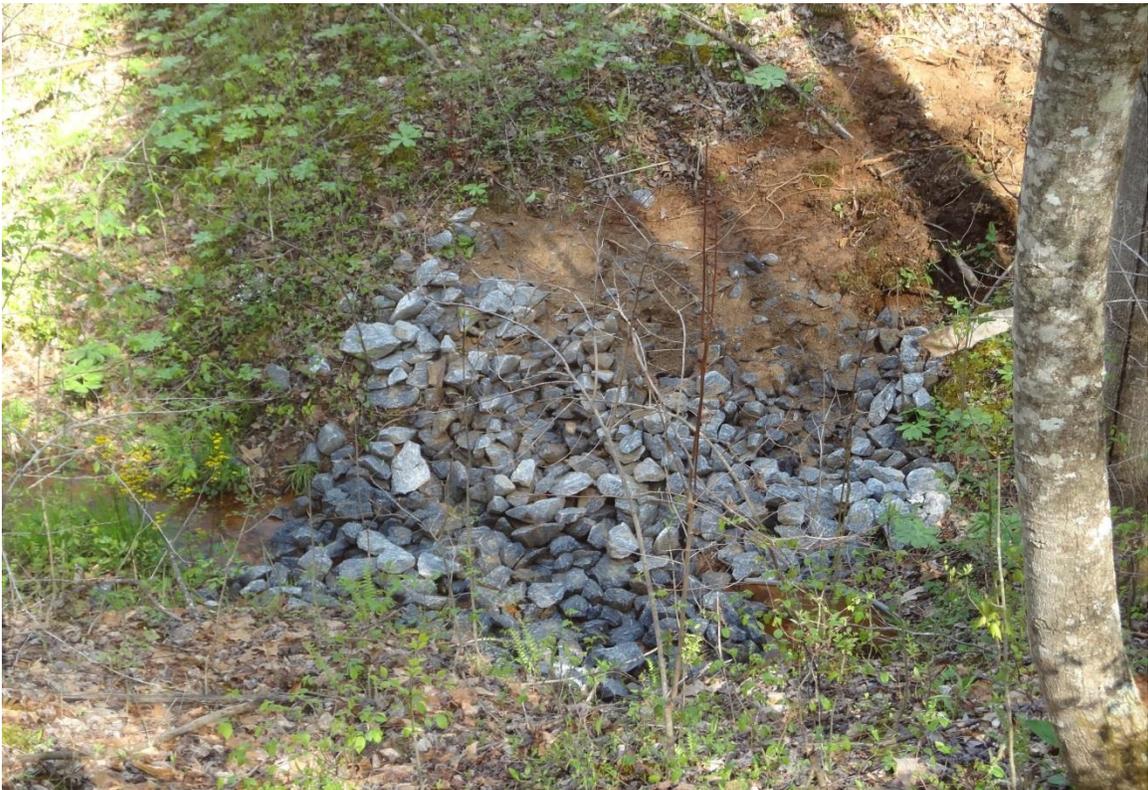
4/23/14 – 5.1-Outlet Stabilization Structure

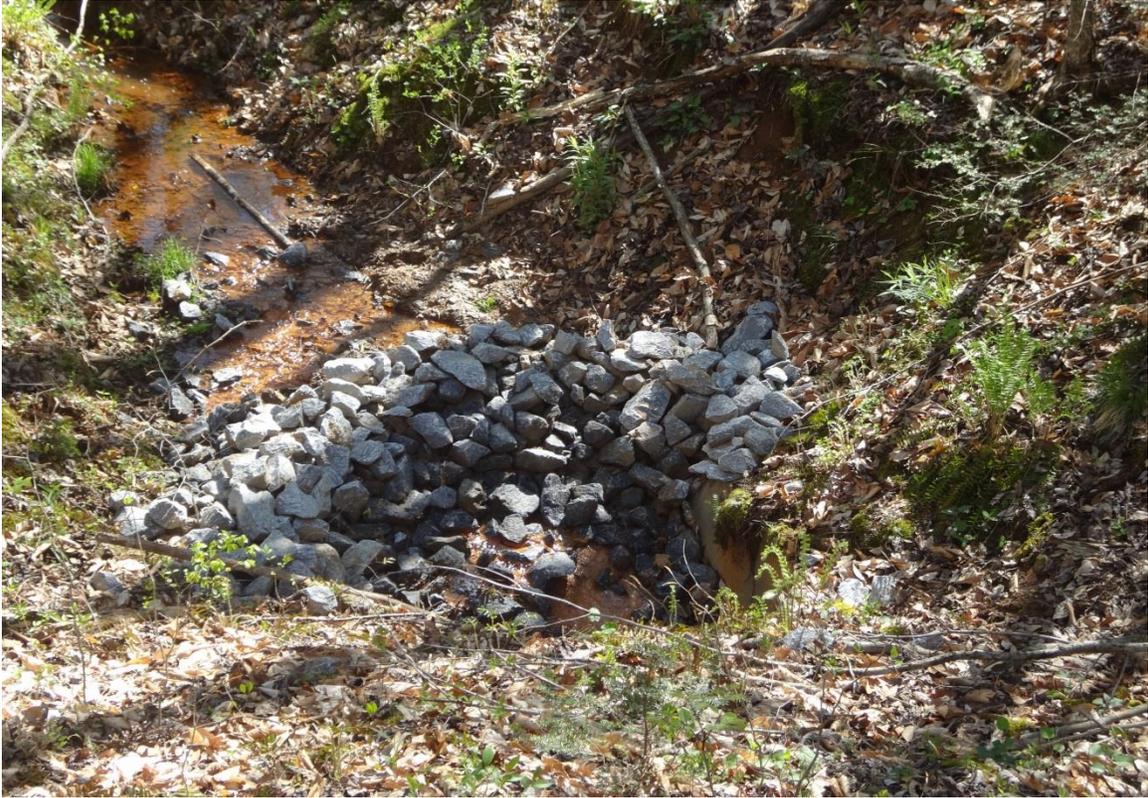
4/23/14 – 6.1-Rock Pipe Inlet Protection

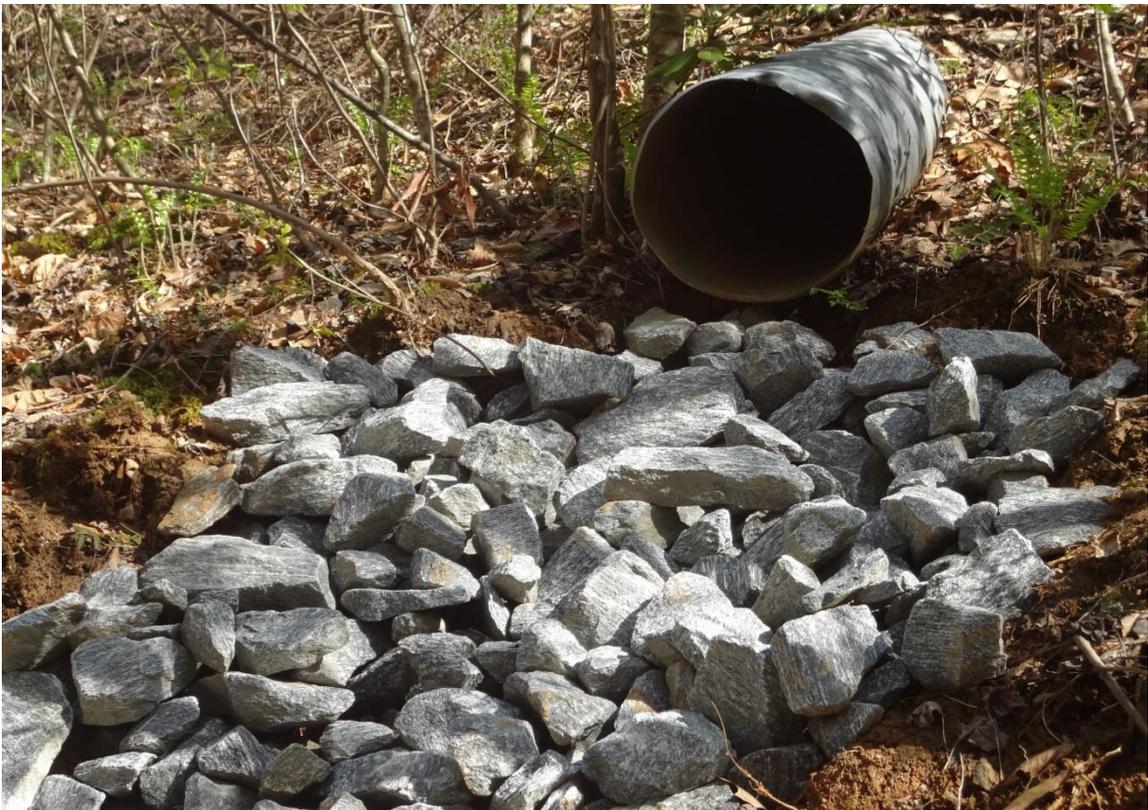
4/23/14 – 7.3-Outlet Stabilization Structure

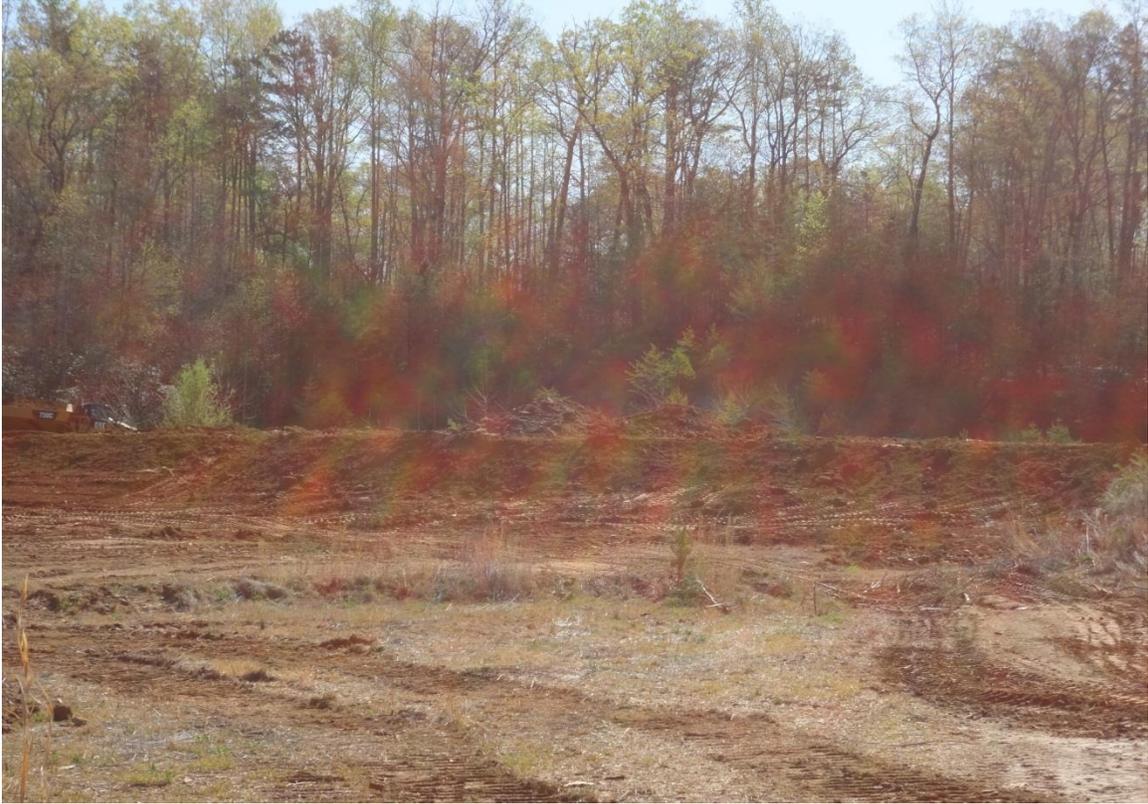
4/23/14 – Initiating placement of Phase 2 cover

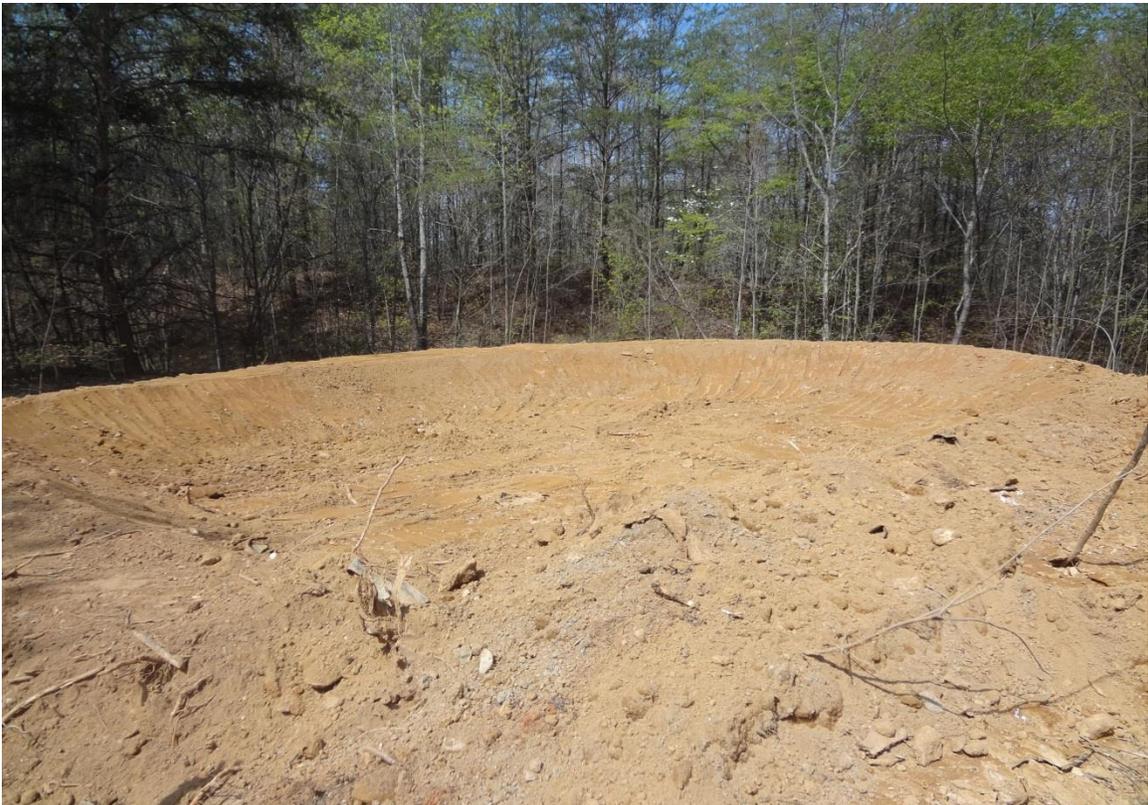
4/24/14 – Excavating 2.1-Detention Basin

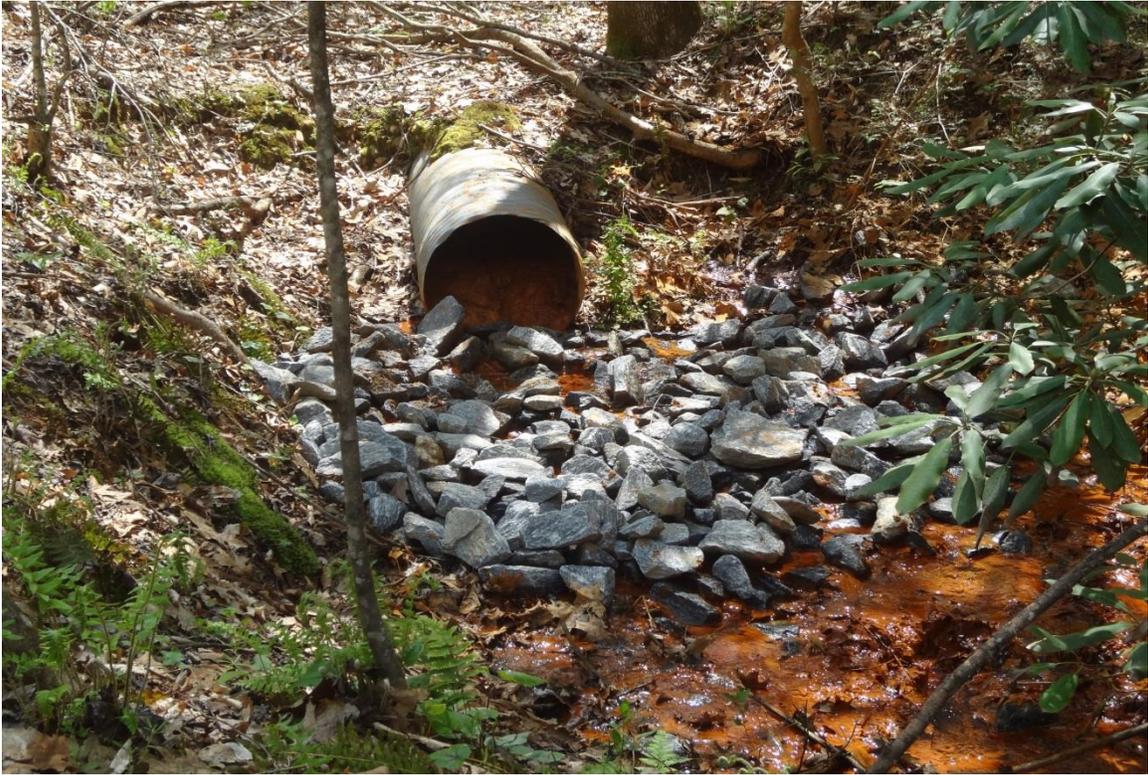
4/24/14 – 5.2-Outlet Stabilization Structure

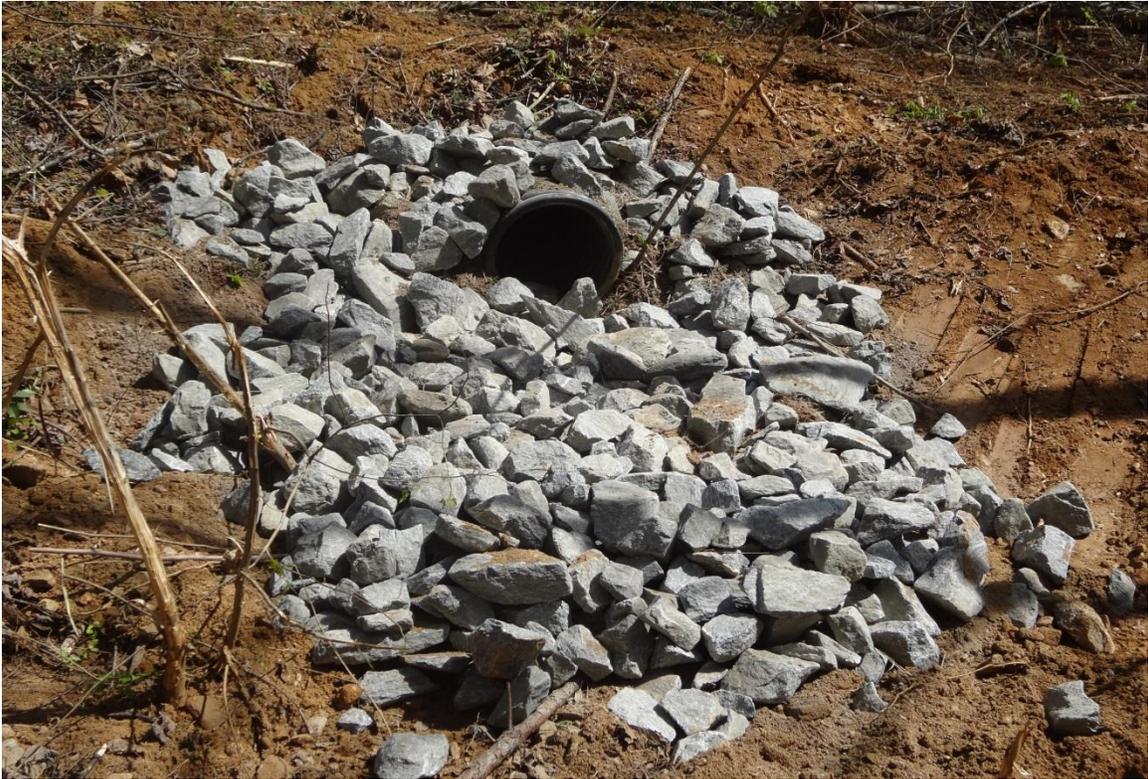
4/24/14 – 5.3-Outlet Stabilization Structure

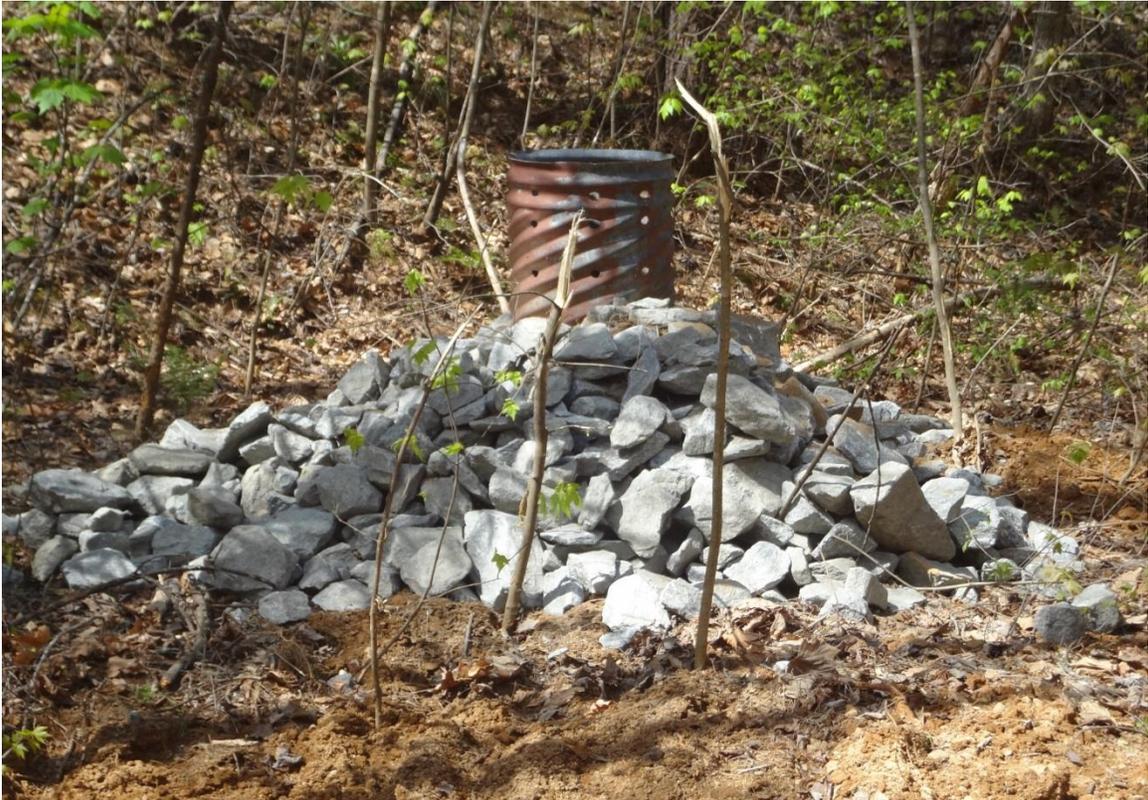
4/24/14 – 5.4-Outlet Stabilization Structure

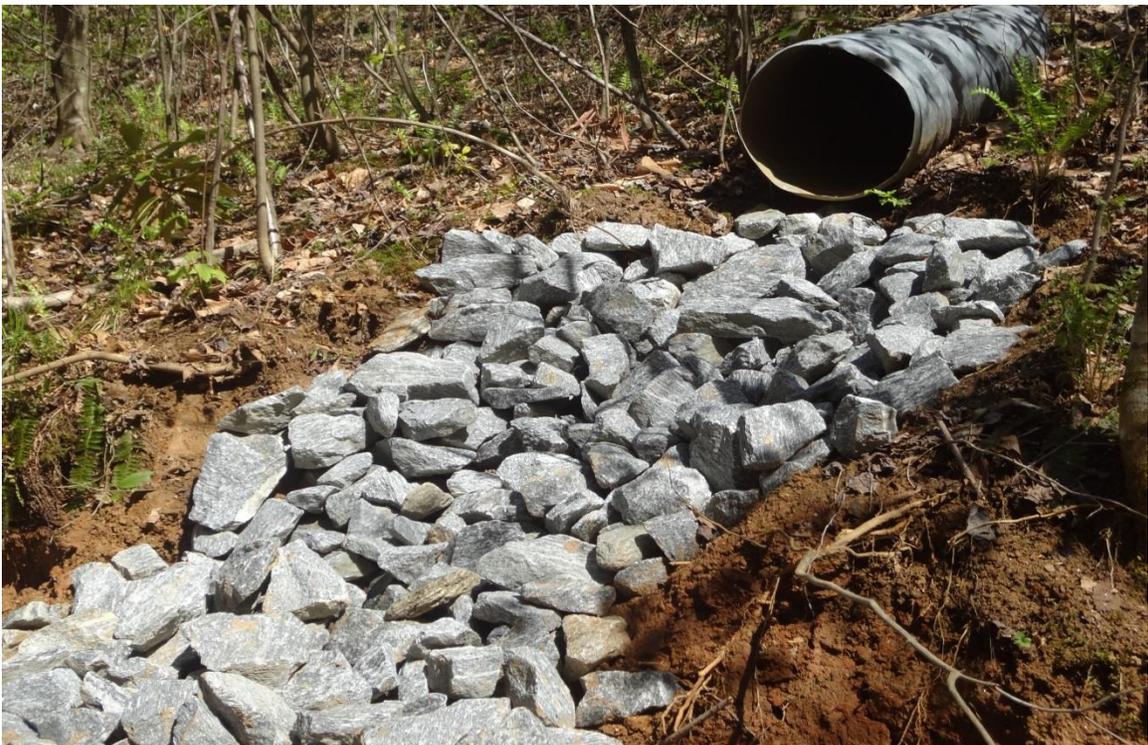
4/24/14 – 6.2-Rock Pipe Inlet Protection

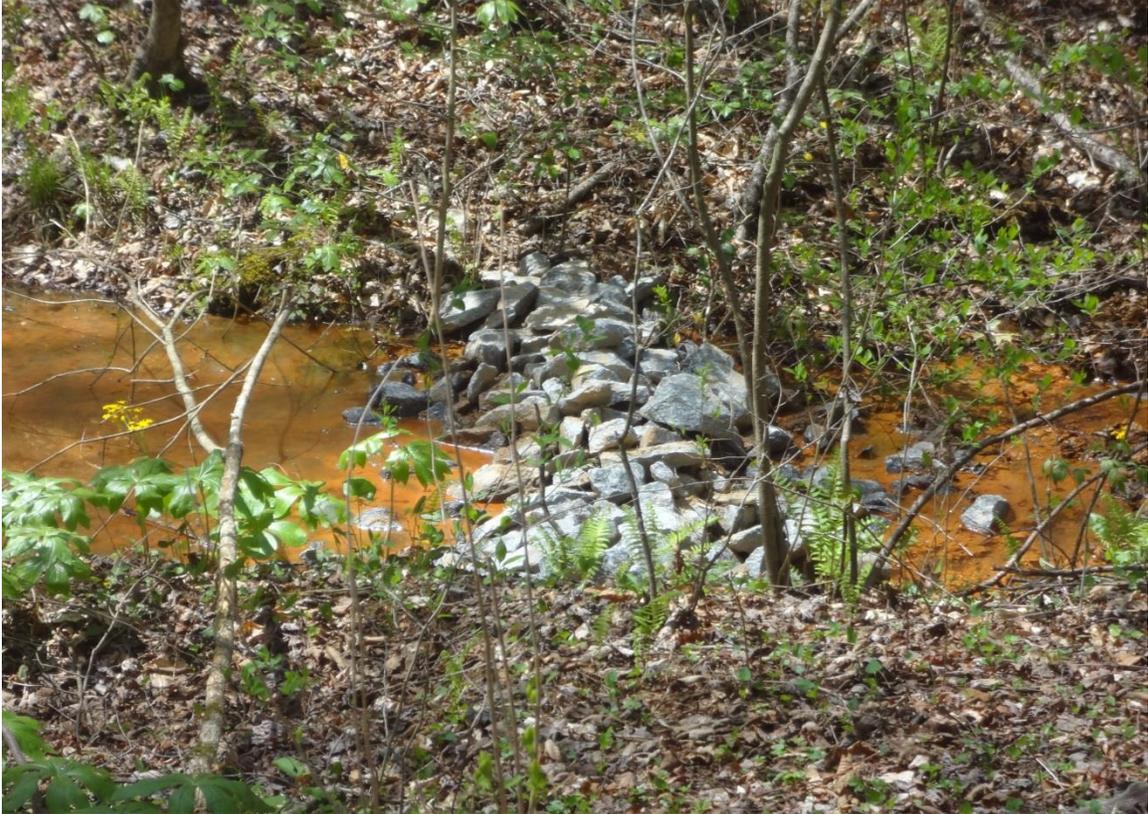
4/24/14 – 7.1-Rock Dam Stabilization Structure

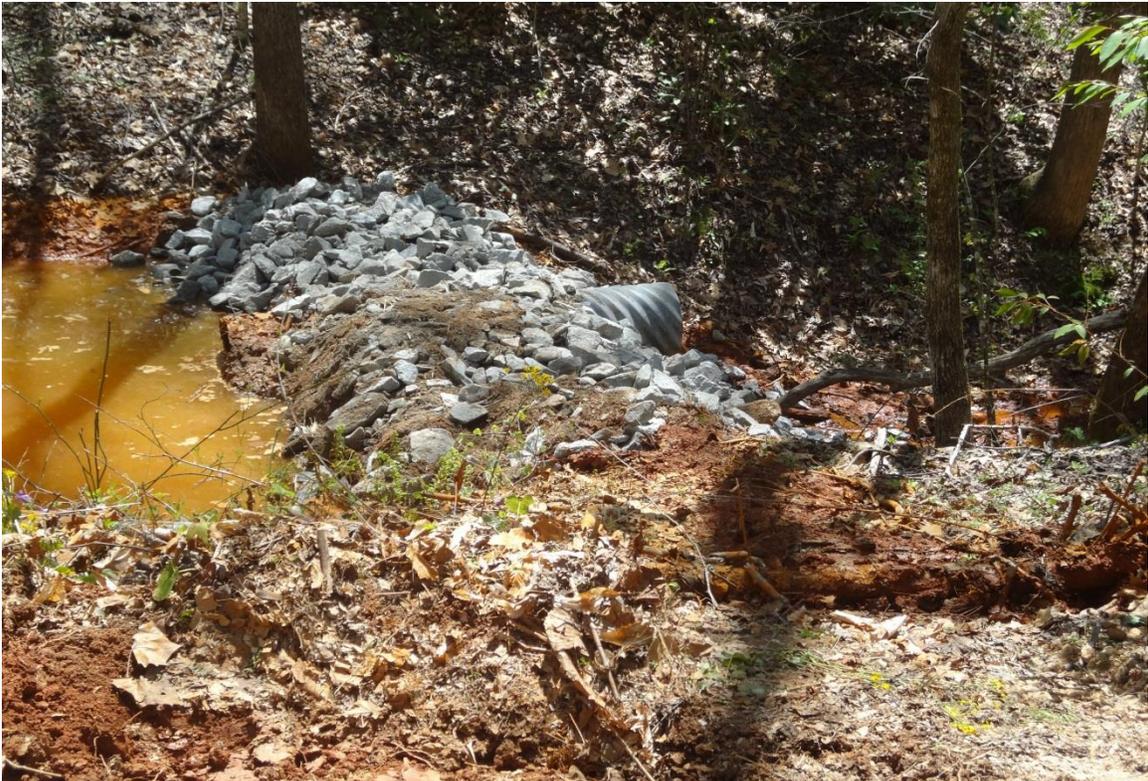
4/24/14 – 7.2-Rock Dam Stabilization Structure

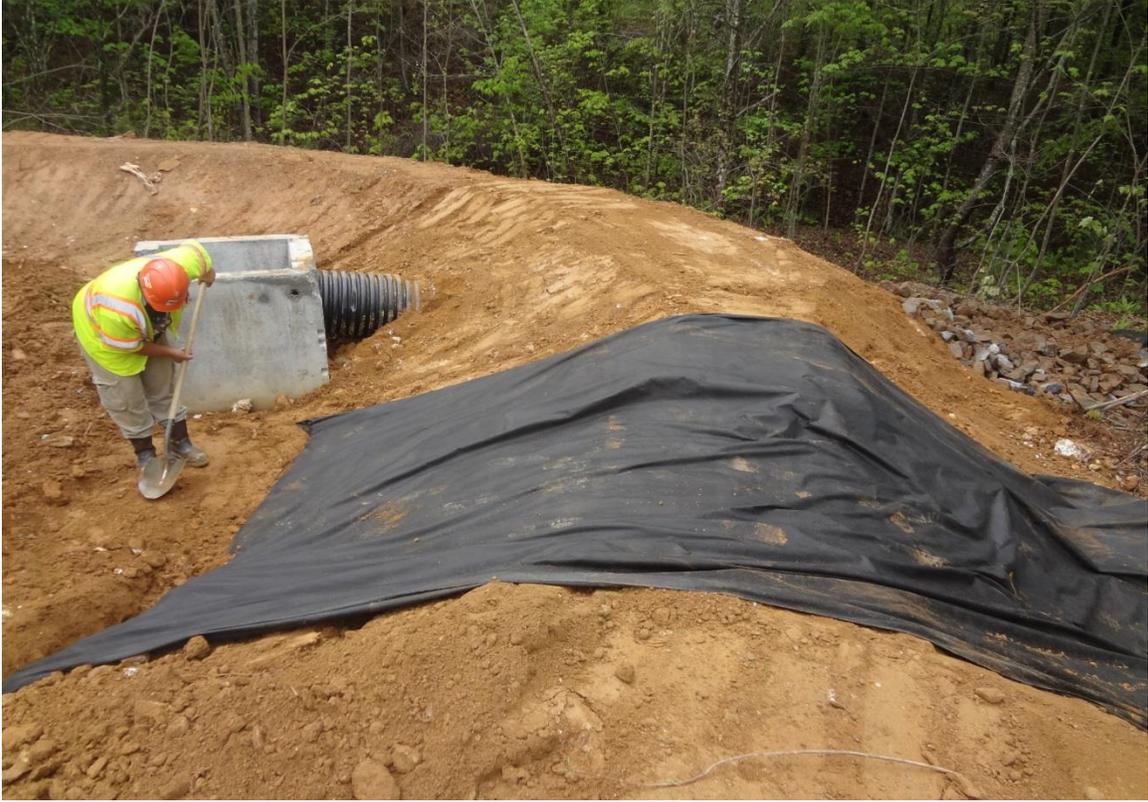
4/30/14 – Installing weir for 2.1-Detention Basin

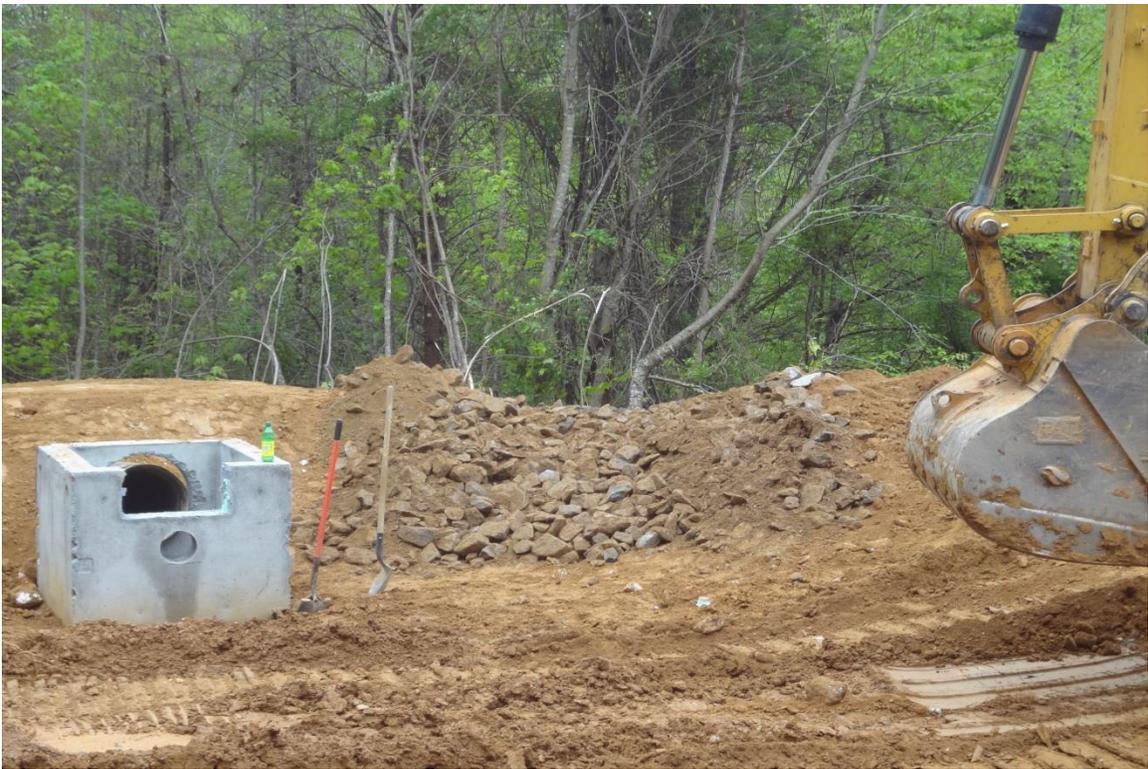
4/30/14 – Installing outlet for 2.1-Detention Basin

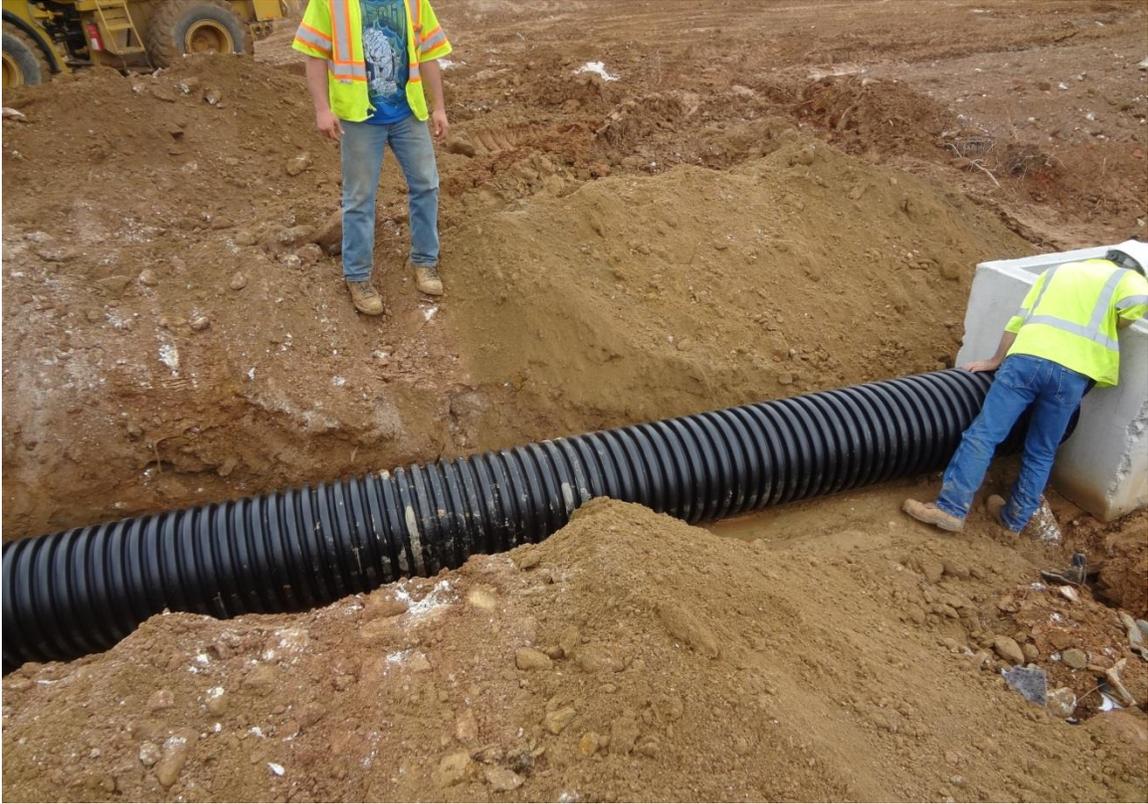
4/30/14 – Installing drain between 2.2-Detention Basin and 1.3-Rip Rap Channel

20' sections, 18" diameter

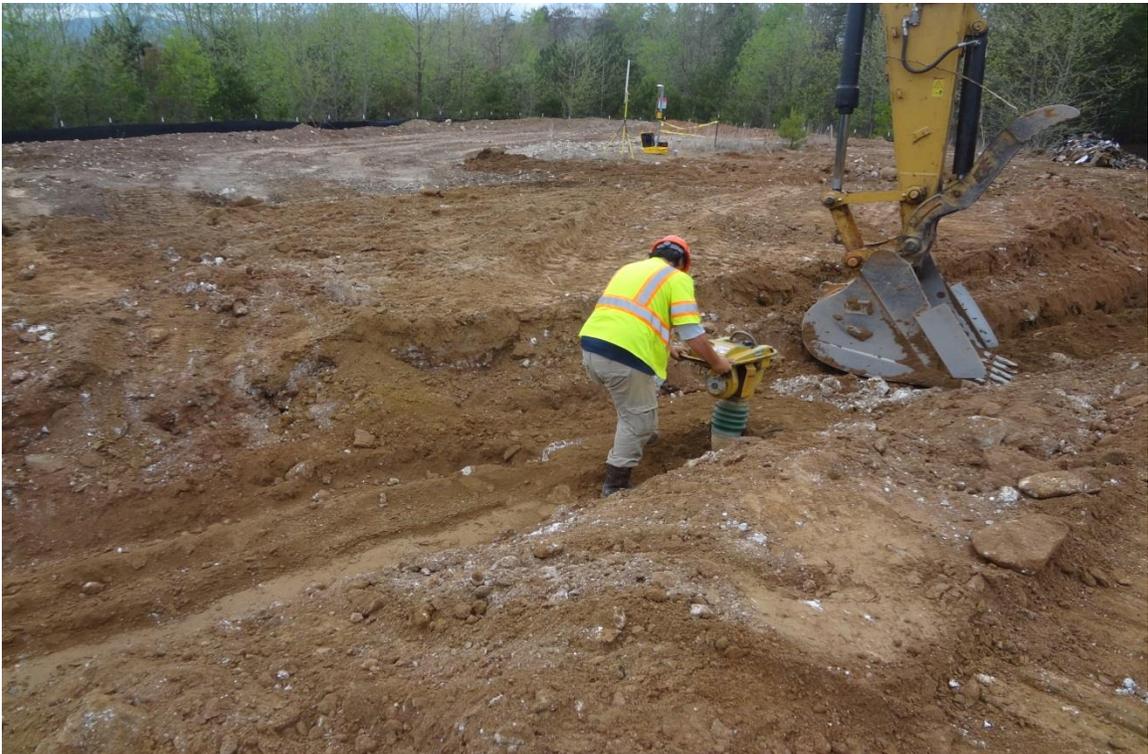
4/30/14 – Compacting soil over and along drain between 2.2-Detention Basin and 1.3-Rip Rap Channel

buried the 7 sections
using a compactor

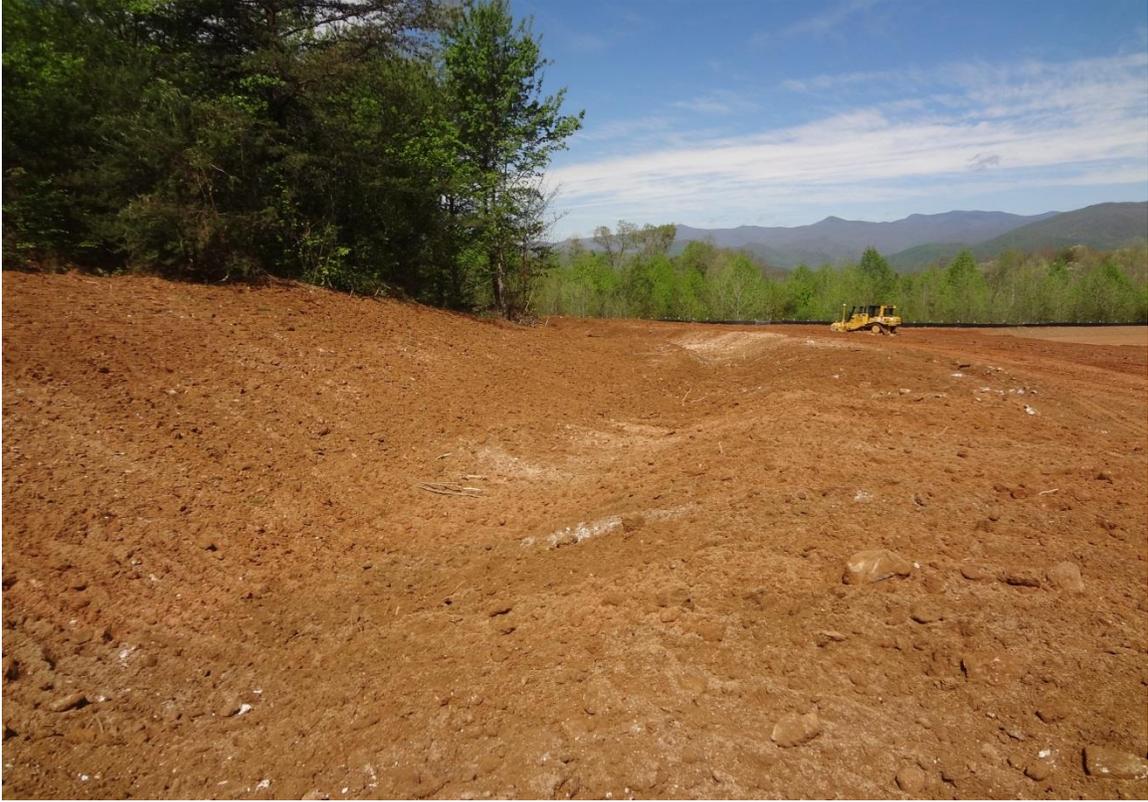
5/1/14 – 1.2 – Excavating Grass Lined Channel

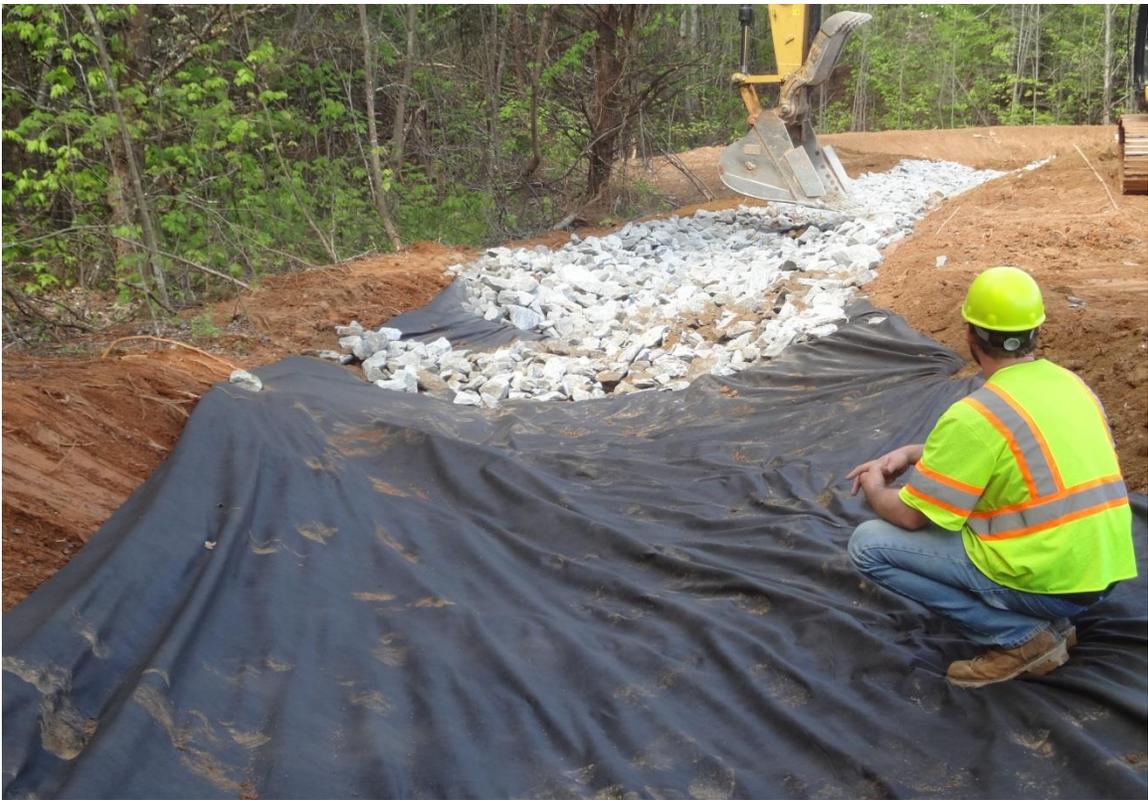
5/1/14 – Constructing 3.0-Perimeter Drain

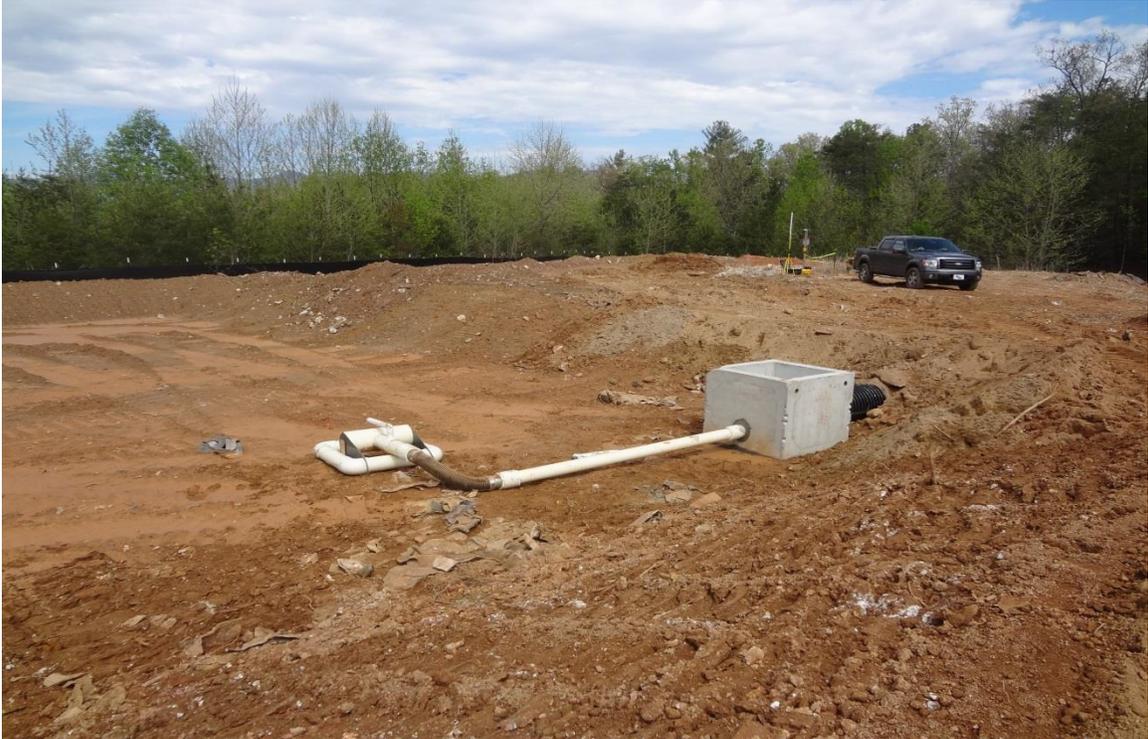
5/2/14 – 2.2-Detention Basin with installed outlet and skimmer

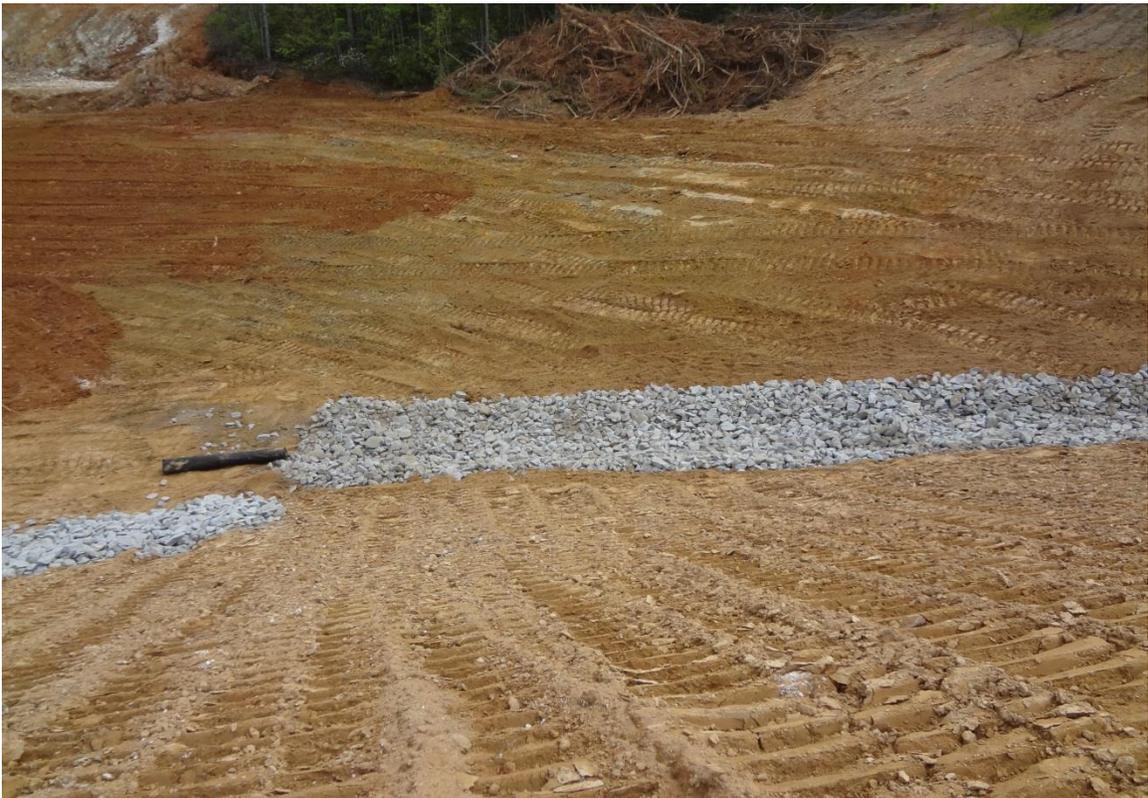
5/5/14 – 2.4-Detention Basin with rip rap lined slope of Phase 2 and Phase 3
