RJN Project: 010057.01

Re: Submission of Old Fort Landfill Closure Report
Old Fort Landfill - 1240 Parker Padgett Road, Old Fort, North Carolina
Permit 56-03

OLD FORT LANDFILL CONSTRUCTION CLOSURE REPORT

**PERMIT #56-03
1240 PARKER-PADGETT ROAD
OLD FORT,
MCDOWELL COUNTY,
NORTH CAROLINA**

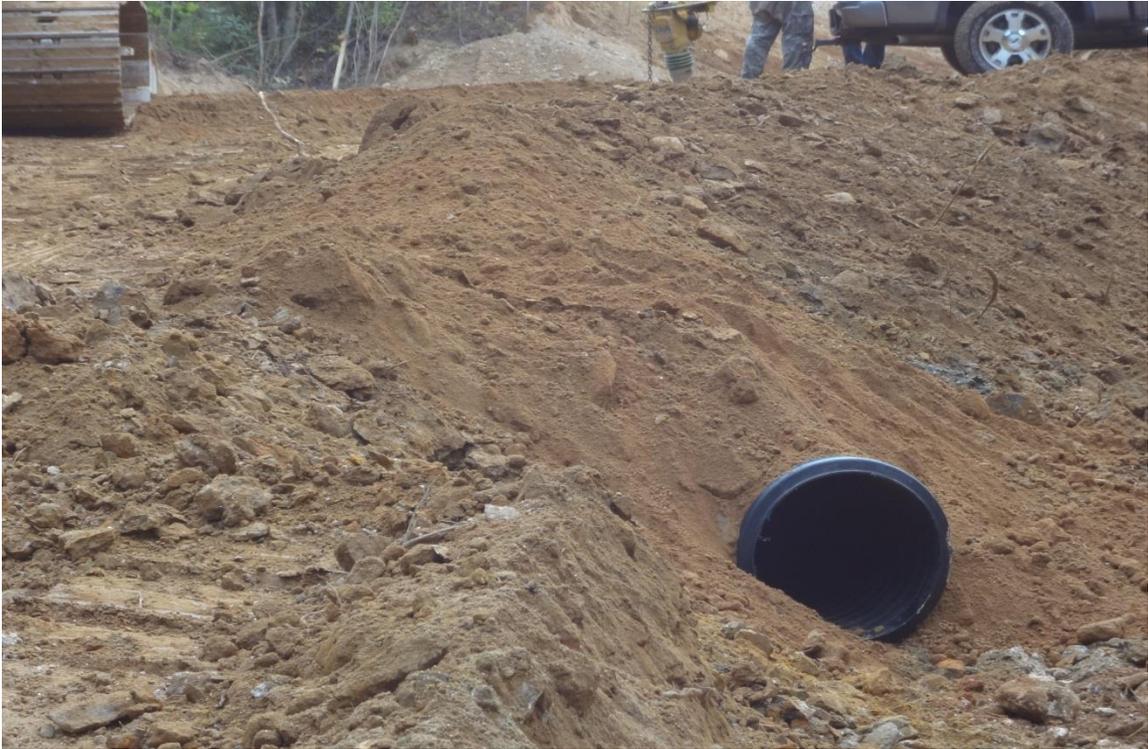
5/5/14 – Outlet from 2.3-Detention basin to 1.3-Rip Rap Channel

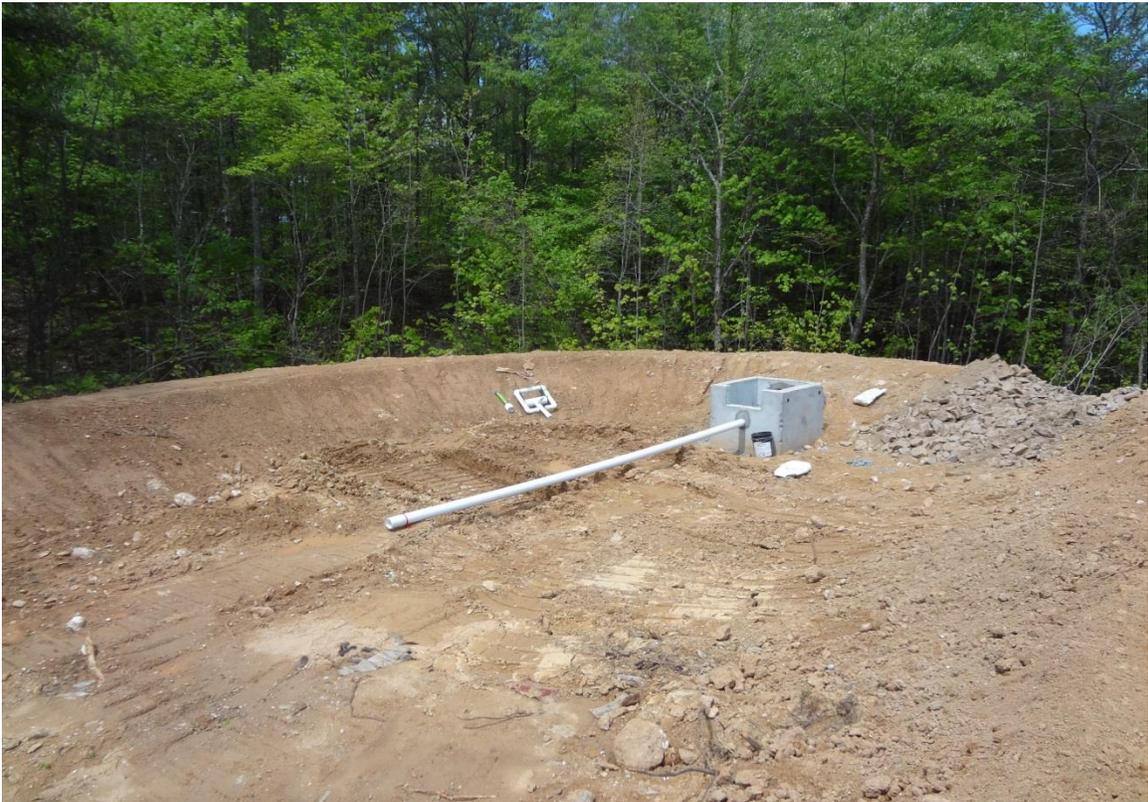
5/5/14 – Skimmer construction for outlet of 2.1-Detention Basin

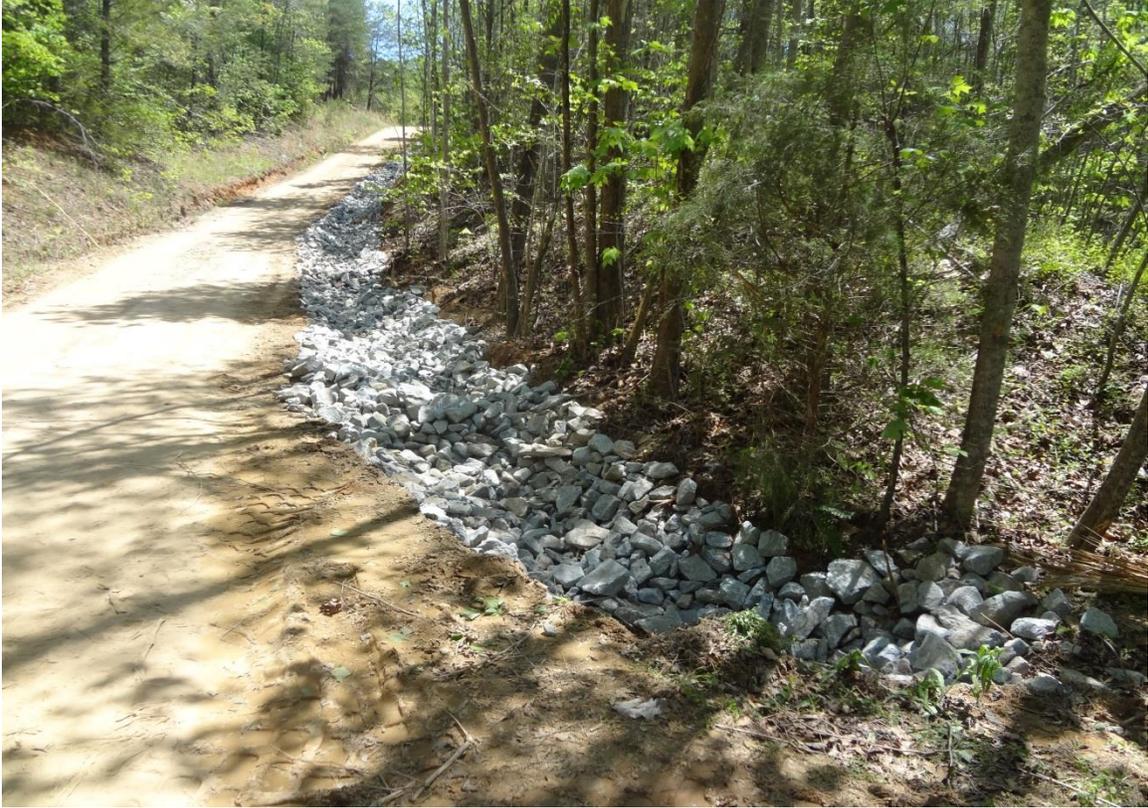
5/6/14 – Construction of 1.3-Rip Rap Channel

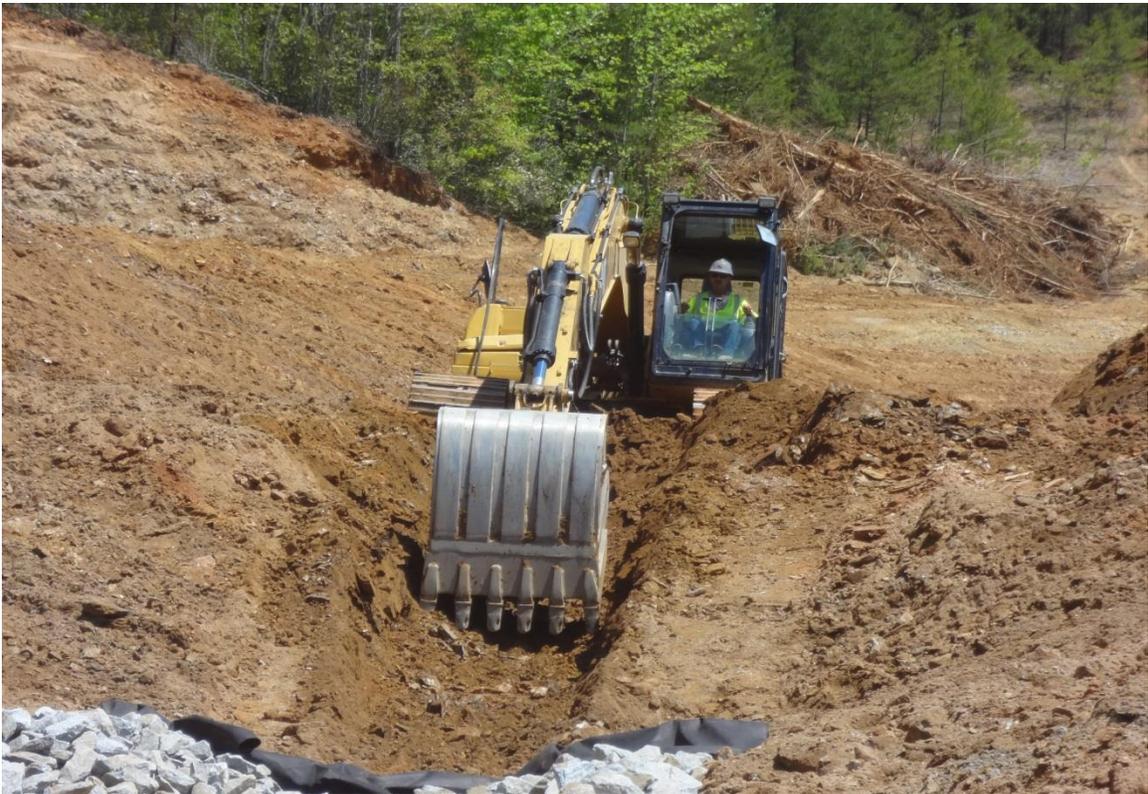
5/6/14 – Construction of Outlet for 2.4-Detention Basin

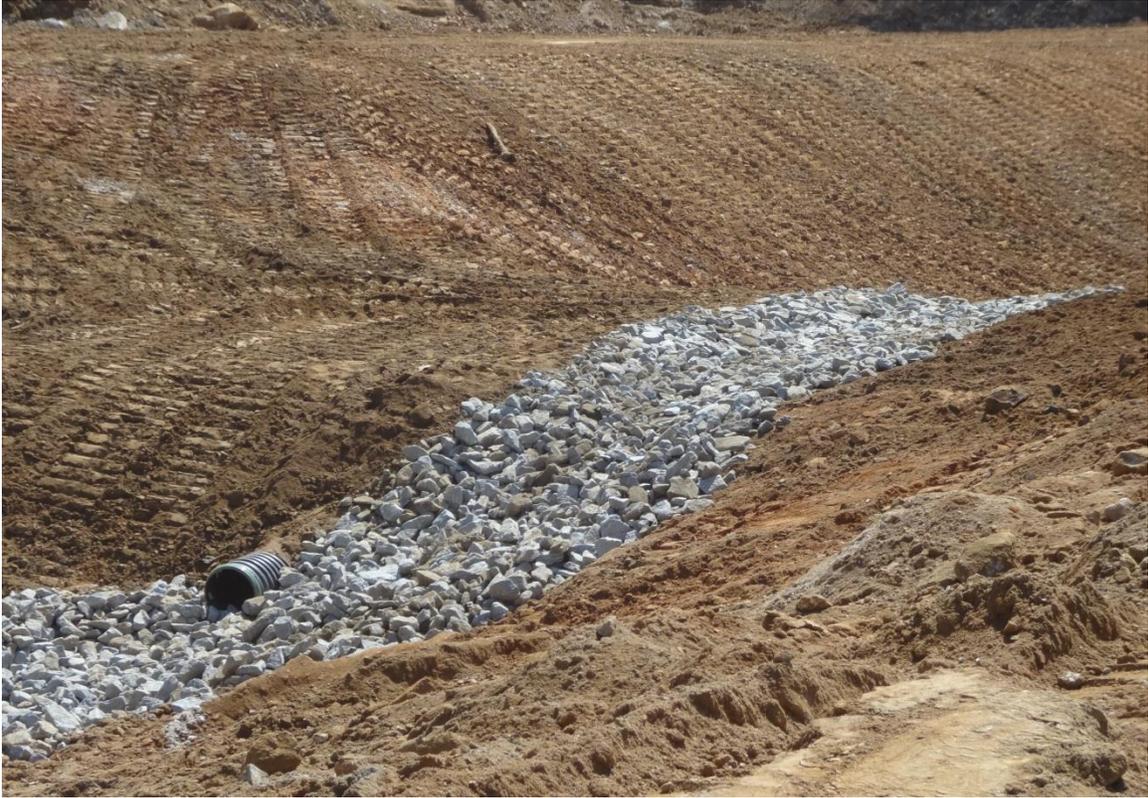
5/7/14 – 2.4-Detention Basin weir and outlet

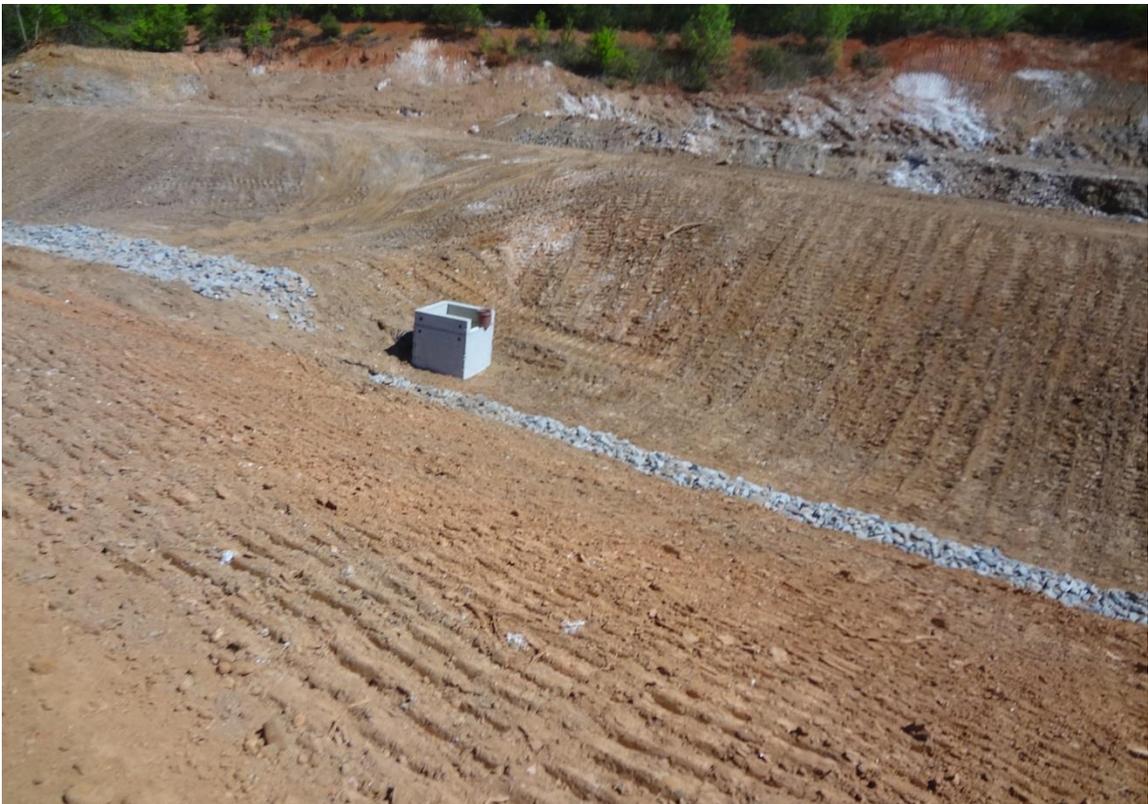
5/8/14 – installing outlet stabilization structure for 2.4-Detention Basin

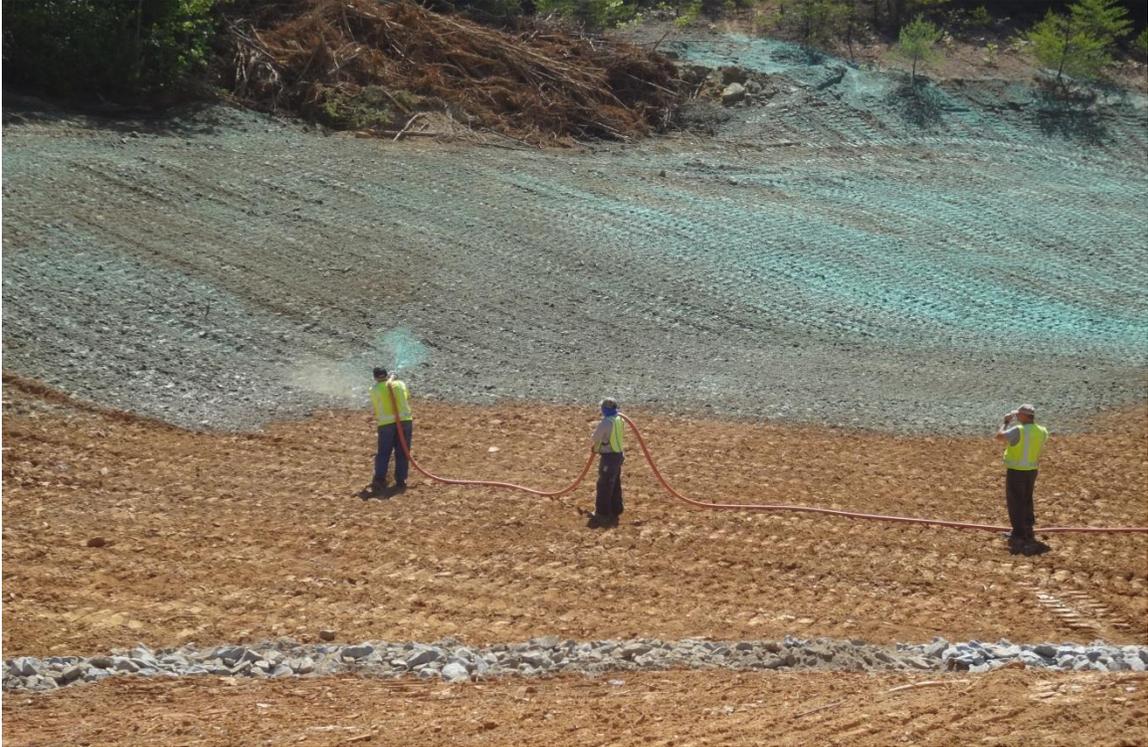
5/9/14 – Hydroseeding Phase 2

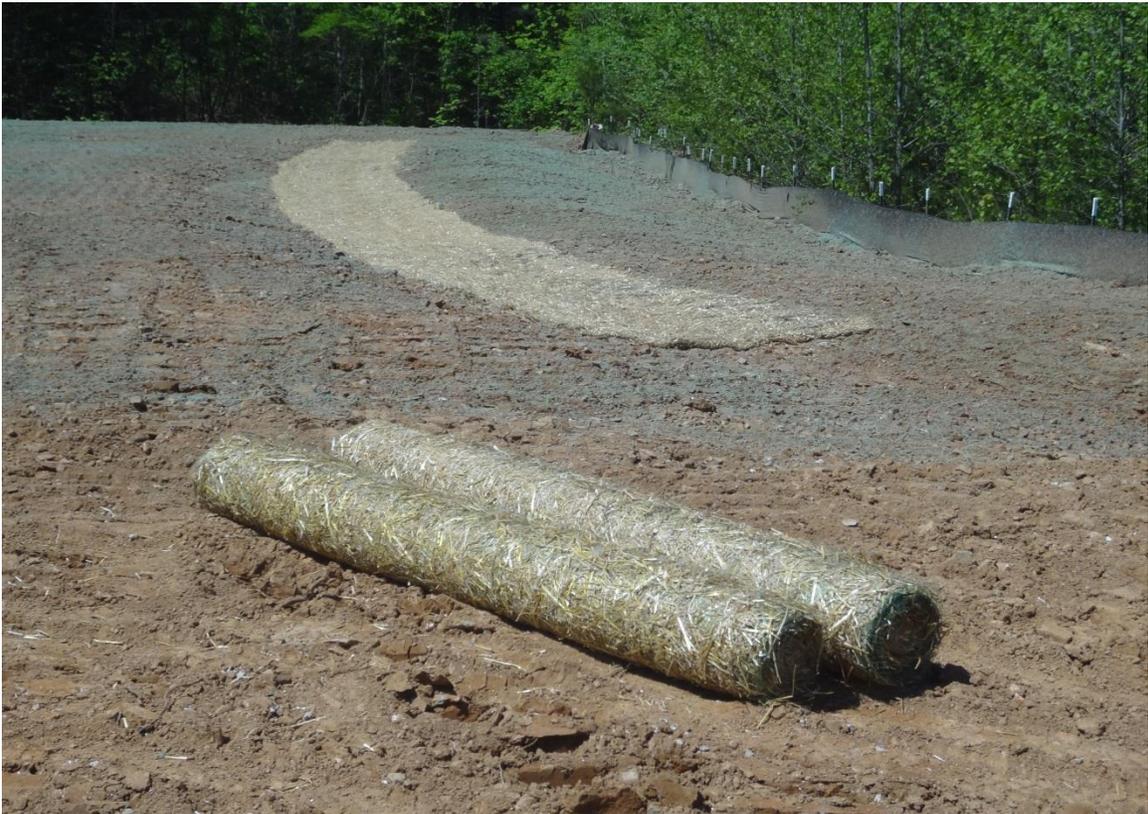
5/9/14 – Installing straw matting for 1.2-Grass Lined Channel

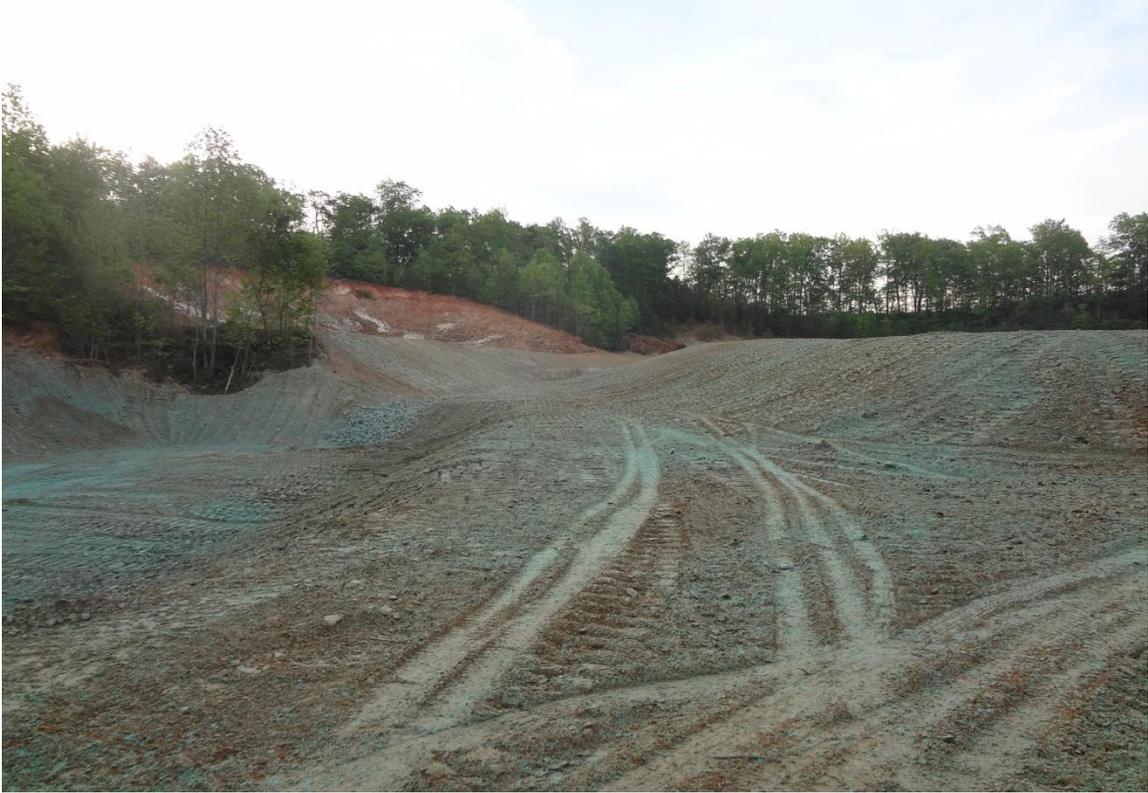
5/9/14 – Hydroseeding Phase 2 and Phase 3

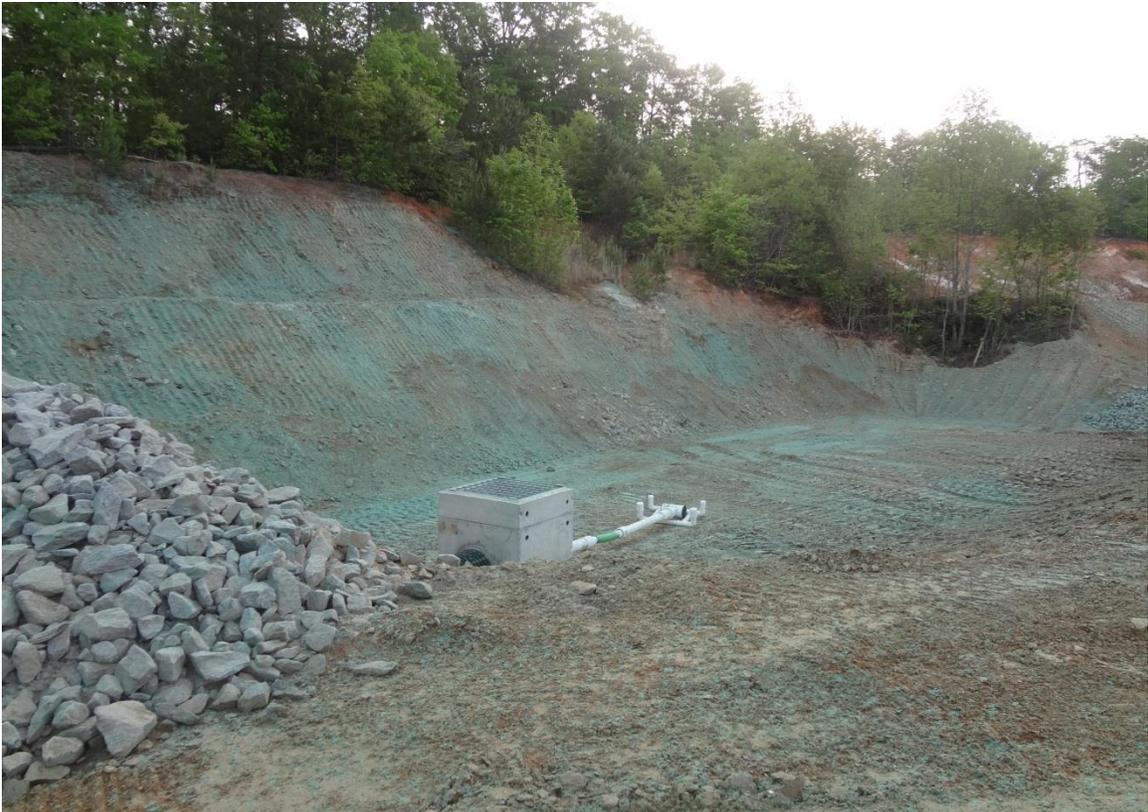
5/9/14 – Hydroseeding 2.3-Detention Basin and slope beyond landfill
