FACILITY COMPLIANCE INSPECTION REPORT
Division of Waste Management
Solid Waste Section

Date of Site Inspection: August 13, 2014 Date of Last Inspection: April 9, 2013

Macon County Municipal Solid Waste Facility
 1448 Lakeside Drive
 Franklin, NC 28724

Comprehensive Inspection

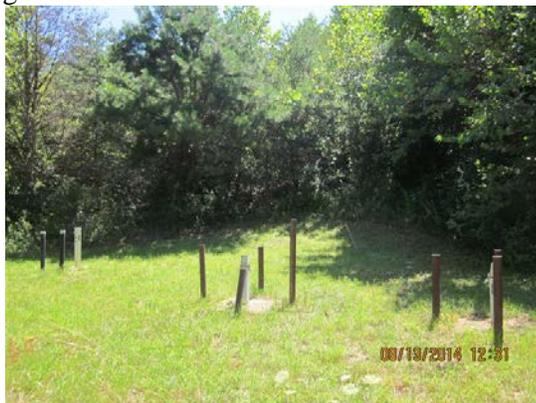
Groundwater Monitoring wells

reports available were of the sampling done in April, 2014. Each groundwater monitoring well observed was in good condition with good access.

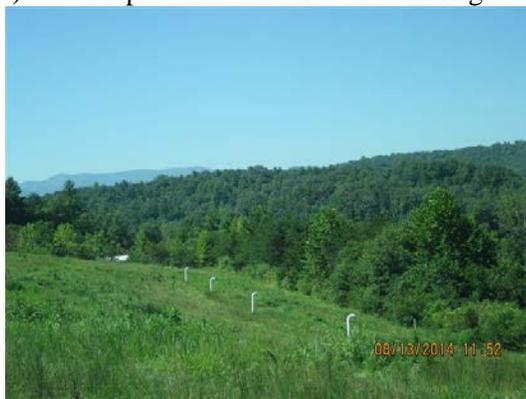
12. Phase 1 has well established grass cover but not the final cap. No significant erosion was observed. A “corrective action plan (CAP)” was implemented in 2011 to address groundwater issues.

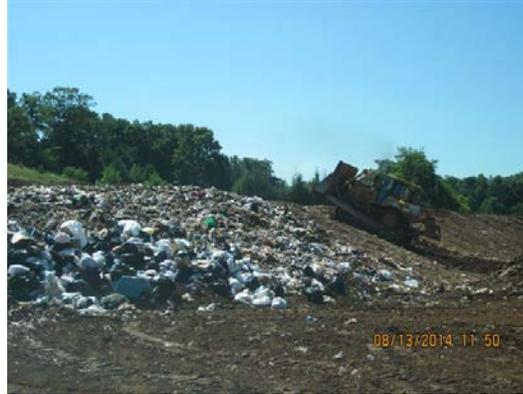
Working Face

13. The MSW landfill was operating in Phase 2 (active since 1998).
14. The facility is permitted to use a mixture of 50% soil and 50% mulch as an alternate daily cover (ADC). This activity is noted in the operations plan (Section 4.2). Mulch and soil is mixed before application. The facility also uses a fabric tarp as an alternate daily cover as approved in the permit.
15. The working face area was observed being confined to a small area. There was no banned material observed with the exception of incidental amounts. The daily cover area was well maintained and appeared to have adequate cover.

16. The intermediate cover was in excellent condition and seeded with little to no erosion. There was a fence surrounding the landfill and no windblown debris was observed outside of the landfill. **There was a small amount of windblown debris was observed inside the landfill that will need to be picked up.**

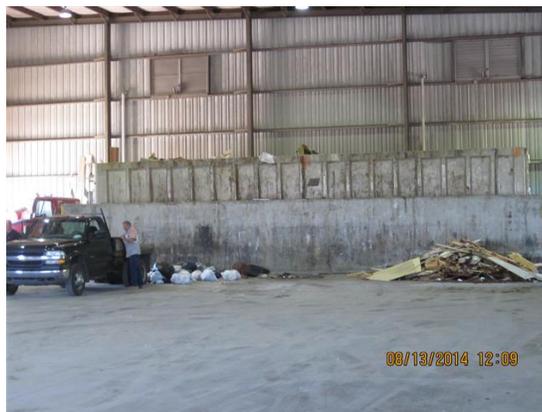
MSW Treatment & Processing Facility

17. The MSW Treatment and Processing (T & P) Facility is located in a covered building and was observed in operation. This facility is permitted to receive all waste allowed for disposal in the MSW Landfill and is used by the general public. Waste is placed on the floor and recyclables are removed by Staff. Material that cannot be recycled is loaded into a semi-trailer and transported to the MSW Landfill. The area was very clean. There are drains in the floor to catch any incidental liquids (leachate) and connects to the Franklin wastewater treatment plant.

18. Separate areas are designated for clean wood, TVs, computers, aluminum, glass, plastics, cardboard and scrap metal inside the building. There was also an area for collection of Universal Wastes – Mercury Containing Lamps and Devices. This activity was approved in the most recent permit modification. The recycling areas were well maintained.
19. Used propane tanks and other gas tanks (not gasoline) are stored outside the T & P building.

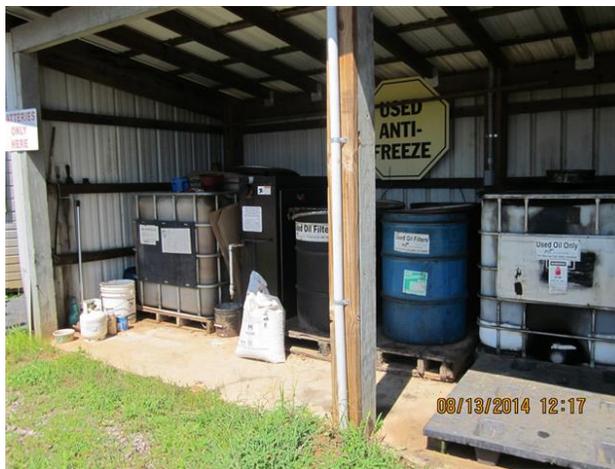
Used Motor Oil/anti-freeze Collection Area

- 22. A recycling facility is part of the approved operations plan.
- 23. Macon County accepts materials to recycle that are dropped off at the facility and from collections sites located throughout the county. Recycled materials are baled and sent to appropriate recycling companies. The area was well maintained.
- 24. There were separate areas for metals, aluminum, steel cans, clothes, cardboard, paper and plastics. Glass was being separated into brown, clear and green.
- 25. The White Goods Area is located in the recycling area and Freon is removed by the facility.
- 26. An area to collect used motor oil and filters, cooking oil, anti-freeze and batteries were observed in good condition
