**FACILITY COMPLIANCE INSPECTION REPORT**  
**Division of Waste Management**  
**Solid Waste Section**

MADISON COUNTY SOLID WASTE FACILITY  
 271 Craig Rudisill Road  
 Marshall, NC 28753

**PURPOSE OF SITE VISIT:** Comprehensive site inspection

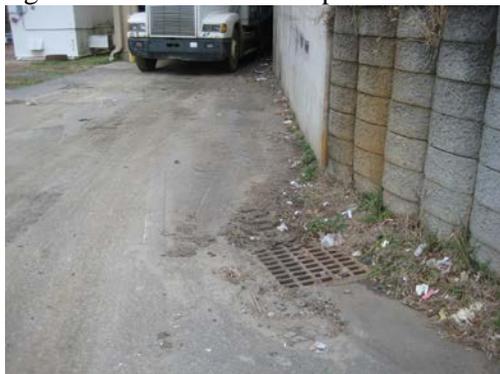
12/5/11

11. The drain located outside the loading bay appeared to be a storm water drain. As such, the facility must ensure that solid wastes and leachate do not reach this discharge location. Note that some windblown was located in this region at the time of the inspection.

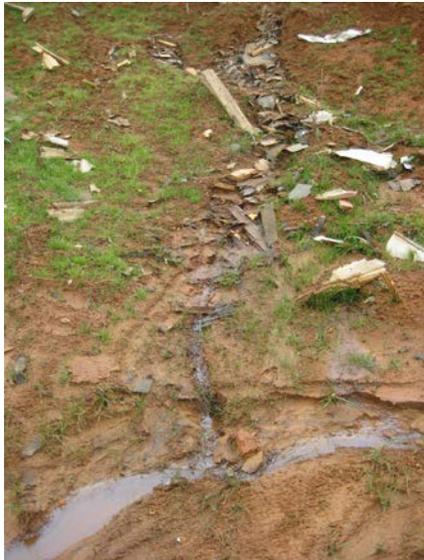
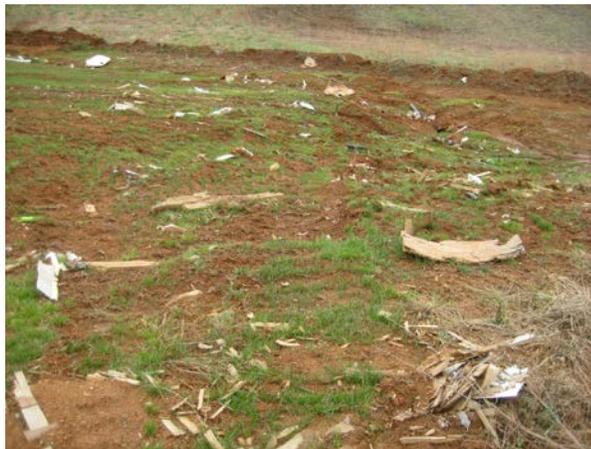
12/05/2011

During the December 5, 2011 site inspection leachate seeps, erosion rills, and uncovered waste were noted within the active C&DLF Unit 2 at the Madison County facility. The area of the disposal unit (see item #15 below) requires additional cover and maintenance to repair the erosion, cover the waste, and stabilize region.

15. As noted in previous inspections, the temporary sediment basin discharges outside the permitted waste fill area of Unit 2. Thus, the **facility must ensure stormwater contacting C&D waste (leachate) and leachate seeps from the active fill area do not reach the sediment basin.** (Discussed on site: A. Keller, J. Huff). Note that during the site inspections seeps were visible within Unit 2. Additionally, significant erosion of the cover had occurred since the previous inspection and waste was visible.

It appears as though the region of the seep and the uncovered waste has been inactive since prior to the May 3, 2011 site inspection. As such, the area must be covered and stabilized with vegetative ground cover or other stabilizing material [15A NCAC 13B .0542 (f)(2)]. While it appears that the facility has attempted to establish vegetation, erosion, rills, and exposed waste require continued observation and maintenance.

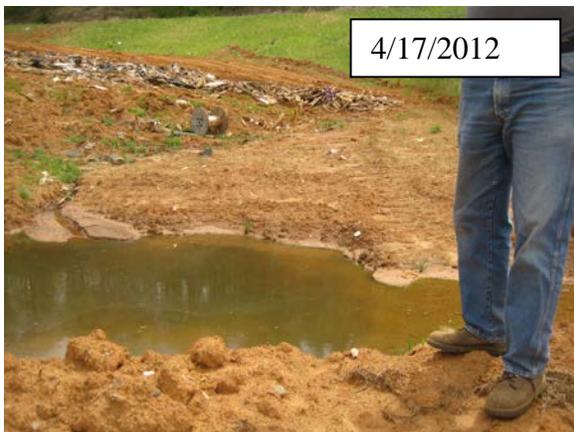
4/17/2012

Additional containment basin to collect leachate from toe of working face.

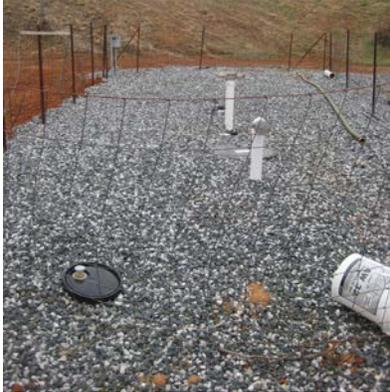
12/5/11

- 16. Edge of Waste (EOW) markers were in place. Access roads were well-maintained. No issues noted with vents or environmental monitoring wellheads.
- 17. Adequate ground cover and vegetation was observed on the closed MSWLF cell and the closed CDLF Unit 1 cells. No issues noted.
- 18. The leachate collection system had recently been modified from an above-ground leachate lagoon to a below-ground storage tank (4000 gallon capacity). The system is equipped with a high-level alarm (light and horn) which is currently being upgraded.
