FACILITY COMPLIANCE INSPECTION REPORT
Division of Waste Management
Solid Waste Section

MADISON COUNTY SOLID WASTE FACILITY
 271 Craig Rudisill Road
 Marshall, NC 28753

C&DLF Unit 2 – Active [5803-CDLF-1995]
 Transfer Facility – Active [5803-TRANSFER-2002]
 MSWLF Unit – Closed [5803-MSWLF-1993]
 C&DLF Unit 1 – Closed
 Permit Renewal: June 17, 2011
 PTO expires: June 16, 2016

Comprehensive site inspection

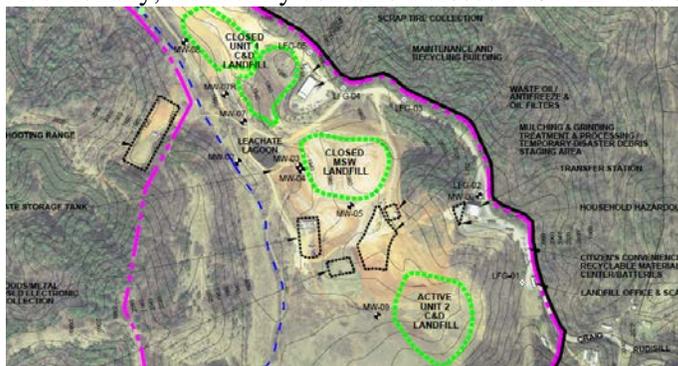
Operations Plan C-101

1. This facility is comprised of an active Transfer Station, CDLF, Treatment & Processing unit, HHW collection site, recycling center, the Madison Co. Sheriff's Dept. firing range, and a convenience center. Additionally, the facility contains a closed MSWLF and CDLF unit.

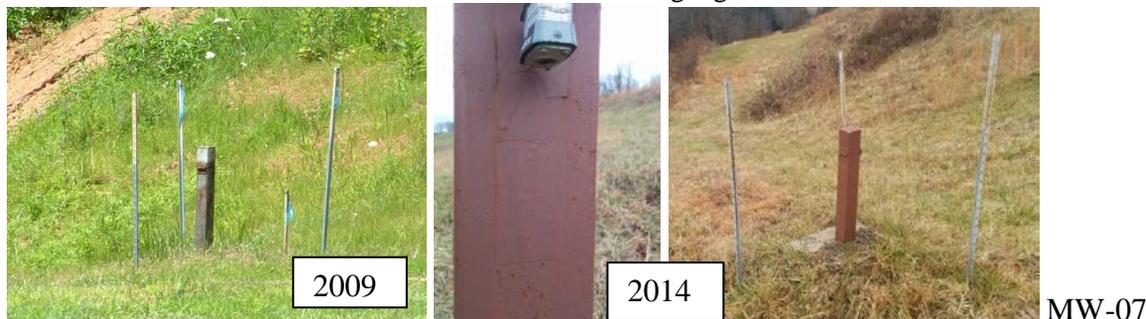
10. The Edge of Waste (EOW) markers were visible at the closed disposal units. Access roads were well-maintained. It was noted that the monitor well casings had been painted and in some cases the paint had obscured both the monitor well name and the well drilling tag.

Note that 15A NCAC 02C .0108 requires that (o) Each non-water supply well shall have permanently affixed an identification plate which includes (6) the well identification number or name assigned by the well owner. It appears as though the casings have been painted as part of general maintenance. While several casings still maintained the well identification plate (without IDs), the well ID tags have been painted over. It is recommended that new ID stickers/paint be place on all on-site monitoring wells.

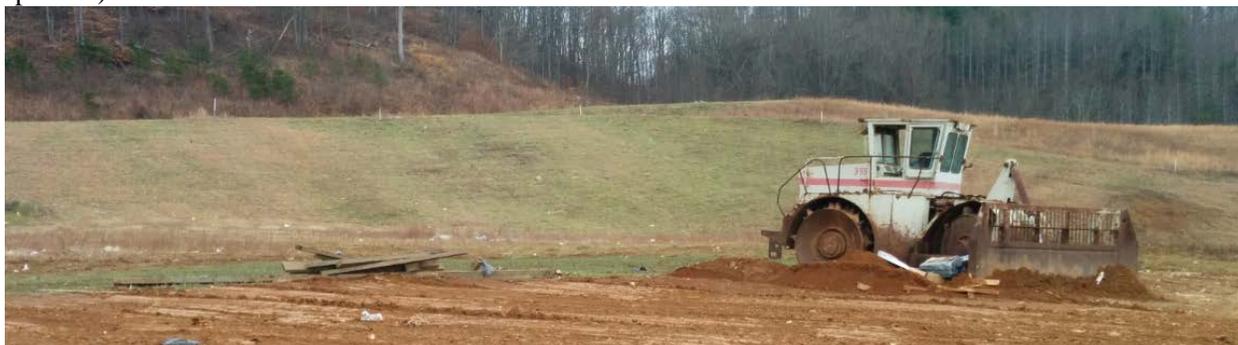
15. The CDLF unit appeared to have adequate weekly cover and the working face was kept to a controlled area. No unacceptable wastes were observed. The intermediate benches (per Ops Plan and landfill design) were intact and the sediment basin appeared to be well maintained. Minimal windblown was noted at the working face during the inspection. Note that some areas below the active working face require maintenance/soil cover during your next weekly cover event (erosion) – this issue was discussed with Larry Wright (landfill operator).

Non-active areas of the cell had been seeded for erosion control.
