FACILITY COMPLIANCE INSPECTION REPORT
Division of Waste Management
Solid Waste Section

Washington County MSW Landfill
 718 Landfill Rd
 Mackeys, NC 27970

Closed MSW Landfill and Scrap Tire Monofill

9402-20140717INSP

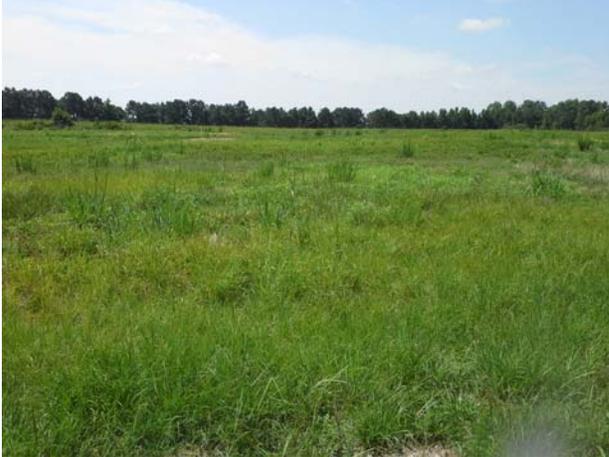
- 7) The Facility cover crop is mowed quarterly. Portions of the cover crop have recently been mowed.

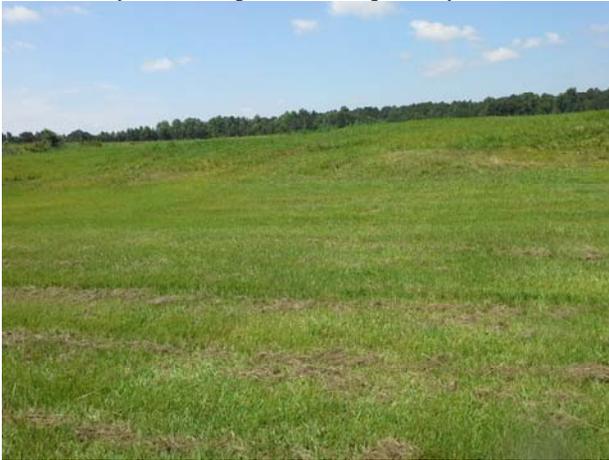
- 8) Small trees, brush, and other woody type vegetation was observed growing on some of the landfill sideslopes. *Plans need to be underway for the mowing of these areas and the removal of all trees, brush, and woody type vegetation. After mowing, please maintain all Facility sideslopes free of trees, brush, and other woody vegetation.

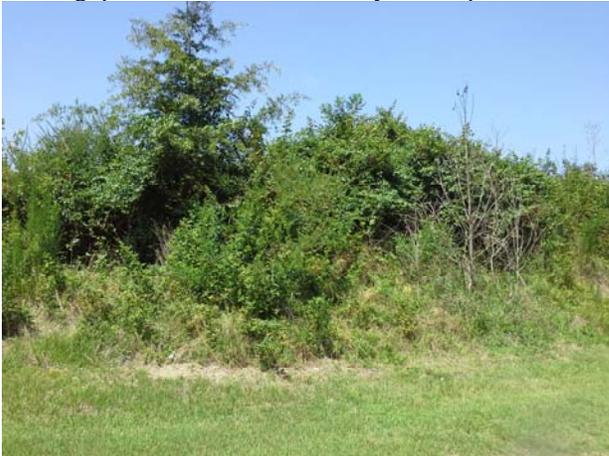
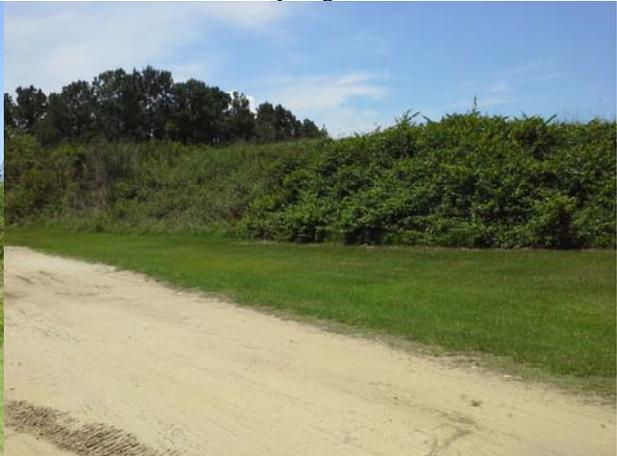
- 9) Inert debris consisting of waste concrete, concrete block, asphalt scrap, and waste brick is stored on-site for crushing/re-use. *Please note that the State rules regarding recovered materials state that for a material to qualify as a recovered material, the majority of the material (51% or more) must be sold, used, or re-used within twelve months of staging on-site.
