# FACILITY COMPLIANCE INSPECTION REPORT

## Division of Waste Management Solid Waste Section

Washington County MSW Landfill  
 718 Landfill Rd  
 Mackeys, NC 27970

9402-20141203INSP

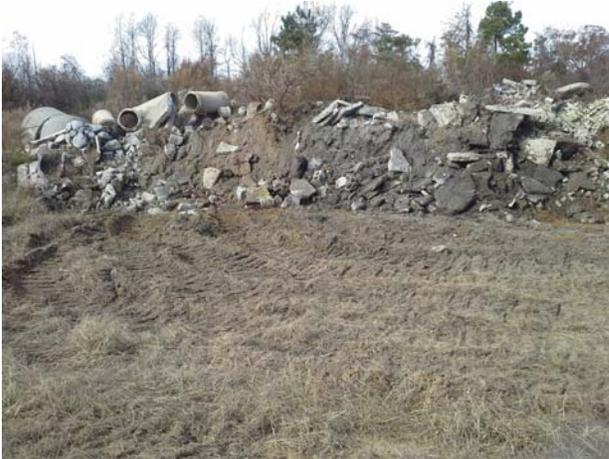
- 7) Facility personnel were on-site loading and transporting inert debris to the active Washington County C&D Landfill for use in constructing a new access ramp for the next phase of operations.

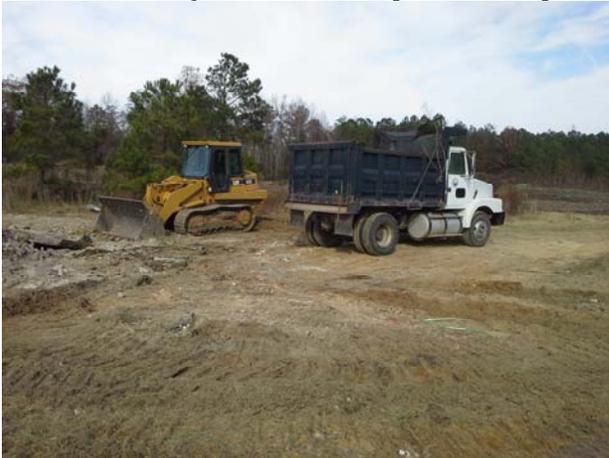
- 8) Soil has been stockpiled on the top lift of the landfill for use in grading and repair operations.

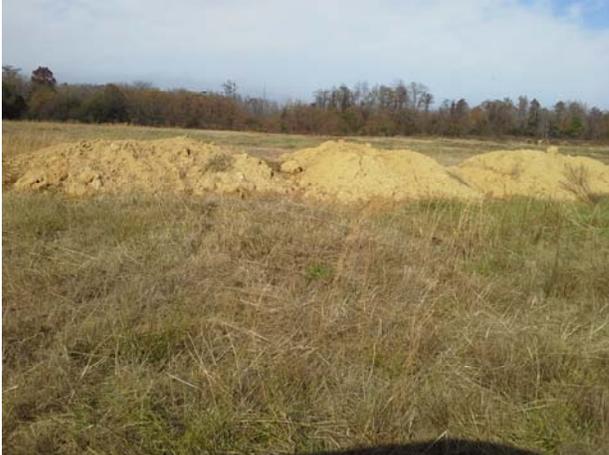
- 9) Facility personnel have repaired areas of differential settlement in various areas around the landfill. \*Please continue to monitor the landfill for areas of differential settlement and make repairs to these areas as needed.

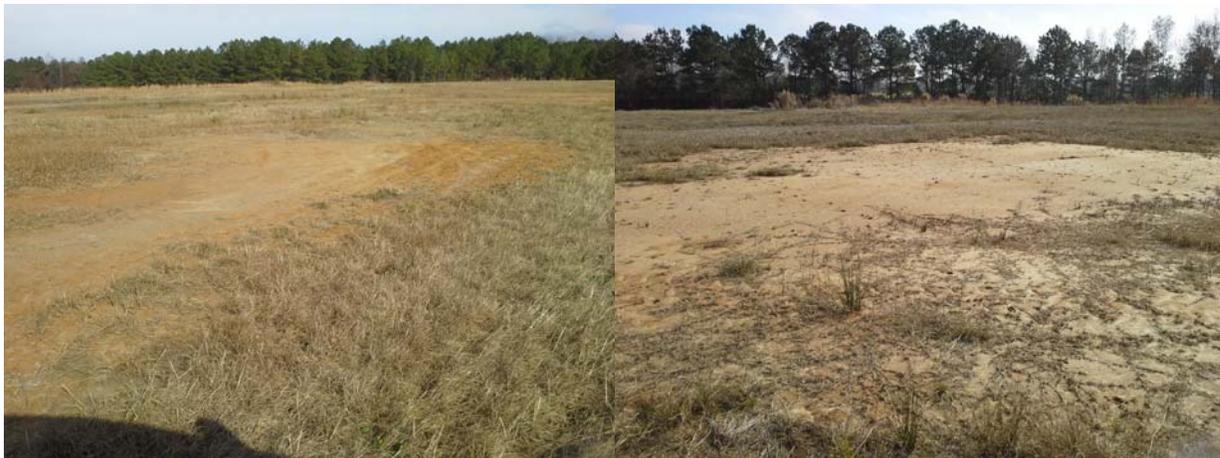
- 10) Several small areas of ponding or standing water were observed on the top lift of the landfill. \*As per our conversation, please continue working to fill and grade these areas to promote positive drainage of surface waters away from the landfill.

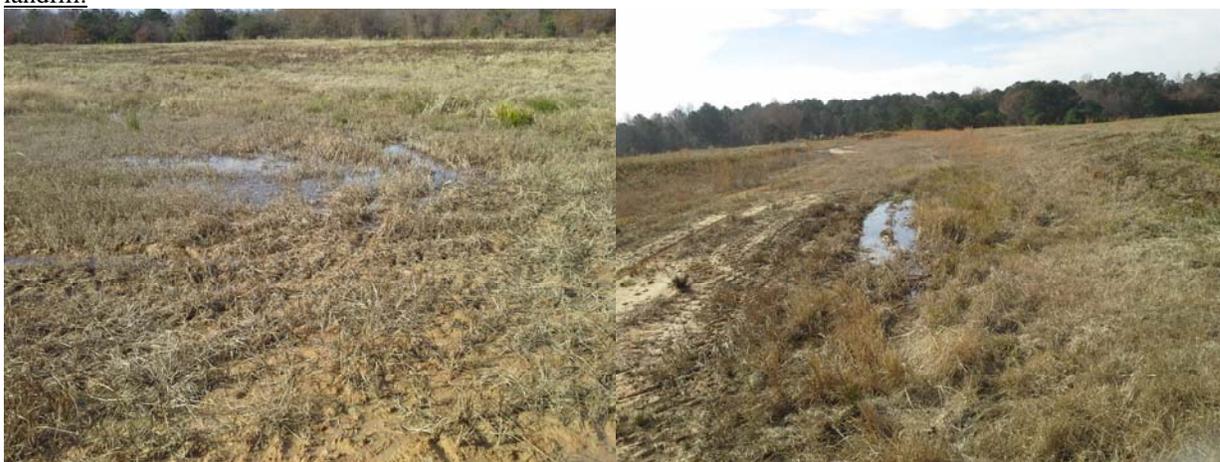
- 11) Overall, this Facility has a well-established cover crop of native warm season grasses.

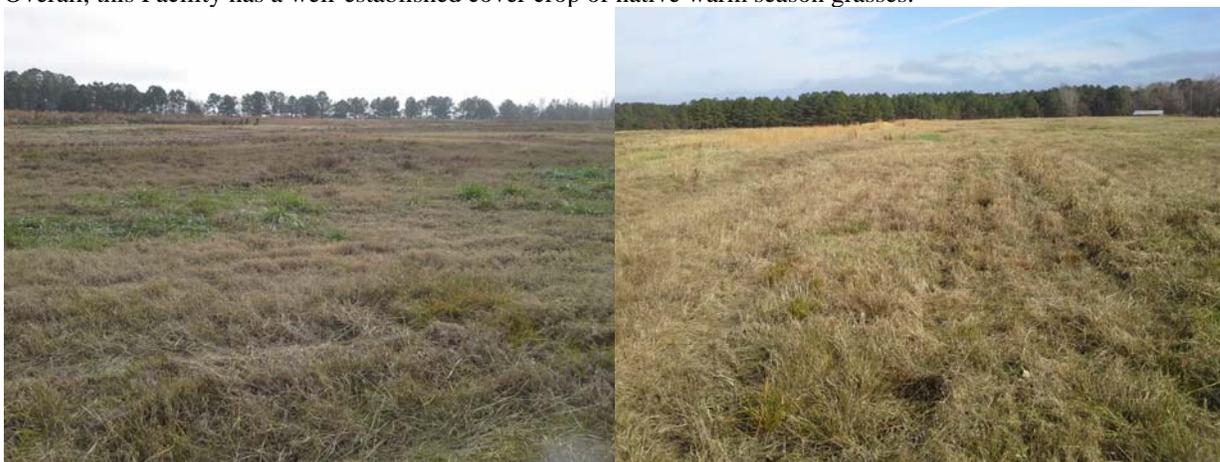
- 12) The Facility cover crop is mowed quarterly.  
13) \*Corrective actions are needed as a result of this Facility Compliance Inspection Report.
