# FACILITY COMPLIANCE INSPECTION REPORT

**Date of Inspection:** 6 May 2015

Washington County C&D Landfill  
 718 Landfill Rd  
 Mackeys, NC 27970

9404-20150506INSP

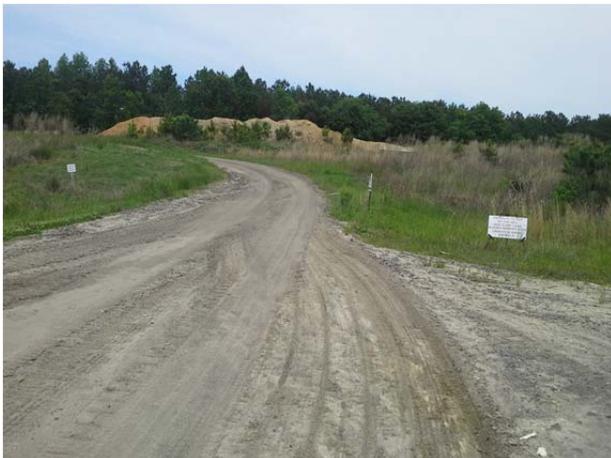
- 9) This Facility is currently receiving +/- 3.5 tons of waste per day.
- 10) This Facility screens all incoming loads for unpermitted waste types. Waste screening activities are recorded in a notebook which is maintained in the scalehouse.
- 11) Inert debris consisting of scrap concrete, concrete block, and brick is being brought on-site from the inert debris storage element of the Closed Washington County Landfill, permit #94-02 and used to build a new access road to the top lift of Phase I.

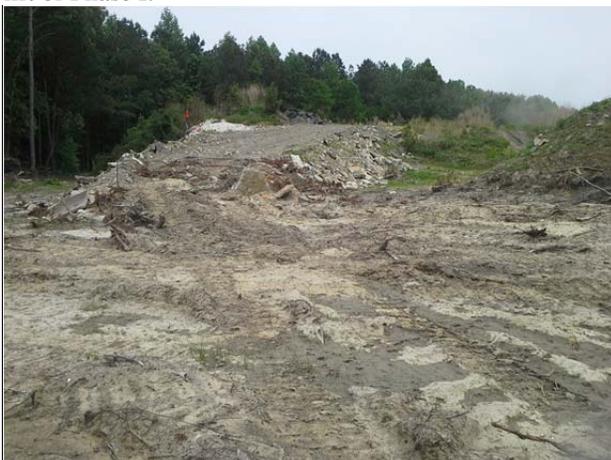
- 12) Permanent Edge of Waste Markers are in place around the footprint of the landfill and are being maintained as required.
- 13) The outside slopes of Phase II have a cover crop established suitable to prevent erosion of the landfill cap system.

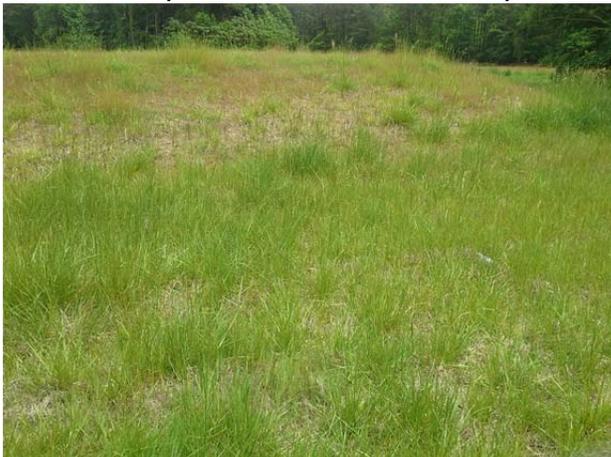
- 14) The cover crop is mowed throughout the year as needed. Mowing operations were underway during this Facility Compliance Inspection.
- 15) The outside slopes of Phase I have a cover crop of native warm season and mixed coppice-type vegetation. Some small trees and other woody vegetation were observed growing in this area. Portions of the Phase I outside slopes have been cleared of brush and other undesirable vegetative cover. \*Please continue working to remove all woody vegetation from

the outside slopes of the landfill. All outside slopes should be graded at a slope not greater than 3:1 and seeded and mulched to establish a groundcover suitable to prevent erosion of your landfill cap system.

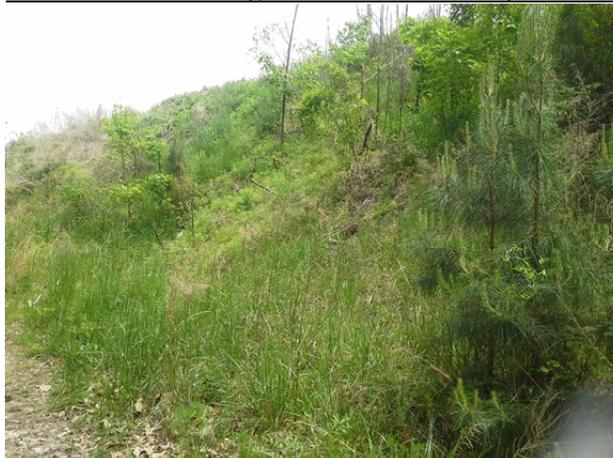
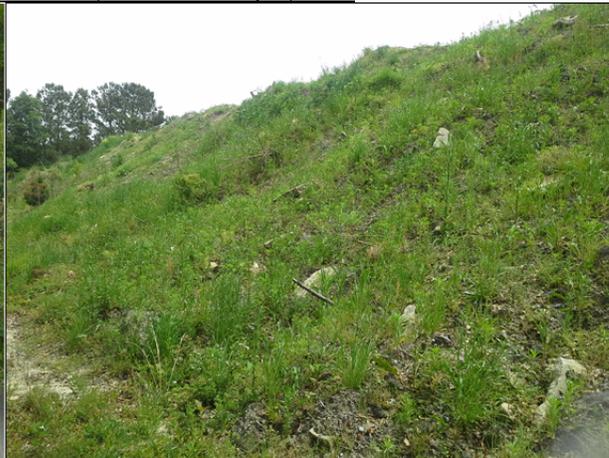
- 16) Soil is being stockpiled adjacent to the landfill and on the top lift of the landfill in an area adjacent to the active working face for use as weekly cover.
- 17) The waste type was reviewed; only Construction & Demolition waste was observed and no unpermitted waste streams were noted in the active disposal area during this Facility Compliance Inspection.

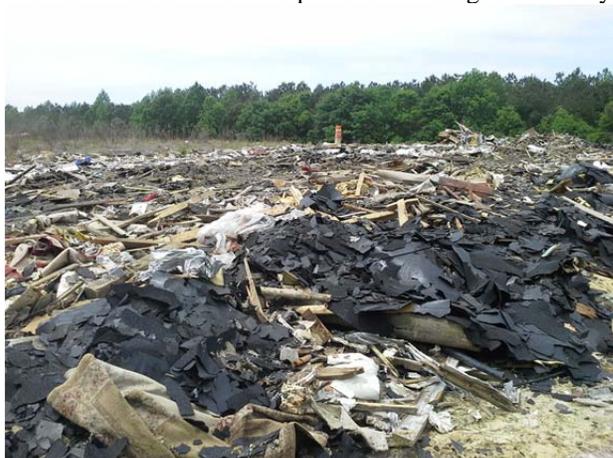
- 18) \*Please continue to ensure that all waste is being covered with a minimum of six inches of soil at least once per week or when the active disposal area reaches ½ acre in size, whichever occurs first.
- 19) Windblown debris is being well managed at this time.
- 20) Minimal windblown debris was observed on the landfill sideslopes and no windblown debris was observed leaving the Facility during this Facility Compliance Inspection.
- 21) The Land Clearing Debris Management Area was reviewed during this Facility Compliance Inspection.

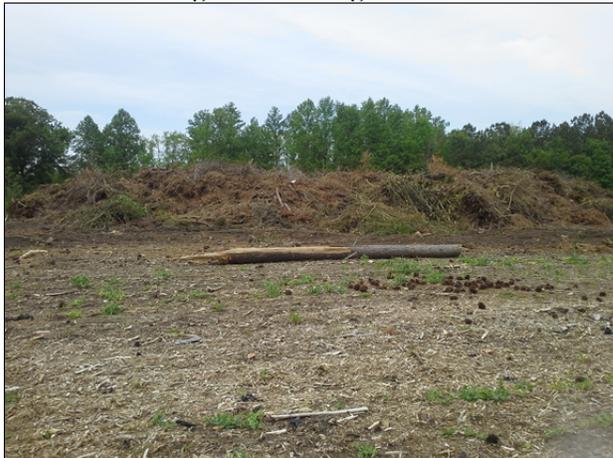
- 22) All Landclearing Debris and other vegetative waste is staged on site for grinding and removal from the site for use as

- boiler fuel.
- 23) No grinding operations were in progress during this Facility Compliance Inspection.
  - 24) The vegetative waste stockpile is being maintained in a safely manageable size.
