FACILITY COMPLIANCE INSPECTION REPORT

Division of Waste Management Solid Waste Section

Washington County C&D Landfill
 718 Landfill Rd
 Mackeys, NC 27970

9404-20140717INSP

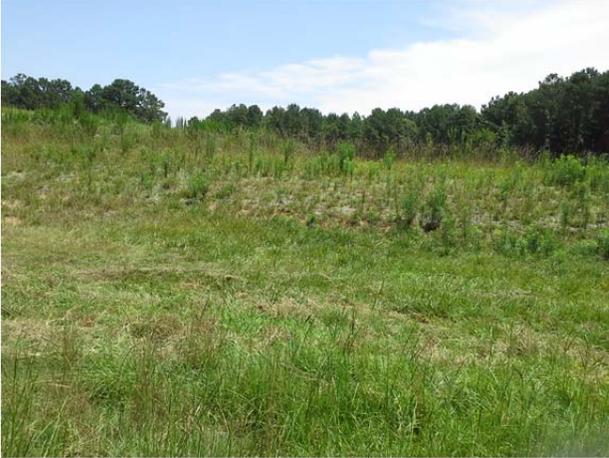
- 16) Portions of the Phase II expansion area were noted as having a sparse cover crop unsuitable to prevent erosion. *Please re-seed and mulch these areas to establish a groundcover suitable to prevent erosion.

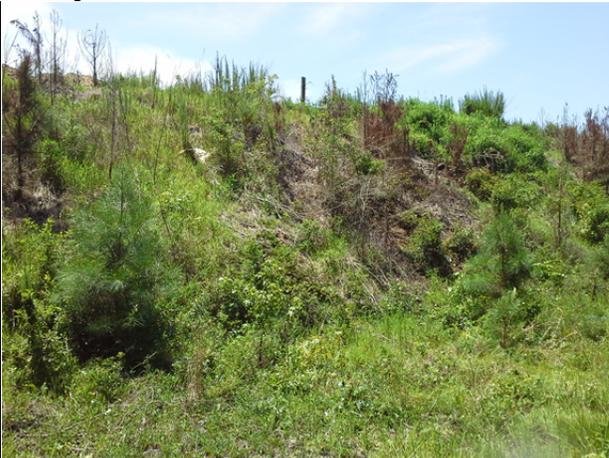
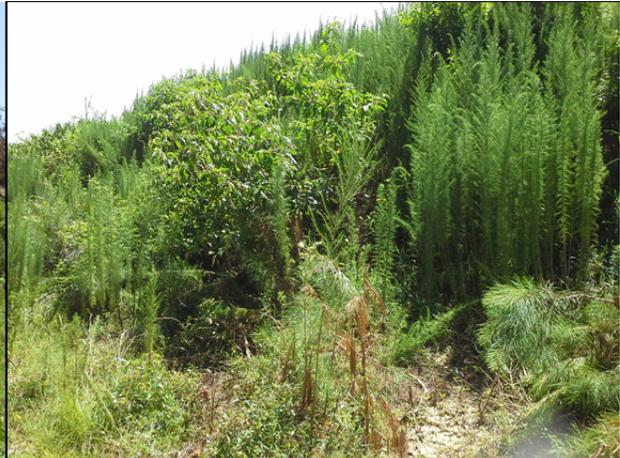
- 17) Small trees, brush, and other woody type vegetation was observed growing on some of the landfill sideslopes. *Plans need to be underway for the mowing of these areas and the removal of all trees, brush, and woody type vegetation. After mowing, please maintain all Facility sideslopes free of trees, brush, and other woody vegetation and work to establish a permanent groundcover suitable to preserve site stability and prevent erosion of your landfill cap system on all Facility sideslopes.

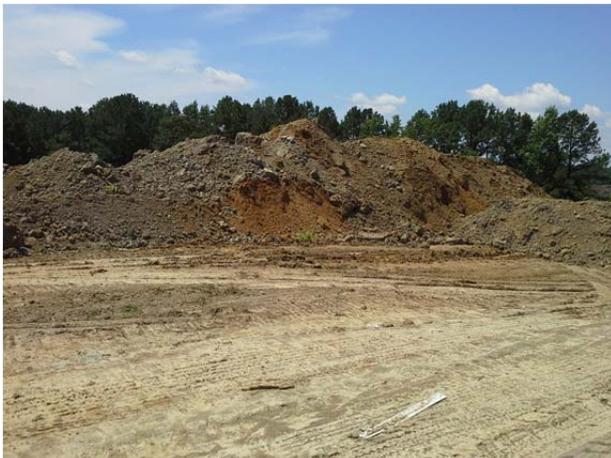
- 18) Soil is being stockpiled in an area adjacent to the landfill for use as weekly cover.

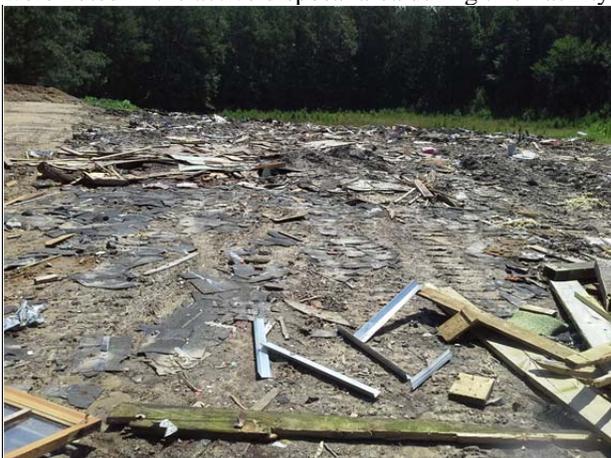
- 19) The waste type was reviewed; only Construction & Demolition waste was observed and no unpermitted waste streams were noted in the active disposal area during this Facility Compliance Inspection.

- 20) *Please continue to ensure that all waste is being covered with a minimum of six inches of soil at least once per week or when the active disposal area reaches ½ acre in size, whichever occurs first.
- 21) The Land Clearing Debris Management Area was reviewed during this Facility Compliance Inspection.
- 22) All Landclearing Debris and other vegetative waste is staged on site for grinding and removal from the site for use as boiler fuel.
- 23) No grinding operations were in progress during this Facility Compliance Inspection.
- 24) The vegetative waste stockpile appears to be approaching the maximum allowable size. *Plans need to be underway for chipping/grinding and removing the waste from the site as soon as possible.

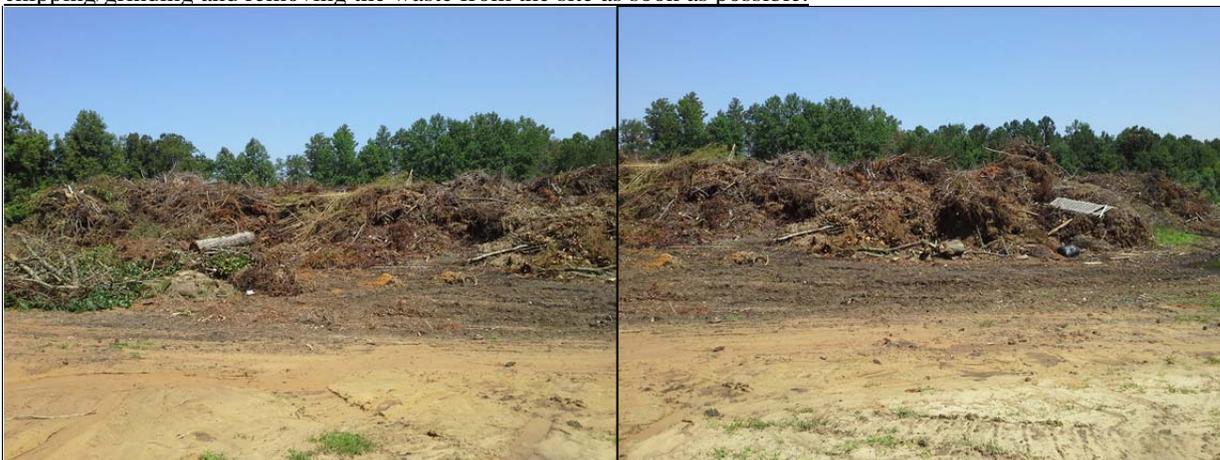
- 25) A small amount of unpermitted waste consisting of treated lattice, treated wood, and plastic bags was observed in the vegetative waste pile. *Please remove all unpermitted wastes from this area for proper management.
- 26) *Please ensure that all waste stockpiles are maintained in a safely manageable size and ensure that all wastes are ground

- and removed from the site in a timely manner.
- 27) *Please ensure that adequate access is being maintained around the wood stockpile for fire suppression and safety inspections.
 - 28) *Please continue to ensure that all waste stockpiles are maintained at a minimum of 25' from all drainage ditches and swales, and a minimum 25' clear area is maintained around the processing area.
 - 29) *Corrective measures are required as a result of this Facility Compliance Inspection.
