FACILITY COMPLIANCE AUDIT REPORT
Division of Waste Management
Solid Waste Section

Date of Inspection: 11 March 2015

Wayne's Construction LCID
 Morehead City, NC 28557

Comprehensive Facility Compliance Inspection

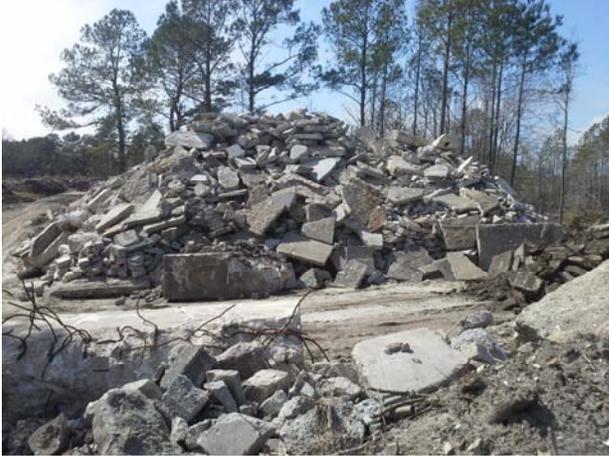
- 8) Inert debris including concrete, brick, and asphalt is being stockpiled in an area adjacent to the landfill for later crushing and re-use. *Please note that the State Rules regarding recovered materials state that for a material to qualify as a recovered material, the majority of the material (51% or more) must be sold, used, or re-used within twelve months.

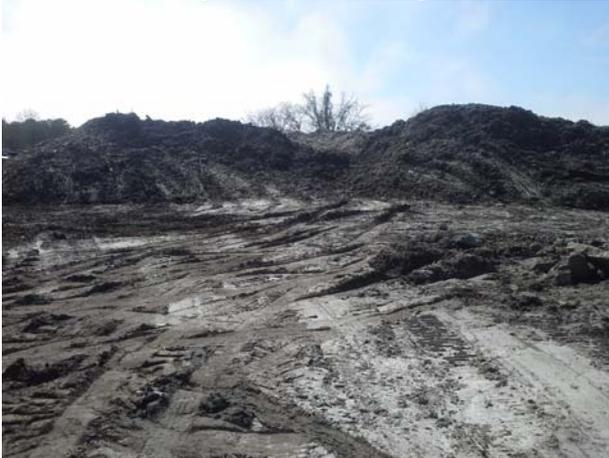
- 9) The active working area of this Facility is being used primarily to stage waste for processing at the adjacent Yard Waste Notification, notification #YWN 16-003.
- 10) The waste type was reviewed. The waste type being managed is LCID waste and no unpermitted wastes were observed during this Facility Compliance Inspection. *As per our conversation; if you are unable to process the vegetative materials staged on-site in a timely manner, all waste should be compacted and covered in the LCID landfill.
- 11) Soil has been brought on-site and stockpiled for use in cover and grading operations.

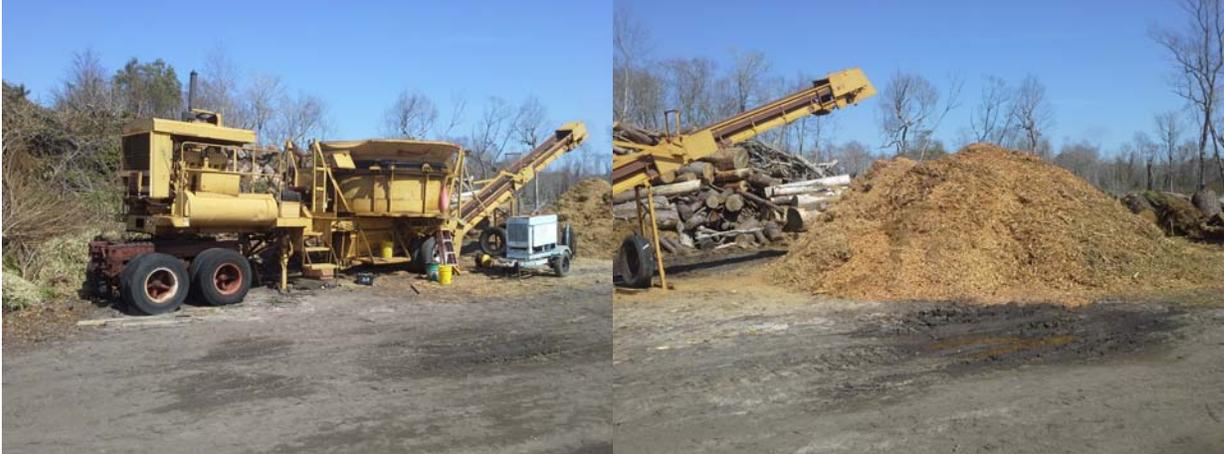
- 13) A tub grinder has been brought on site to process all vegetative waste at the Facility. The tub grinder was out of service for repairs and no grinding operations were underway during this Facility Compliance Inspection. *Grinding operations need to be underway as soon as possible. If you are unable to grind vegetative waste brought on-site in a timely manner;

please dispose of the waste in the landfill. All disposed waste should be compacted, covered, and graded as required.

- 14) No off-site erosion was noted during this Facility Compliance Inspection.
- 15) *As per our conversation, within seven days, please submit a schedule of compliance outlining your plans for repairing your equipment, processing the vegetative waste on-site, and removing the processed materials from the site.
- 16) *Corrective actions are required as a result of this Facility Compliance Inspection.
