FACILITY COMPLIANCE AUDIT REPORT
Division of Waste Management
Solid Waste Section

Carteret LCID
 Community Road
 Morehead City, NC 28557

Comprehensive Facility Compliance Inspection

N0077-20150529INSP

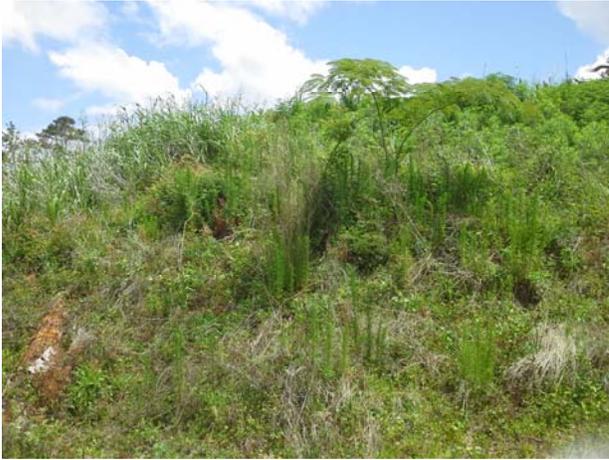
- 10) The landfill sideslopes have been covered with native warm season grasses and/or a natural coppice-type cover with some small trees and brush. Portions of the landfill sideslopes have been cleared of brush and woody vegetation. *Please continue working to remove all trees and woody brush and mow the landfill and the access around the landfill for proper monitoring and maintenance of the landfill cap system. Upon completion of the vegetation clearing project, please ensure that all sideslopes are maintained at a slope not greater than 3:1 with a cover crop established which is adequate to prevent erosion of your landfill cap system.

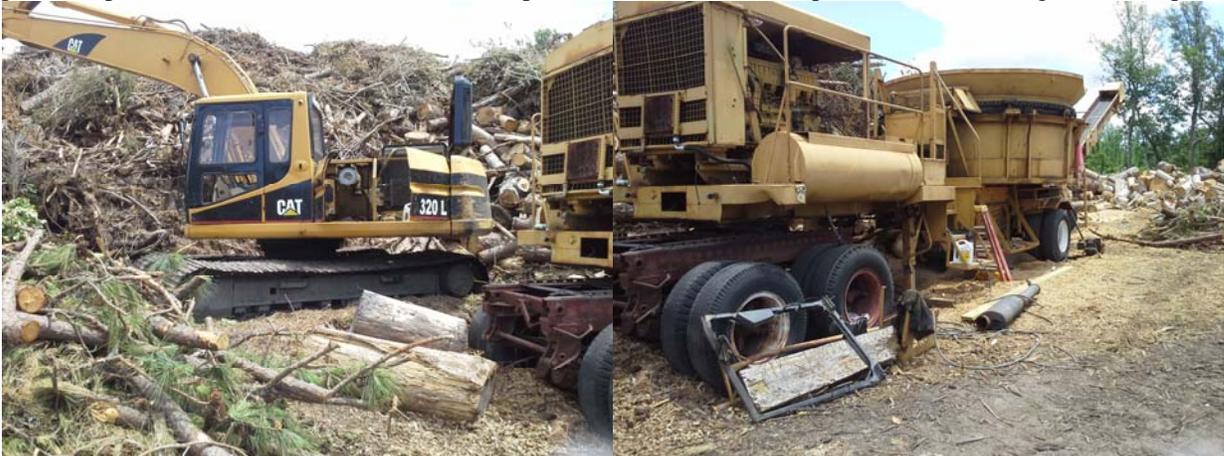
- 13) Soil has been brought on-site and stockpiled for use in cover and grading operations.
- 14) A tub grinder is maintained on site to process all vegetative waste at the Facility. The grinder and the Facility excavator were off-line for routine maintenance and no grinding operations were underway during this Facility Compliance Inspection. *As per our conversation, if you are unable to grind the vegetative waste brought on-site in a timely manner; please dispose of the waste in the landfill. All disposed waste should be compacted, covered, and graded as required.
