FACILITY COMPLIANCE INSPECTION REPORT
Division of Waste Management
Solid Waste Section

Date of Site Inspection: 16 July 2014

Rouse's Septic Tank Service LCID
 Gloria Dawn Road
 Morehead City, NC 28557

Comprehensive Facility Compliance Inspection

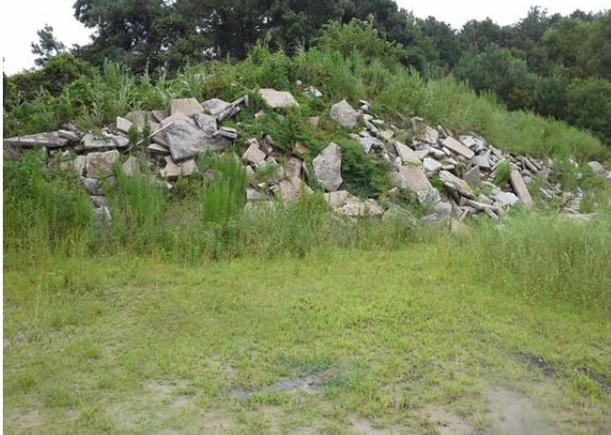
- 8) Inert debris including concrete, brick, and asphalt is being stockpiled for reuse in an area adjacent to the landfill access

road. *Please note that the State rules regarding recovered materials state that for a material to qualify as a recovered material, the majority of the material (51% or more) must be sold, used, or re-used within twelve months.

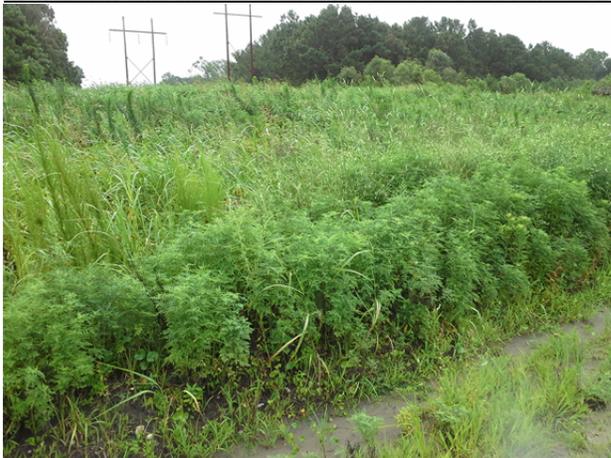
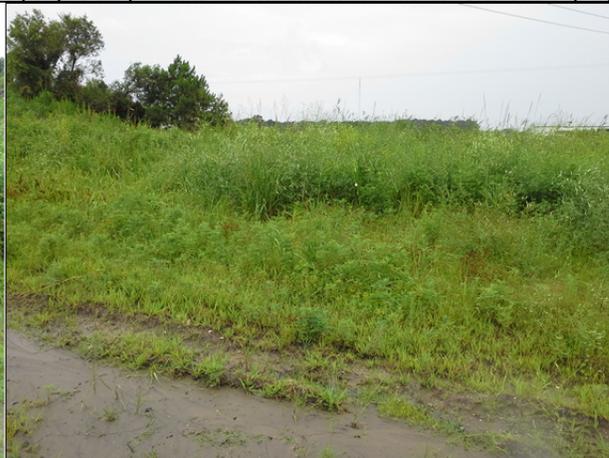
- 10) The landfill working face is less than one acre and is being maintained in a compact and manageable size.
- 11) *Please ensure that all waste is compacted, covered and graded monthly or when the active working area reaches one acre in size, whichever occurs first.
- 12) *Please ensure that all outside slopes are covered and graded at a slope not greater than 3:1, and are seeded and mulched to establish a groundcover suitable to prevent erosion of the landfill cap system.
- 13) Overall, the landfill has been covered with native warm season grasses and/or a natural coppice-type cover. *Please mow the landfill and the access around the toe of the landfill for proper inspection and maintenance of the landfill cap system.

- 14) Trees and other woody vegetation were observed growing on many of the outside slopes. *Please remove all trees, brush, and other woody vegetation from the sideslopes of the landfill.
