**FACILITY COMPLIANCE INSPECTION REPORT**  
**Division of Waste Management**  
**Solid Waste Section**

**Date of Site Inspection:** 29 May 2015

Willis Construction & Grading Company LCID Landfill  
 500 Miller Farm Road  
 Morehead City, NC 28557

Comprehensive Facility Compliance Inspection to review actions taken in response to the 1 June 2015 fire event.

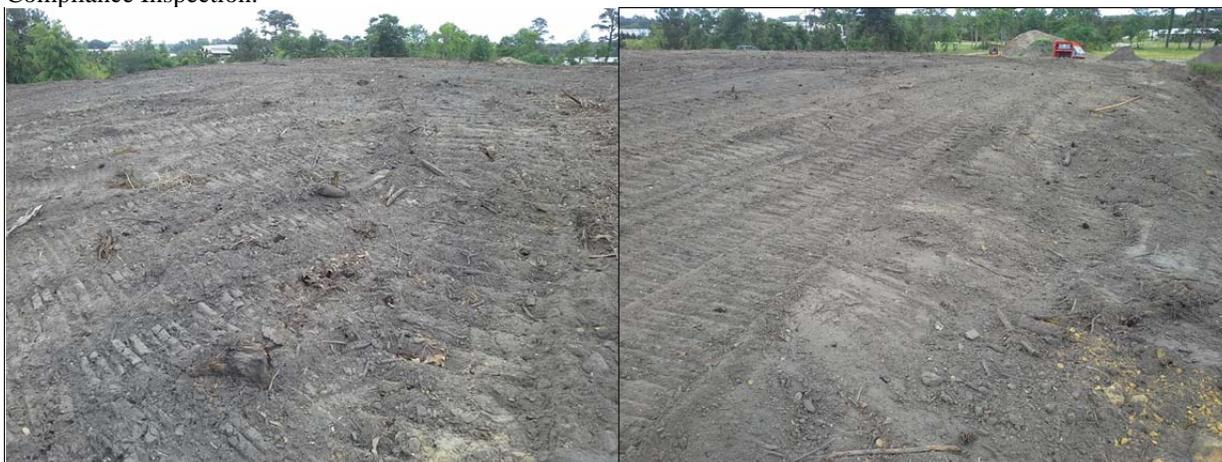
- 12) Soil has been stockpiled in an area adjacent to the landfill for use in cover and grading activities.
- 13) The waste type being disposed is LCID waste only; no unacceptable waste streams were noted during this Facility Compliance Inspection.

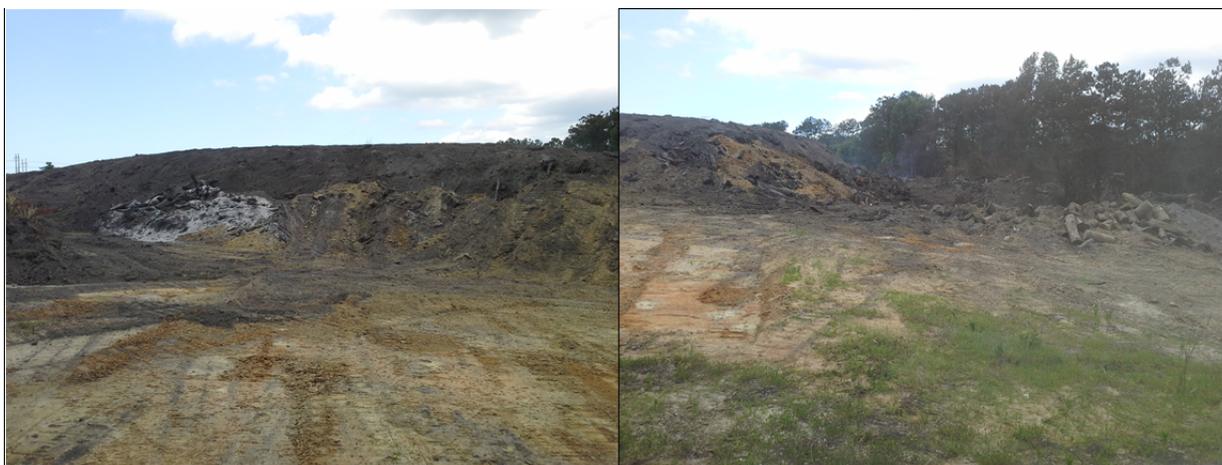
- 14) Facility personnel were on-site during this Facility Compliance Inspection covering and compacting the recently burned area of the landfill.

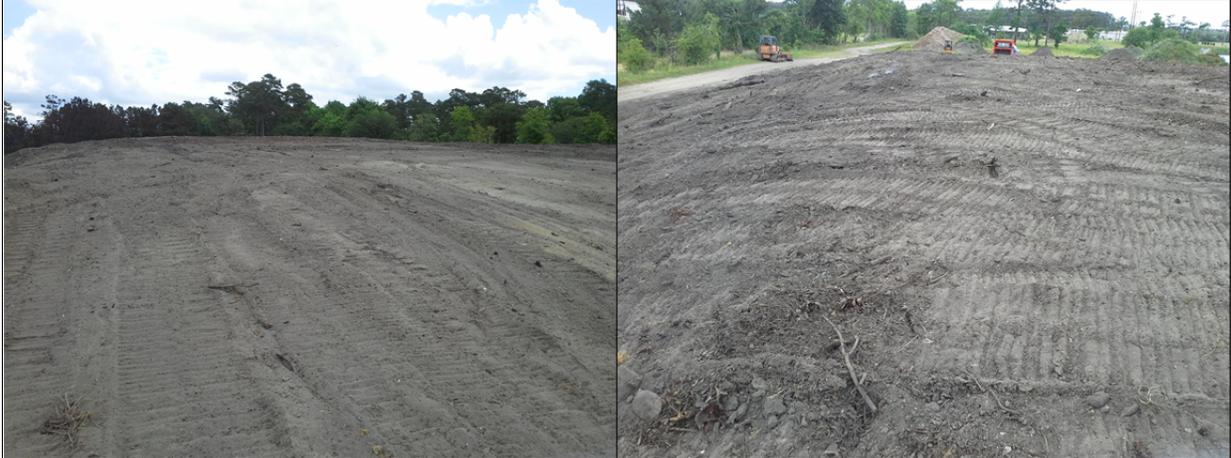
- 15) The outside slopes appear to be properly graded but, due to the fire event, are lacking sufficient cover. \*As soon as practical please ensure that all slopes are seeded and mulched to establish a groundcover suitable to prevent erosion of the landfill cap system.

- 16) \*Please continue to ensure that all waste is covered monthly or when the active working faces reaches 1 acre in size, whichever occurs first.
- 17) No violations were observed during this Facility Compliance Inspection.
- 18) \*Corrective actions are required as a result of this Facility Compliance Inspection.
