FACILITY COMPLIANCE INSPECTION REPORT
Division of Waste Management
Solid Waste Section

Miller Farm LCID Landfill
 Miller Farm Road
 Morehead City, NC 28557

Comprehensive Facility Compliance Inspection

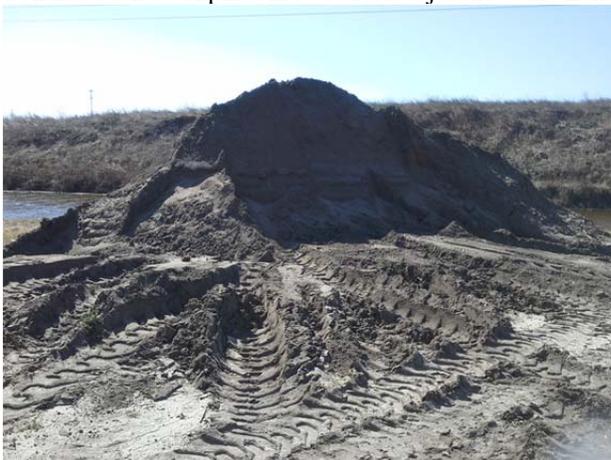
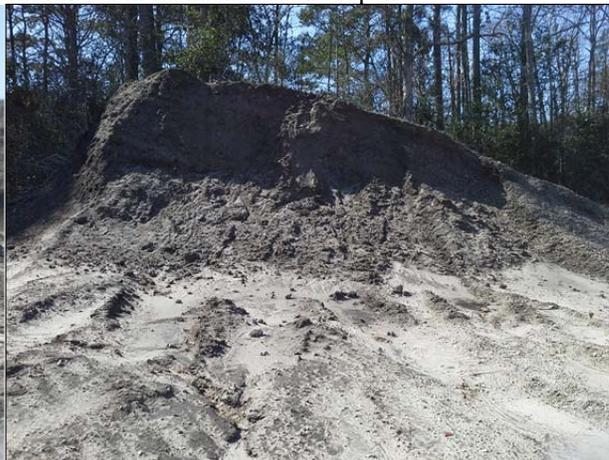
- 7) Proper signage is posted at the Facility entrance stating the Facility emergency contact number and types of waste accepted.
- 8) The access road to the Facility is of all-weather construction and is being managed properly at this time.
- 9) The perimeter road is well maintained, providing for clear access around the Facility.
- 10) Permanent markers have been installed around the perimeter of the Landfill to identify the Landfill disposal boundaries.
- 11) Soil has been stockpiled in two areas adjacent to the Landfill for use in maintenance and repair.

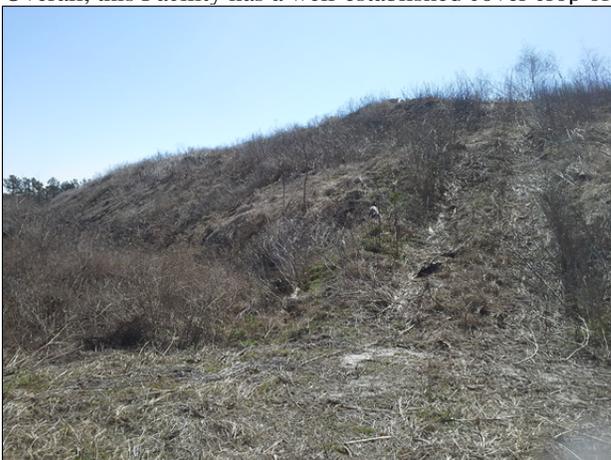
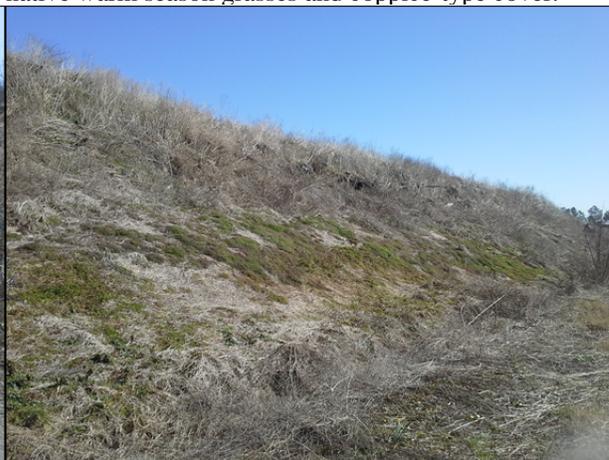
- 12) The Landfill access road has been blocked at the Landfill entrance to prevent unauthorized access to the Facility.
- 13) No new disposal activity was noted as having occurred since the last Facility Compliance Site Inspection.
- 14) Overall, this Facility has a well-established cover crop of native warm season grasses and coppice-type cover.

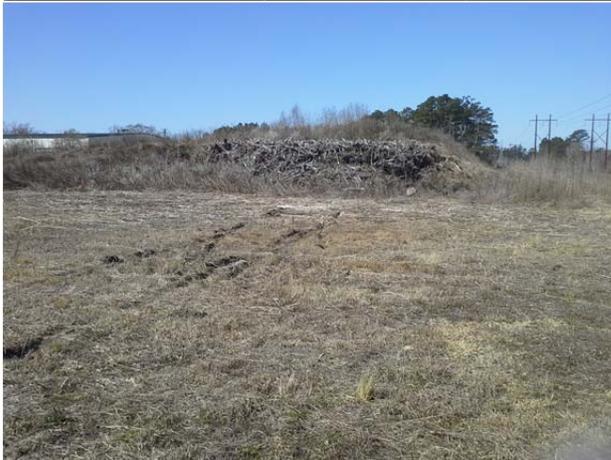
- 15) The northern sideslope adjacent to the access ramp is in need of cover. *Please compact, cover, and grade this area at a slope not greater than 3:1. After completion of cover and grading, please seed and mulch this area to establish a groundcover suitable to prevent erosion of your landfill cap system.

- 16) *Please continue to fill, compact, and cover all areas of differential settlement to provide for positive drainage of surface

water away from the landfill. All sideslopes and repaired areas should be graded at a slope not greater than 3:1 and seeded and mulched to establish a groundcover suitable to prevent erosion.
