FACILITY COMPLIANCE INSPECTION REPORT
Division of Waste Management
Solid Waste Section

Date of Site Inspection: 16 July 2014

Larry Styron LCID Landfill
 Herring-Smith Road
 Newport, NC 28570

N0218-20140716INSP

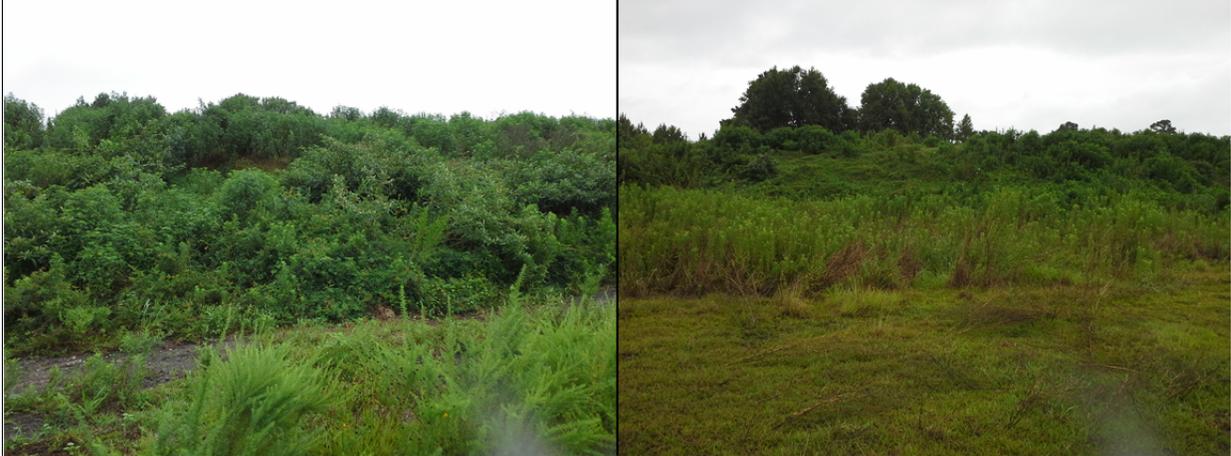
- 9) The Facility sign has been damaged. *Please re-post proper signage at the facility entrance stating the facility emergency contact number and types of waste accepted.
- 10) A cover crop of native warm season grasses and coppice-type cover has been established throughout the facility. Some brush and woody vegetation has been established on portions of the landfill sideslopes. *Plans need to be underway for the mowing of the landfill cover crop and removal of the brush and other woody type vegetation. After mowing, please ensure that all landfill sideslopes have a groundcover established suitable to prevent erosion of your landfill cap system.

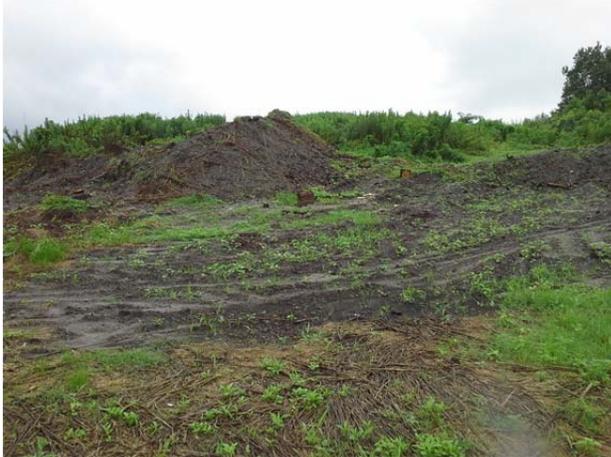
- 11) Soil has been stockpiled on-site for use in cover maintenance in an area adjacent to the landfill access ramp.
