FACILITY COMPLIANCE INSPECTION REPORT
Division of Waste Management
Solid Waste Section

Date of Inspection: 26 August 2014

Dixon Pit LCID Landfill
 2628 Hwy 24
 Newport, NC 28570

Comprehensive Facility Compliance Inspection

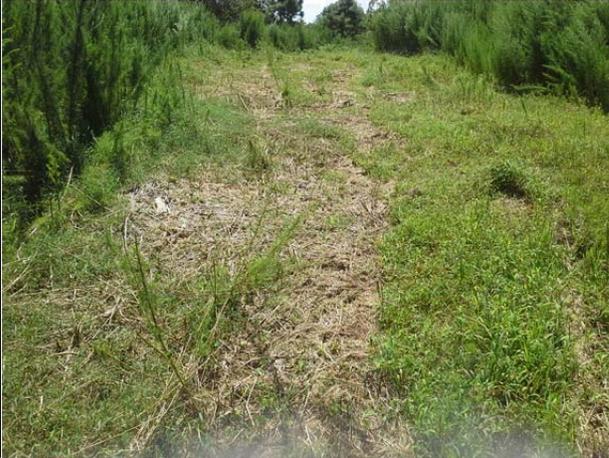
- 9) Overall, this Facility has a well-established cover crop of native warm season grasses and coppice-type cover.
- 10) Portions of the Facility have recently been mowed.

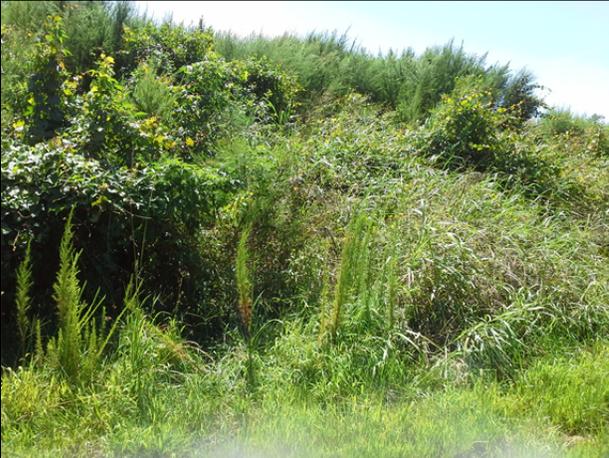
- 11) *The Facility sideslopes need to be mowed and maintained to prevent the growth of brush and woody vegetation which can shade out and otherwise inhibit the growth of the desired grass cover crop.

- 12) *Corrective actions are required as a result of this Facility Compliance Inspection.
