FACILITY COMPLIANCE INSPECTION REPORT
Division of Waste Management
Solid Waste Section

Date of Inspection: 4 March 2015

Bennett Neck Road Mine LCID Landfill
 382 Bennett Neck Road
 Grantsboro, NC 28529

N1070-20150304INSP

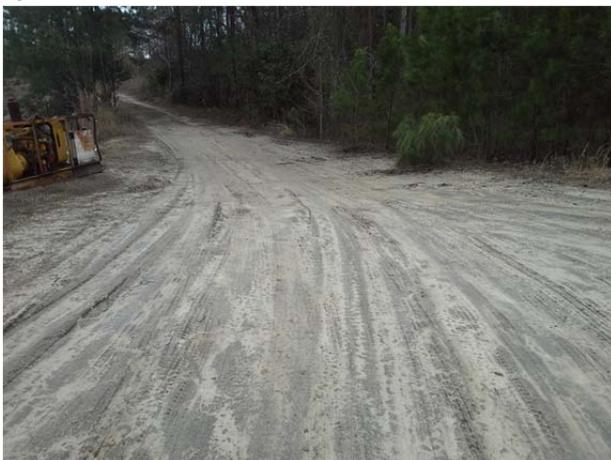
- 6) This Facility is secured by a locked gate at the Facility entrance and has controlled access for safety. The gate was closed and locked upon my arrival and no attendant was on site during this Facility Compliance Inspection.
- 7) Proper signage has not been posted at the Facility entrance. *Please install proper signage at the Facility entrance stating the Facility Name and Emergency Contact number.
- 8) Landfill disposal footprint markers have not been installed. *Please install highly visible, permanent markers around the perimeter of the landfill delineating the permitted disposal area.
- 9) The inactive areas are covered with a crop of native warm season grasses and coppice type cover.

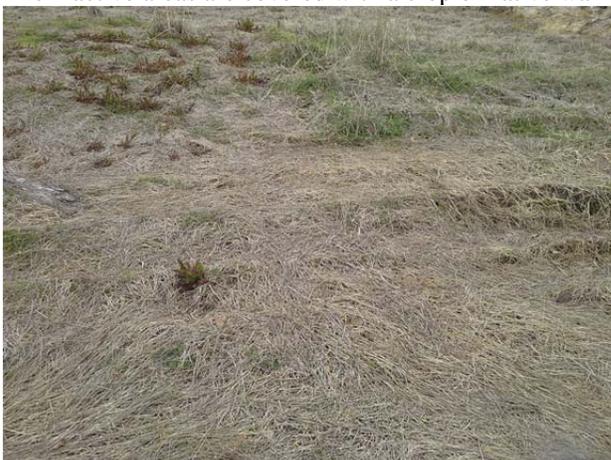
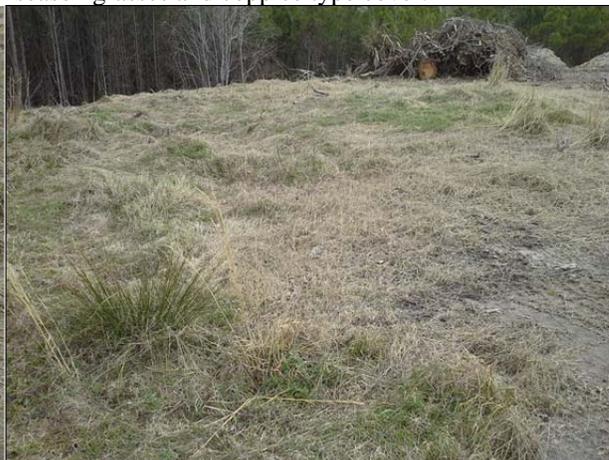
- 10) The landfill side slopes have been covered and graded to promote positive drainage of surface waters away from the landfill.
- 11) The landfill working face is being maintained in a manageable size.
- 12) The waste type was reviewed, no unpermitted wastes were observed during this Facility Compliance Inspection.

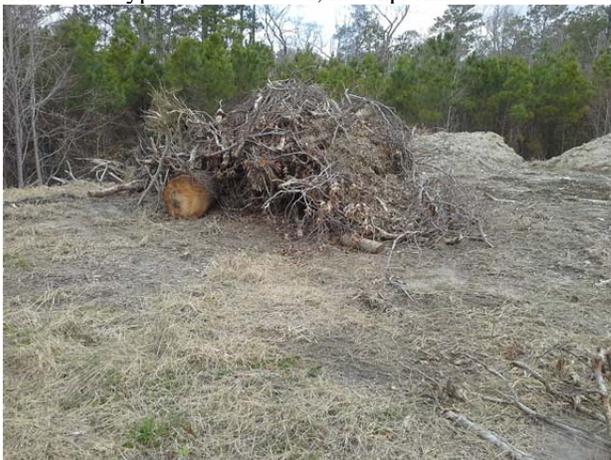
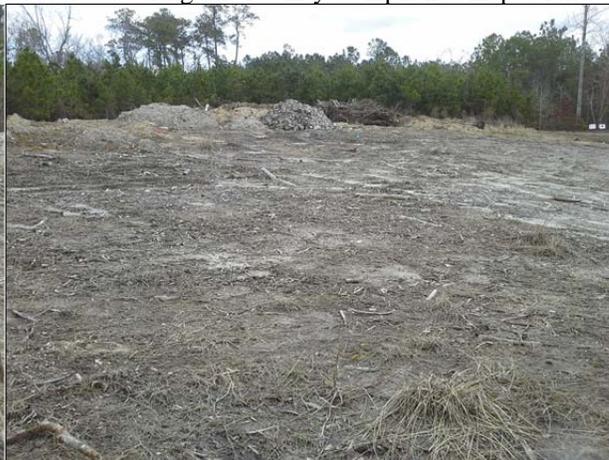
- 13) Soil has been stockpiled at the landfill for use as cover.
- 14) *Please ensure that all waste is covered every thirty days or when the active working area reaches one acre in size.

whichever occurs first.
