**FACILITY COMPLIANCE INSPECTION REPORT**  
**Division of Waste Management**  
**Solid Waste Section**

**Date of Inspection:** 13 January 2015

Anna Wink LCID Landfill #2  
 Anna Wink Road  
 Newport, NC 28570

Comprehensive Facility Compliance Inspection

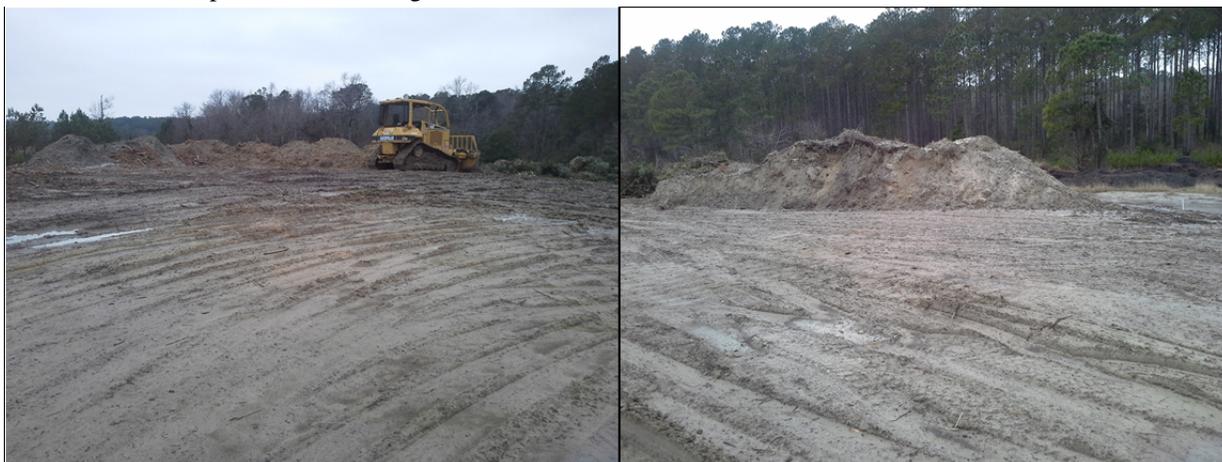
- 10) Soil has been stockpiled at the working face for use as cover.

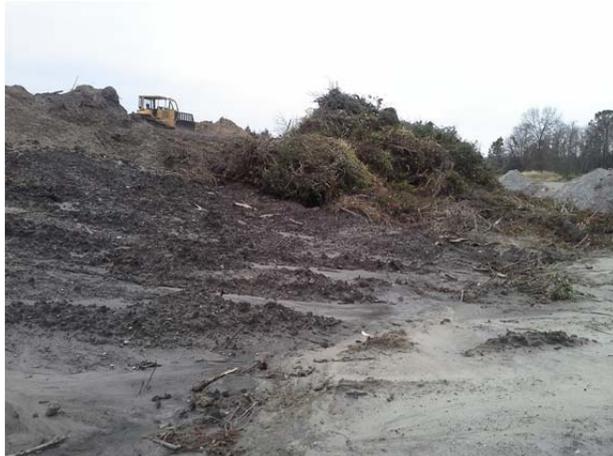
- 11) The waste type in the landfill was reviewed. No unpermitted wastes were observed during this Facility Compliance Inspection.
- 12) Waste has been pushed from the working face over the southwestern sideslope. \*Please ensure that the active working area is maintained in a compact area and that the landfill is constructed using a lift-type progression. All outside slopes should be compacted and covered with adequate soil as soon as possible.

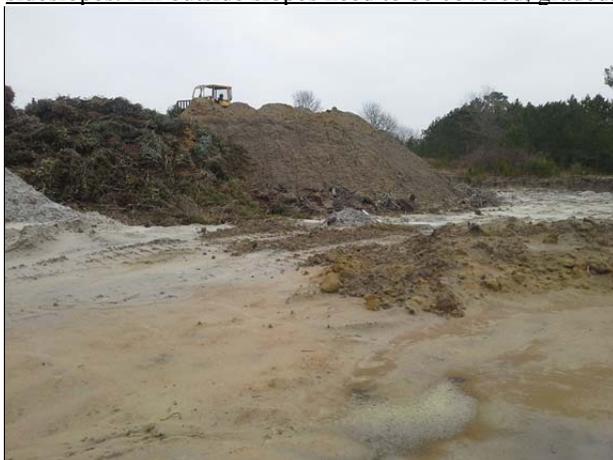
- 13) Portions of the outside slopes have been covered and graded. \*Please continue working to cover and grade all landfill sideslopes. All outside slopes need to be covered, graded, and maintained at a slope not greater than 3:1.
