FACILITY COMPLIANCE INSPECTION REPORT
Division of Waste Management
Solid Waste Section

Date of Inspection: 3 September 2015

Anna Wink LCID Landfill #2
 Anna Wink Road
 Newport, NC 28570

Comprehensive Facility Compliance Inspection

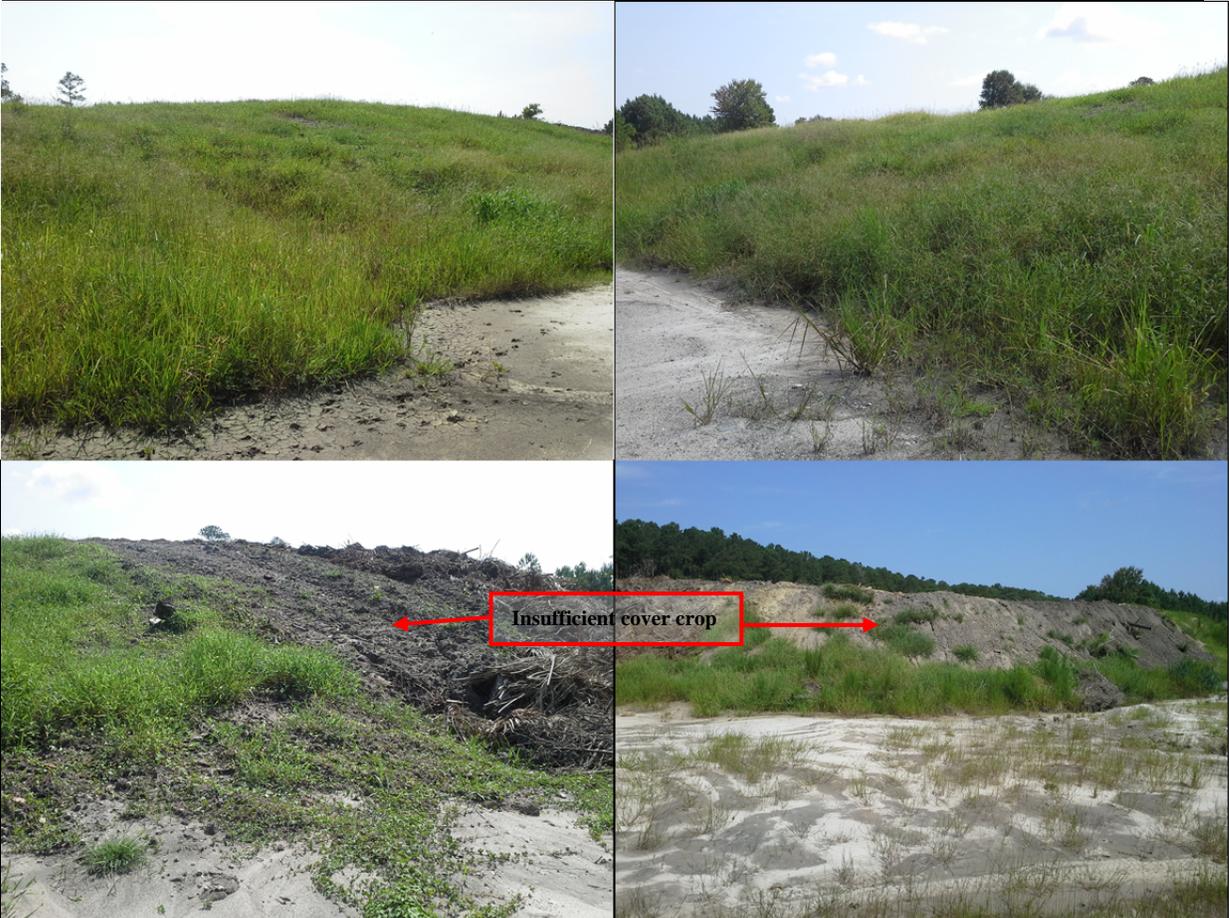
- 8) Proper signage has been posted at the Facility entrance.
- 9) Marker stakes have been placed around the toe of the landfill delineating the disposal area boundaries.
- 10) Soil has been stockpiled at the working face and in an area adjacent to the landfill for use as cover.
- 11) A cover crop has been established on portions of the landfill sideslopes. *Please continue working to establish a cover crop suitable to prevent erosion of your landfill cap system on all outside slopes. All areas lacking in sufficient cover need to be seeded and mulched to establish a groundcover suitable to prevent erosion of your landfill cap system.

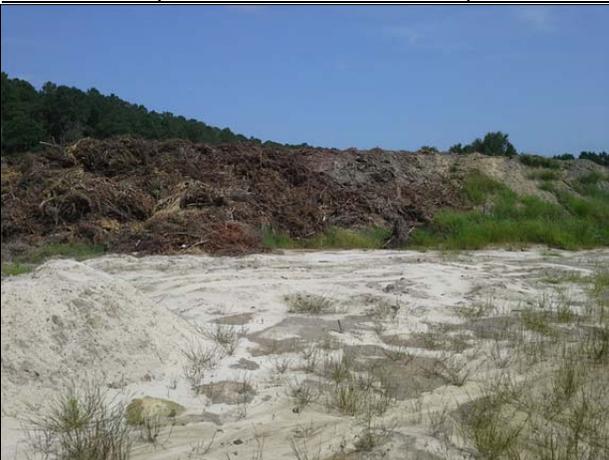
- 12) Waste has been pushed from the working face over the southwestern sideslope. *Please ensure that the active working area is maintained in a compact area and that the landfill is constructed using a lift-type progression. All outside slopes should be compacted and covered with adequate soil as soon as possible.

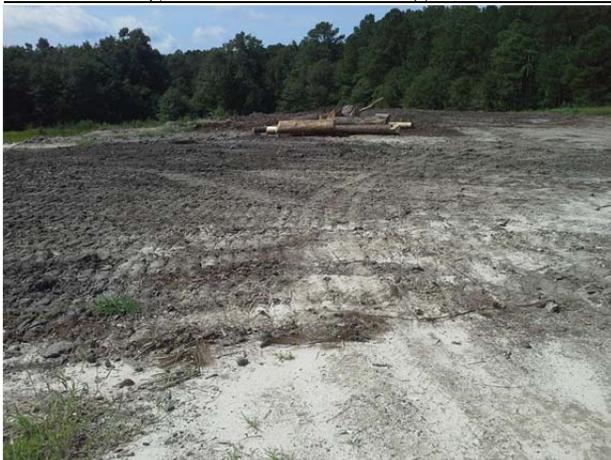
- 14) The waste type in the landfill was reviewed. No unpermitted wastes were observed during this Facility Compliance Inspection.
- 15) The active working area on the top lift has recently been compacted and covered. Please continue to ensure that the active working area is covered monthly, or when the active working area reaches 1 acre in size, whichever occurs first.
