FACILITY COMPLIANCE INSPECTION REPORT
Division of Waste Management
Solid Waste Section

Date of Inspection: 20 November 2014

Anna Wink LCID Landfill #2
 Anna Wink Road
 Newport, NC 28570

Comprehensive Facility Compliance Inspection

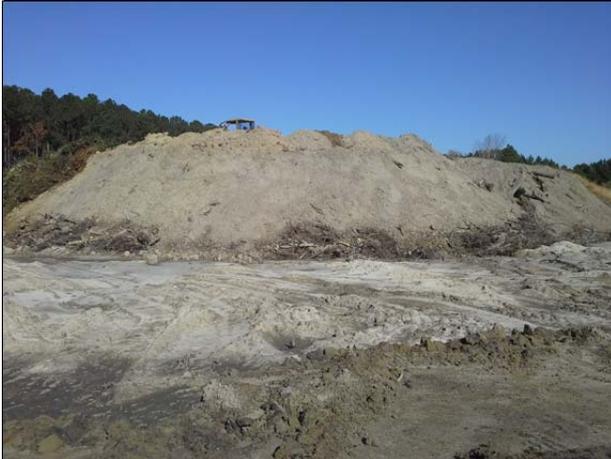
- 10) Portions of the outside slopes have been covered and graded. *Please continue working to cover and grade all landfill sideslopes. All outside slopes need to be covered, graded, and maintained at a slope not greater than 3:1.

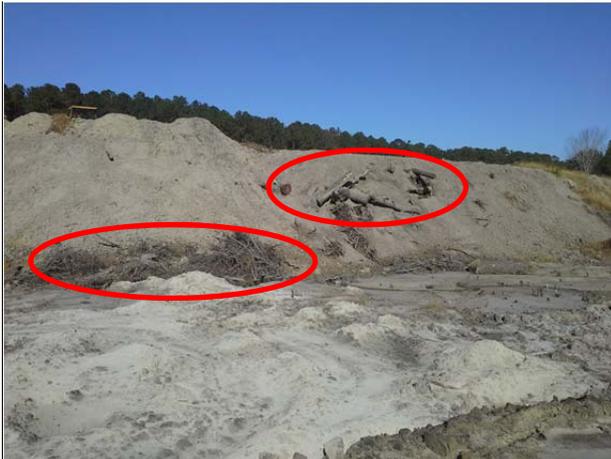
- 11) Some waste was observed protruding through the cover on the southeastern slope of the landfill and at the toe of the southern sideslope. *Please ensure that all outside slopes are adequately compacted and covered.

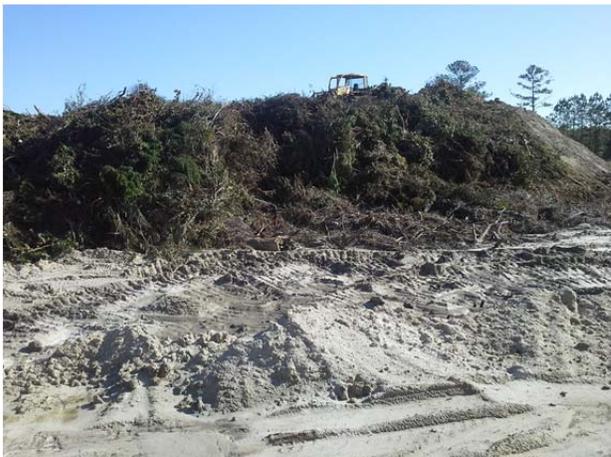
- 12) A cover crop has not been established on the landfill sideslopes. *Please note in your LCID Landfill Notification Package .0566 OPERATIONAL REQUIREMENTS FOR LAND CLEARING AND INERT DEBRIS (LCID) LANDFILLS #7 states that "Provisions for groundcover sufficient to restrain erosion must be accomplished within 30 working days or 120 calendar days upon completion of any phase of landfill development." And, as such, all outside slopes need to be seeded and mulched to establish a groundcover suitable to prevent erosion of your landfill cap system.
- 13) Waste has been pushed from the working face over the southwestern sideslope. *Please ensure that the active working area is maintained in a compact area and that the landfill is constructed using a lift-type progression. All outside slopes should be compacted and covered with adequate soil as soon as possible.

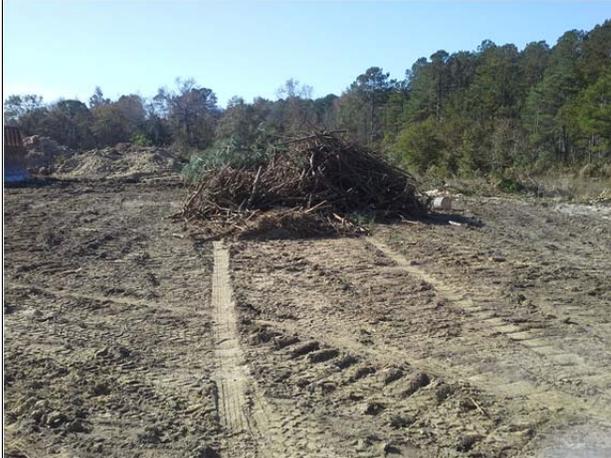
- 14) Please ensure that the active working area is covered monthly, or when the active working area reaches 1 acre in size, whichever occurs first.
- 15) Soil has been stockpiled at the working face for use as cover.
- 16) The waste type in the landfill was reviewed. No unpermitted wastes were observed during this Facility Compliance Inspection.
