FACILITY COMPLIANCE INSPECTION REPORT
Division of Waste Management
Solid Waste Section

Rhea's Backhoe & Septic Tank Service

Comprehensive Inspection and collection of one soil sample.

Figure 1: Rhea's Septage Land Application Site (SLAS) 23-11
1140 Long Branch Rd. (SR-2238), Cleveland County, Grover, NC

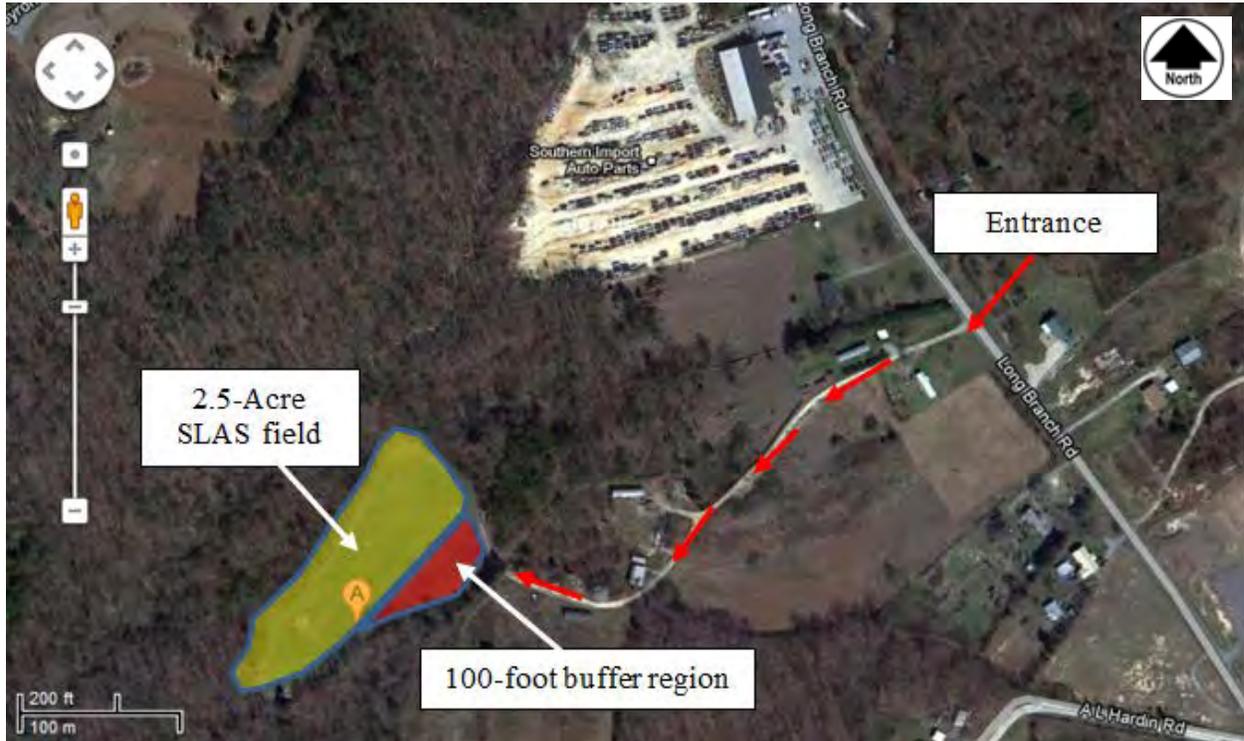
2. The site consists of one 2.5-acre land application field located at the end of an un-named dirt road (south of *Southern Import Auto Parts*) off the west side of Long Branch Road (SR-2238).
3. The site (Parcel #10140) is owned by Donald Whitworth, 1132 Long Branch Rd., Grover, NC 28073
4. **The access road was passable, but needs improvement to address existing ruts and erosion.** (Photo #1)

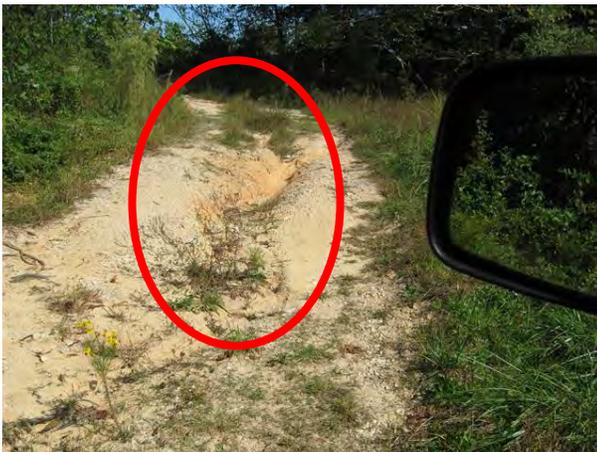
2. Significant ruts / erosion on the western section of the access road that is in need of repair.

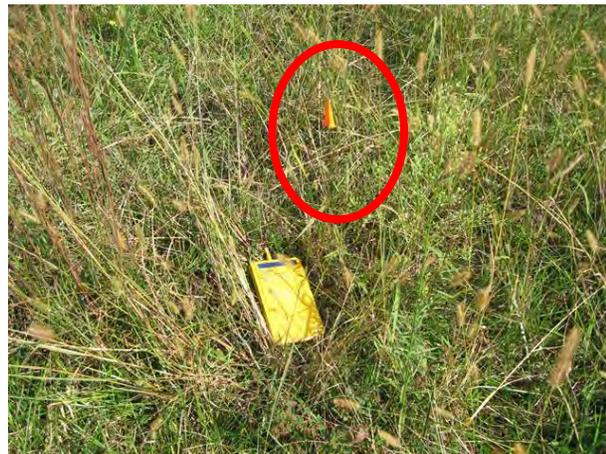
1. Small red "flag" (typical) used to mark the "100-ft. buffer region" of the application field.

5. The “100-foot buffer area” is marked with multiple small red flags. (Photo #2)
6. Permitted setbacks and buffers appeared to be maintained.
7. Disposal area boundaries were apparent and septage discharges were made within the disposal area boundary.
8. The facility it permitted to use both Septage Detention & Treatment Facility (SDTF) #23-20 and the Shelby, NC Waste Water Treatment Plant as alternative disposal sites.
9. One soil sample was collected for analysis for the possible presence of heavy metals by the NCDA&CS Agronomic Soil Testing Section.

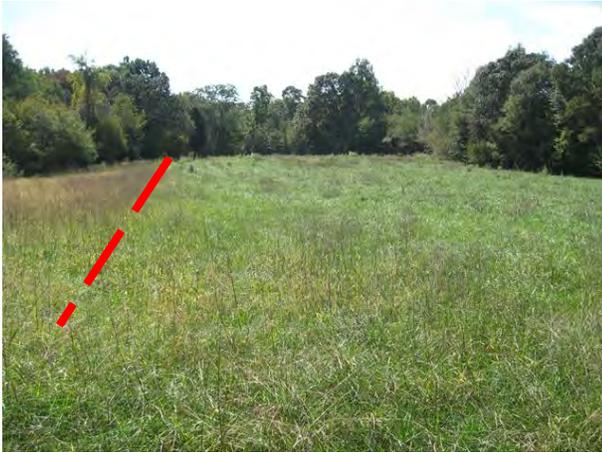
3. Looking SW across the land application field.
 (Note the approximate location of the “100-foot
 buffer line” on the left.)
