FACILITY COMPLIANCE INSPECTION REPORT
Division of Waste Management
Solid Waste Section

UNIT TYPE:												
Lined MSWLF		LCID		YW		Transfer		Compost		SLAS	X	COUNTY: Halifax PERMIT NO.: SLAS-42-06 FILE TYPE: COMPLIANCE
Closed MSWLF		HHW		White goods		Incineration		T&P		FIRM		
CDLF		Tire T&P / Collection		Tire Monofill		Industrial Landfill		DEMO		SDTF

Date of Site Inspection: 4/11/2014 **Date of Last Inspection:** 10/10/2013

James Greene Jr.
Greene's Septic Tank Service
1215 Daniel Str.
Weldon, NC 27890

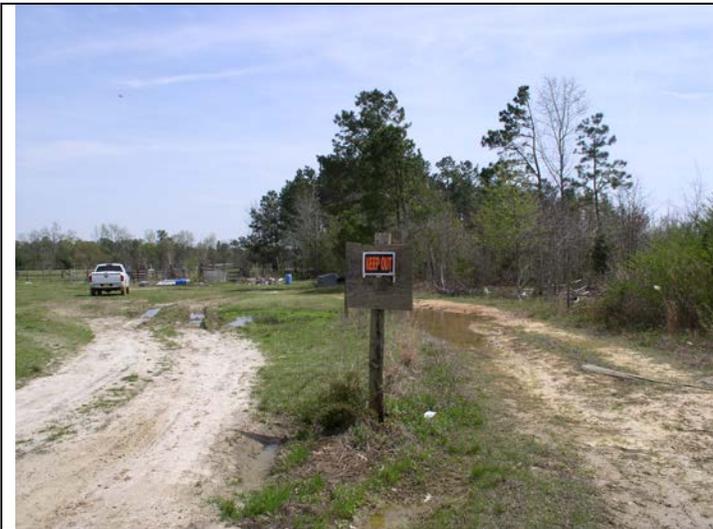
- 1) Access road is in very bad shape with deep potholes. Rule .0838 (a) (3) states "Each site shall have an all weather access road." Improvements with the access road is needed. Access road continues to be a problem.
- 2) I did not observe a "Septage Land Application Site" sign. Rule .0838 (a) (2) states "Each site shall be posted with "NO TRESPASSING" signs. Access roads or paths crossing or leading to the disposal area shall be posted "NO TRESPASSING" and a legible sign of at least two feet by two feet stating "SEPTAGE LAND APPLICATION SITE" shall be maintained at each entrance to the land application area. A "Keep Out" sign was present.

"Keep Out" sign present but no "Septage Land Application Site" sign.

1. A "Septage Land Application Site" sign is needed at the entrance to the site. Rule .0838 (a) (2) states that the sign shall be legible and at least two (2) feet by two (2) feet. Please place a "Septage Land Application Site" by the entrance to the site. A "No Trespassing" sign was present.

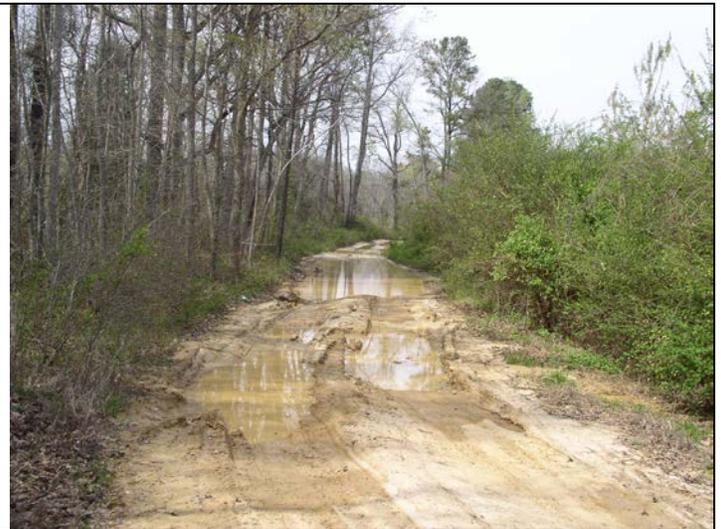
2. Access road in poor conditions. Deep potholes in places within the path. Numerous locations have very deep potholes.
3. Fences that serve as markers were up.

One of the numerous pothole locations within the access road.

11. Access road continues to need work. A "Septage Land Application Site" sign is needed at the entrance to the site.

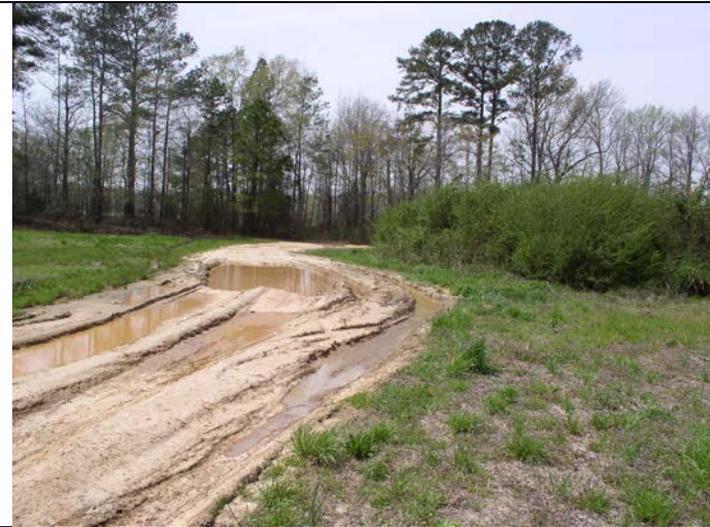
Another example of the numerous pothole locations within the access road.

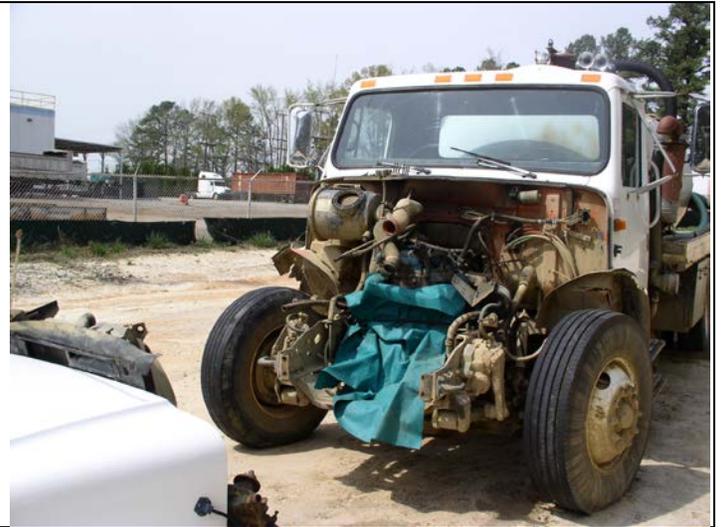
Pump truck had been parked along the access road. Truck appeared to be broke down.
