FACILITY COMPLIANCE INSPECTION REPORT
Division of Waste Management
Solid Waste Section

UNIT TYPE:												
Lined MSWLF		LCID		YW		Transfer		Compost		SLAS	X	COUNTY: Pasquotank PERMIT NO.: SLAS-70-01 FILE TYPE: COMPLIANCE
Closed MSWLF		HHW		White goods		Incin		T&P		FIRM		
CDLF		Tire T&P / Collection		Tire Monofill		Industrial Landfill		DEMO		SDTF

Brinson & Miller, Inc.
 1731 N Road Street
 Elizabeth City, NC 27909

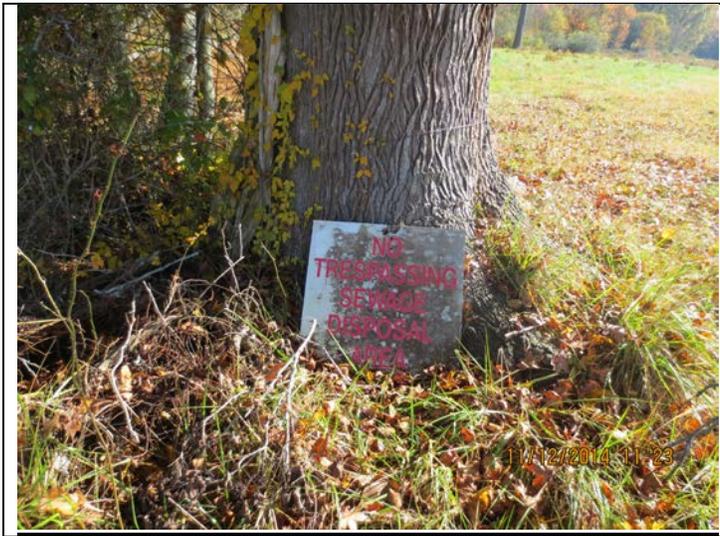
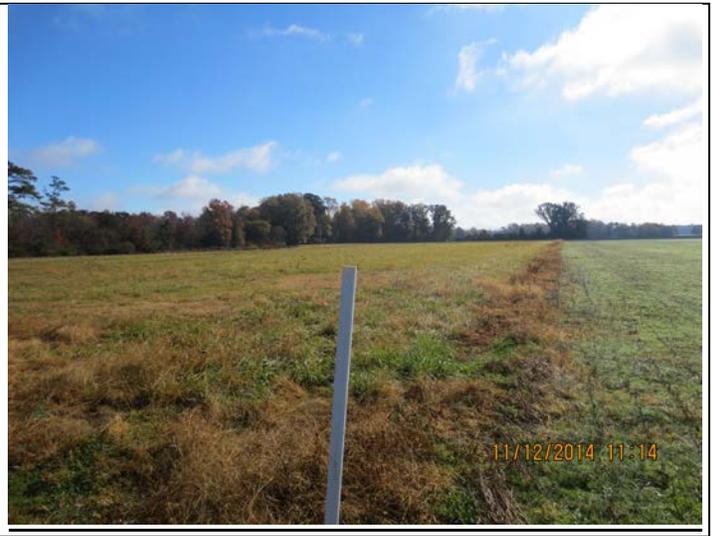
- 1 – Has sign. Need to put on pole or tree so it can be seen. Now sign is on ground. See attached picture.
- 2 – Good road.
- 3 – Markers up.
- 4 – Discharges appear to be in compliance.
- 5 – South side Fescue needs herbicide to control native grasses. North side Fescue is almost gone. Has some common Bermuda grass. Need to reseed Fescue or may could use the common Bermuda as crop on north side. Nutrient Management Plan would have to be changed to do this.
- 6 – No objectionable odors noted.
- 7 – Setbacks appear to be in compliance.
- 8 – Soil Samples taken.
