FACILITY COMPLIANCE INSPECTION REPORT
Division of Waste Management
Solid Waste Section

UNIT TYPE:												
Lined MSWLF		LCID		YW		Transfer		Compost		SLAS	X	COUNTY: Pitt PERMIT NO.: SLAS-74-18 FILE TYPE: COMPLIANCE
Closed MSWLF		HHW		White goods		Incineration		T&P		FIRM		
CDLF		Tire T&P / Collection		Tire Monofill		Industrial Landfill		DEMO		SDTF

*Jamey Way
 Tarboro Septic Tank NC LLC
 211 Barrington Dr.
 Tarboro, NC 27886*

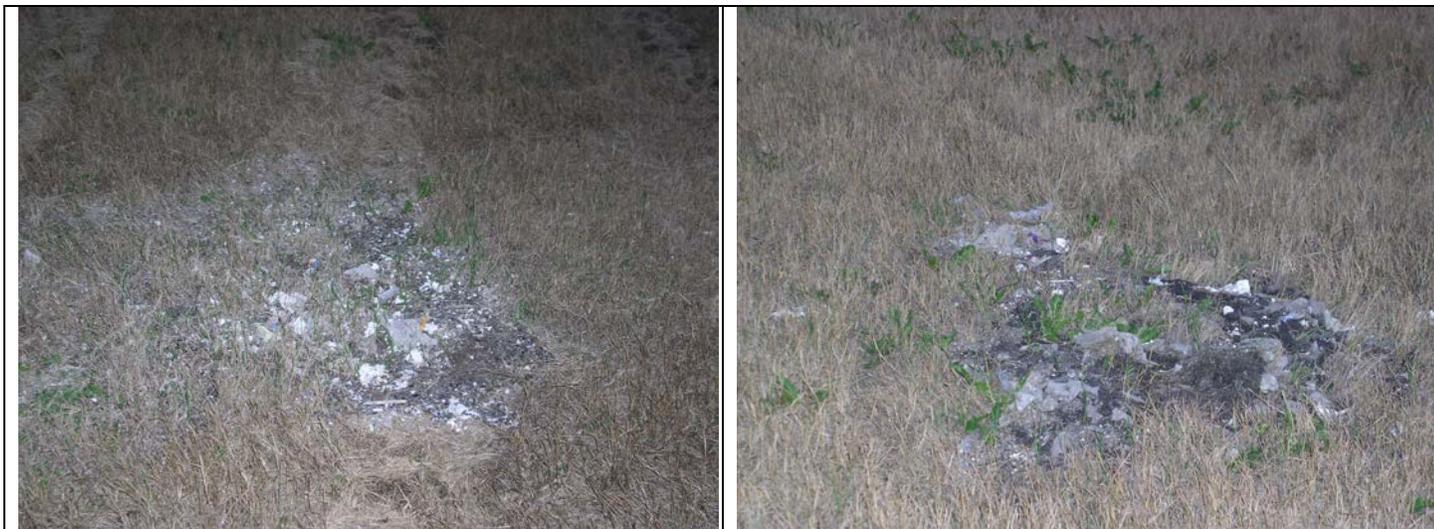
1. "Septage Land Application Site" with "No Trespassing" sign present at entrance to the site.
2. Access road ok.
3. Markers were up.
4. All discharges within the permitted boundaries of the fields.
5. A couple of small spot dumps were noticed. Be sure to rake spot dumps to spread the septage solids such that they do not mat the grass down and kill the vegetation.

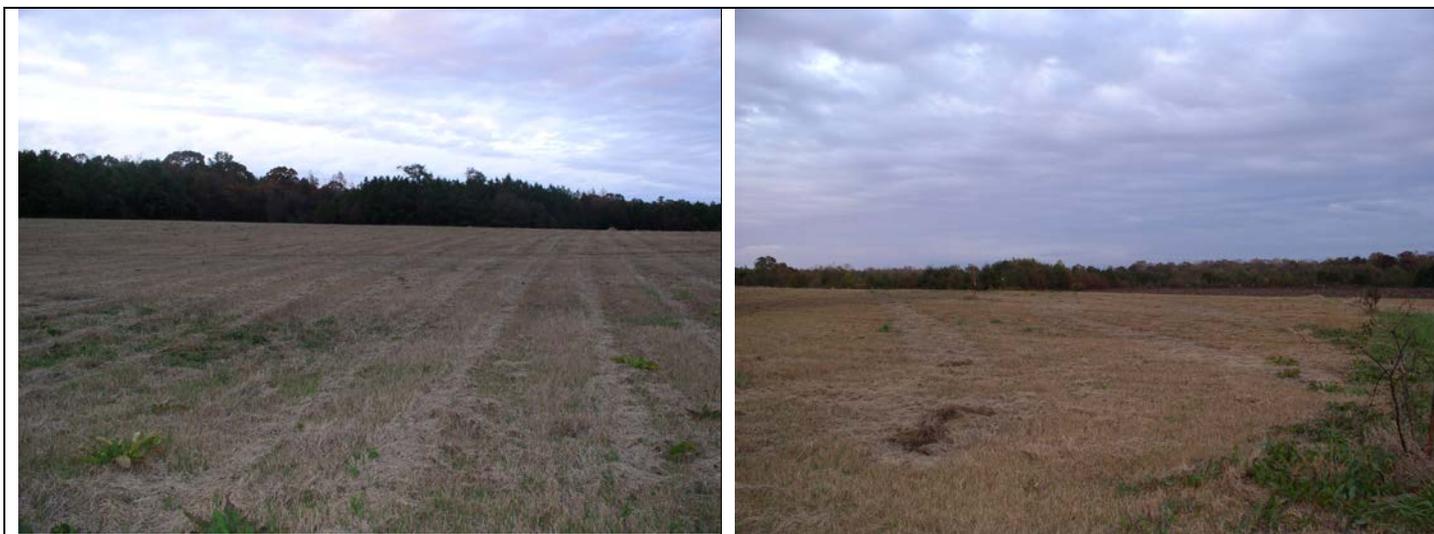
6. No evidence of any small grain coming up. The small grain should at least be coming up by now. The small grain needs to have some growth before it gets so cold. Also, the bermudagrass had been cut on Field #1 with the cut vegetation remaining on the field in windrows. There had been some septage applied to the cut material. Cut material is to be removed as hay as described in the nutrient management plan.

7. pH not checked. No application at time of inspection.
8. No objectionable odors noticed at the site today.
9. Records not checked.
10. Talked to Jamey and he told me that the small was planted on 10-20-13. In the future, need to do everything possible to ensure that a small grain crop is present for the winter crop. Also, need to make sure that the crop is harvested as covered within the nutrient management plan. I collected soil samples from each of the two fields.
