FACILITY COMPLIANCE INSPECTION REPORT
Department of Environmental Quality
Division of Waste Management - Solid Waste Section

UNIT TYPE:												
Lined MSWLF		LCID		YW		Transfer		Compost		SLAS	X	COUNTY: Rockingham PERMIT NO.: SLAS-79-06 FILE TYPE: COMPLIANCE
Closed MSWLF		HHW		White goods		Incin		T&P		FIRM		
CDLF		Tire T&P / Collection		Tire Monofill		Industrial Landfill		DEMO		SDTF

Date of Site Inspection: 9/16/2015

Billingsley Septic Tank Company
 149 Penn Road
 Reidsville, North Carolina 27320

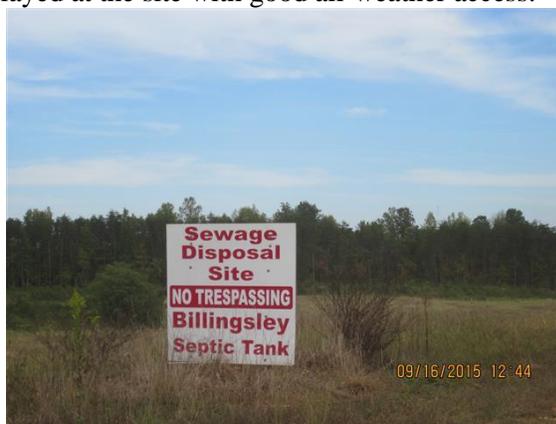
1. All photographs were taken by Troy Harrison on September 16, 2015.
2. The Septage Land Application Site consists of one 10.5 acre field from which soil samples were taken.
3. The site is permitted for land application of domestic septage and grease septage.
4. The site is located on Mizpah Church Road directly across from Penn Road and had an accessible all-weather road to the site.
5. Appropriate signage was displayed at the site with good all-weather access.

Sign at entrance to Field

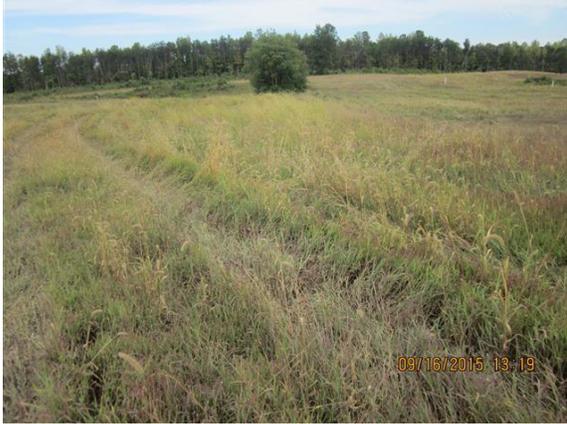
6. This field has been used due to problems at the other fields. All septage discharges appear to have been made within the disposal area boundary.
7. **The crop stand was observed to have not been maintained with the vegetation very tall and very weedy and allowed to grow uncontrolled. This field needs to be harvested as soon as possible; keeping in mind that a 30-day waiting period between the last application of septage and the harvest of a crop must be maintained (as required by Solid Waste Permit SLAS-79-06, Condition 2). Fields cannot be used for land application unless an adequate fescue crop is established and maintained. This includes weed control.**

Looking northeast at field

In order to come into compliance, Billingsley Septic Tank Company must immediately follow the nutrient management plan. Specifically, Section B.1 paragraph 2 states: "Areas that develop with less than 80% ground cover by fescue will be re-seeded with fescue at a rate of 15-20 lbs seed/acre. This seed should not be tilled, but depending on moisture status, a light rolling may be needed. Further advice may be sought through the Cooperative Extension Service or NCDA&CS regional agronomist." This should be done taking into consideration that the 30-day waiting period between the last application of septage and the harvest of a crop shall be maintained.

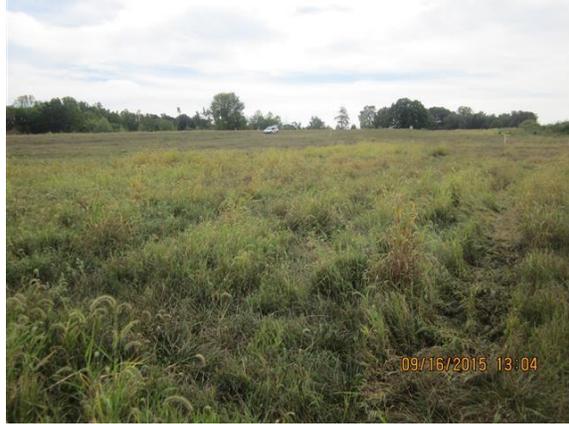
Looking southeast toward entrance to field
