FACILITY COMPLIANCE INSPECTION REPORT
Division of Waste Management
Solid Waste Section

Date of Site Inspection: 02/01/16

Avery Co. Construction & Demolition (C&D) Landfill
 2175 Brushy Creek Rd. (SR-1011)
 Ingalls, NC

Partial Inspection Limited to the Construction and Demolition (C&D) Landfill.

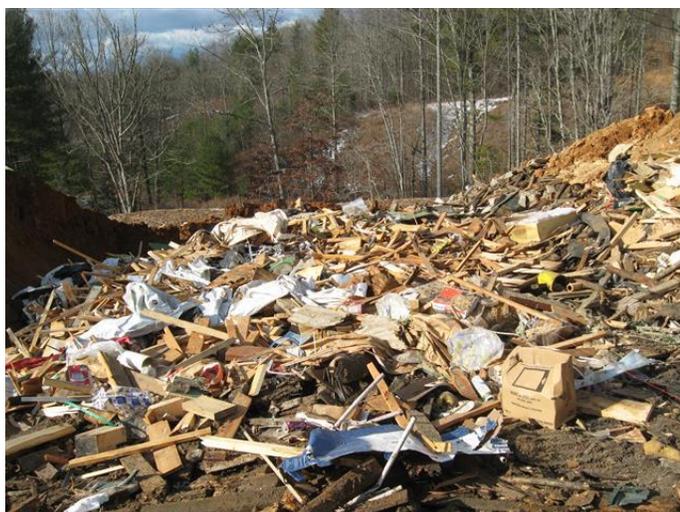
1. The C&D facility is permitted to receive solid waste generated in Avery, Burke, Caldwell, McDowell, Mitchell, and Watauga counties in North Carolina, and, Carter, Johnson, and Unicoi counties in Tennessee.
2. The C&D landfill currently accepts approximately 25-tons of waste per day.
3. Wastes were actively being accepted during the inspection. No unacceptable wastes were observed at the landfill. (Photo #1)

1. Looking at the small working face of the C&D landfill

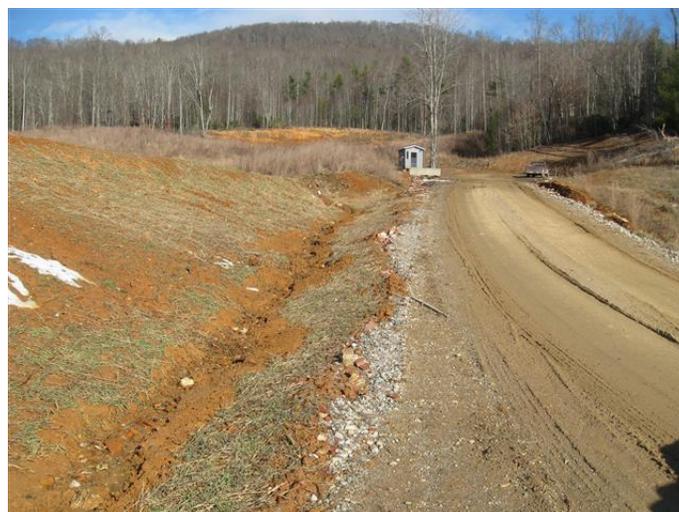
2. Looking (N) up the access road on the east side of the active cell. (The active C&D cell is to the left.)

- 4. The access roads are well maintained. (Photo #2)
- 5. Edge-of-waste markers are in place and well maintained. (Photo #3)

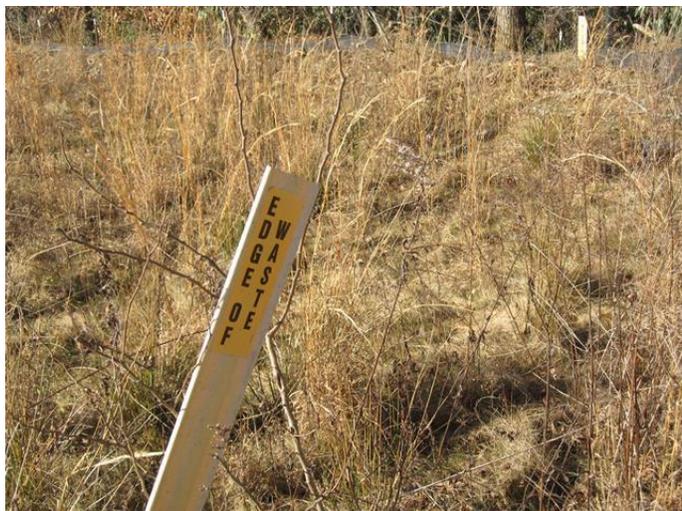
3. Edge-of-waste marker on the C&D landfill.

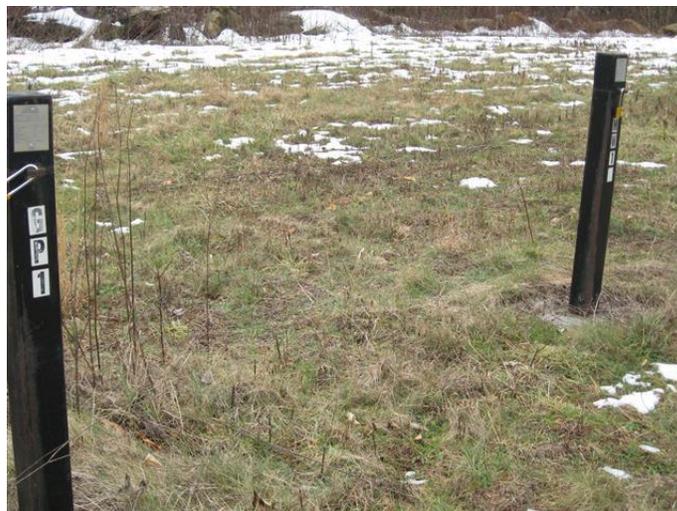
4. Landfill gas monitoring well GP-1 on the (L), groundwater monitoring well MW-1 on the (R).

6. A random inspection of groundwater and landfill gas monitoring wells (Photo #4) found them to be properly secured, labeled and maintained.
7. Passive landfill gas vents have been installed on the closed out cells of the landfill. (Photo # 5) **It is recommended that these passive landfill gas vents be labeled with IDs to facilitate any maintenance, repairs and or monitoring that maybe needed.**
8. The stormwater basins have ample freeboard and do not appear to need to be dredged of sediments at this time. (Photos #6)
9. The vegetative cover on the closed and active cells is well established. No evidence of any excessive erosion was observed.

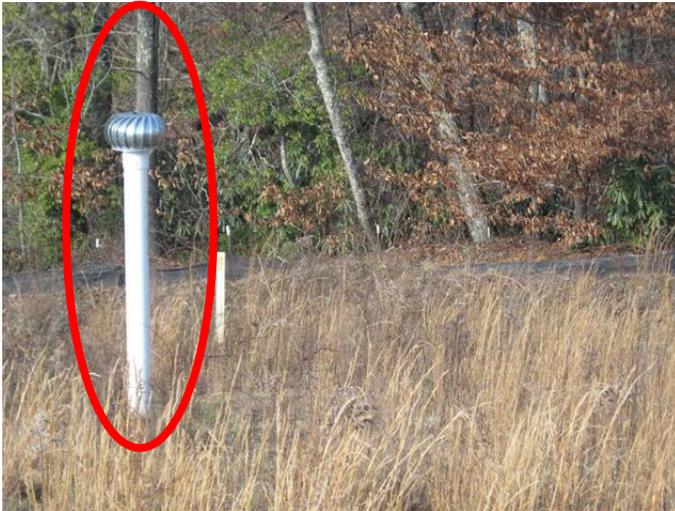
5. Passive landfill gas vent (typical) on the C&D landfill.

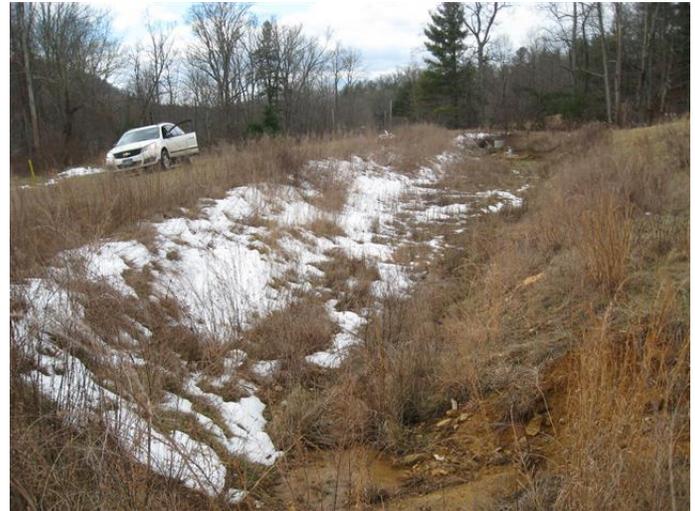
6. Looking (W) along the length of Sediment Basin No. 4
