Subject: **Report of CQA Monitoring of Repair of Base Liner Geomembrane
Cell No. 13
East Carolina Regional MSW Landfill
Facility Permit No. 08-03
Bertie County, North Carolina
BLE Project Number J15-1001-80**

The purpose of this letter is to document CQA monitoring and observations by Bunnell-Lammons Engineering, Inc. (BLE), of the repair of an approximately 13-foot x 63-foot area of damage to the base liner geomembrane (FML). The damage had been inadvertently caused during operational grading of the outside toe of the waste slope on September 23, 2015. The repair is located on the top of the cell edge embankment at the northeast corner of Cell No. 13, at the East Carolina Regional MSW Landfill.

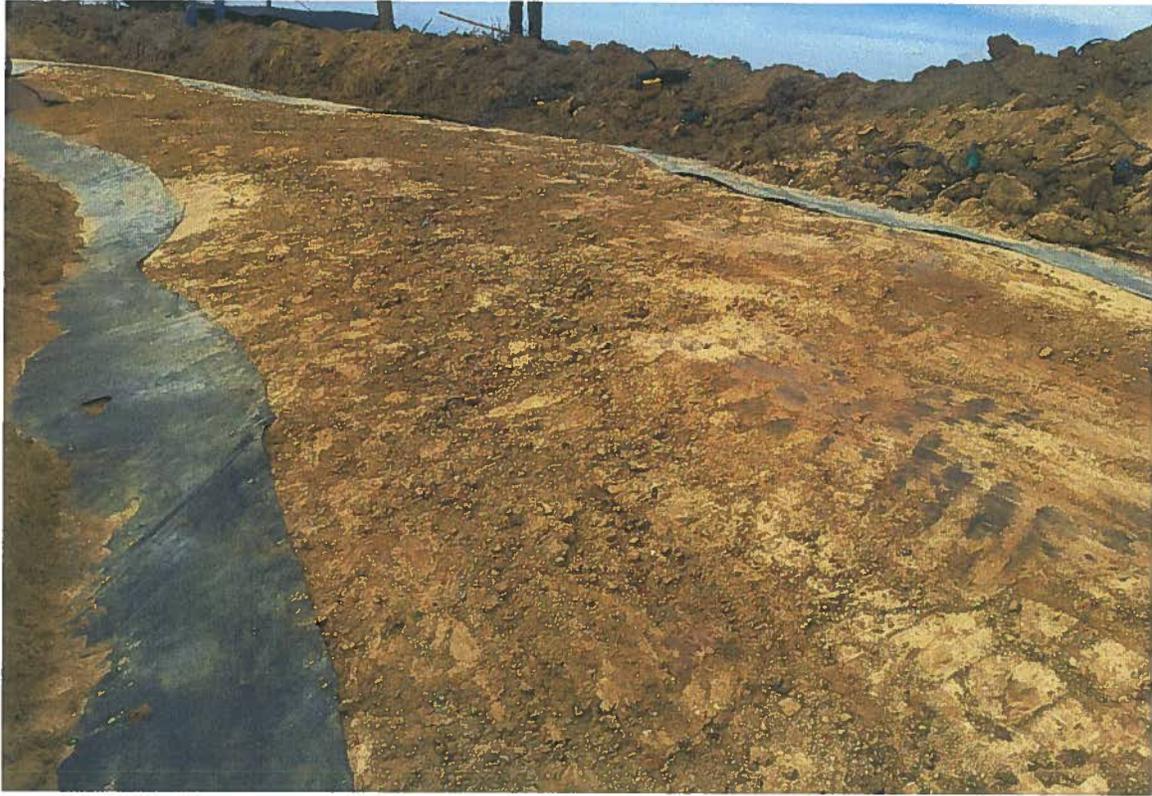
Photograph No. 1: Liner damage within Cell No. 13, looking from east to west.

The repair was performed by American Environmental Group (AEG) on September 23, 2015. BLE's CQA Technician, Mr. Brian Taylor, was on-site to observe the repair. East Carolina Regional MSW Landfill operations personnel exposed the FML where the damage had occurred, repaired the clay liner surface in the area by back dragging and compacting it with the bucket of a CAT skid steer loader. Granular bentonite was placed over the exposed clay liner surface to fill in surface defects. Two hand auger thickness checks were performed by BLE in the repaired clay liner area and confirmed the clay liner thickness was greater than 24 inches. The hand auger holes were backfilled with a combination of clay liner soils and granular bentonite, and the mixture moistened and compacted.

AEG cut out the damaged FML, cleaned the surface of the FML around the damaged area, and installed a minimum 60-mil HDPE textured geomembrane 13-foot x 63-foot repair patch. The patch was extrusion welded to the base liner. A minimum 60-mil HDPE geomembrane 1 foot wide seam cap was

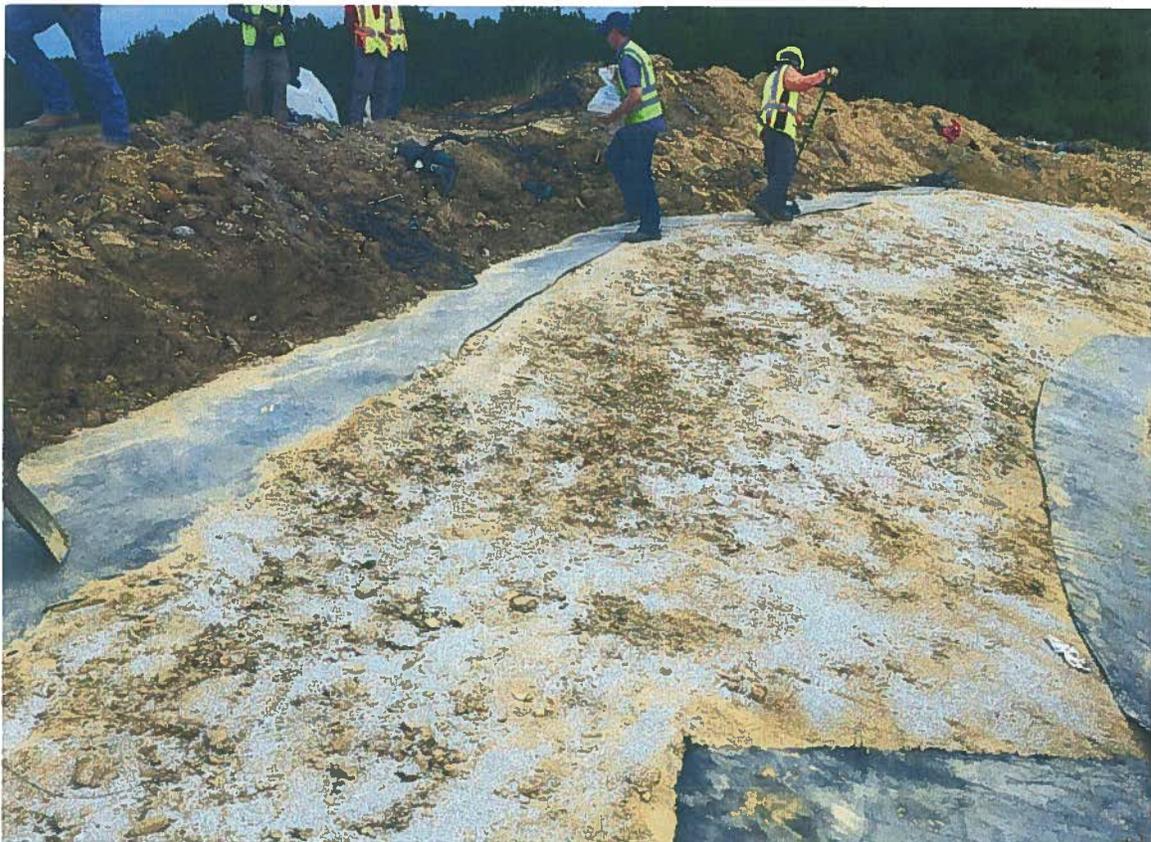
Photograph No. 2: Repaired soil liner area. Thin layer of powdered bentonite over soil repair.

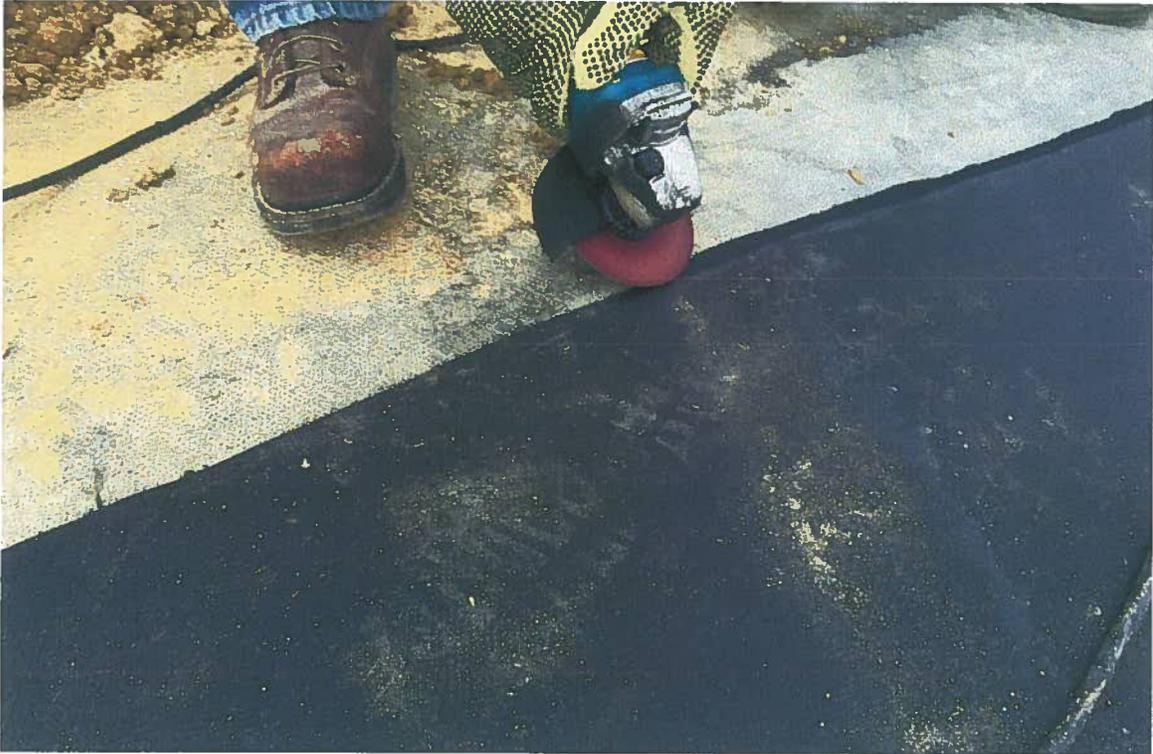
Photograph No. 3: Grinding seam area of the new and existing geomembrane prior to extrusion welding.

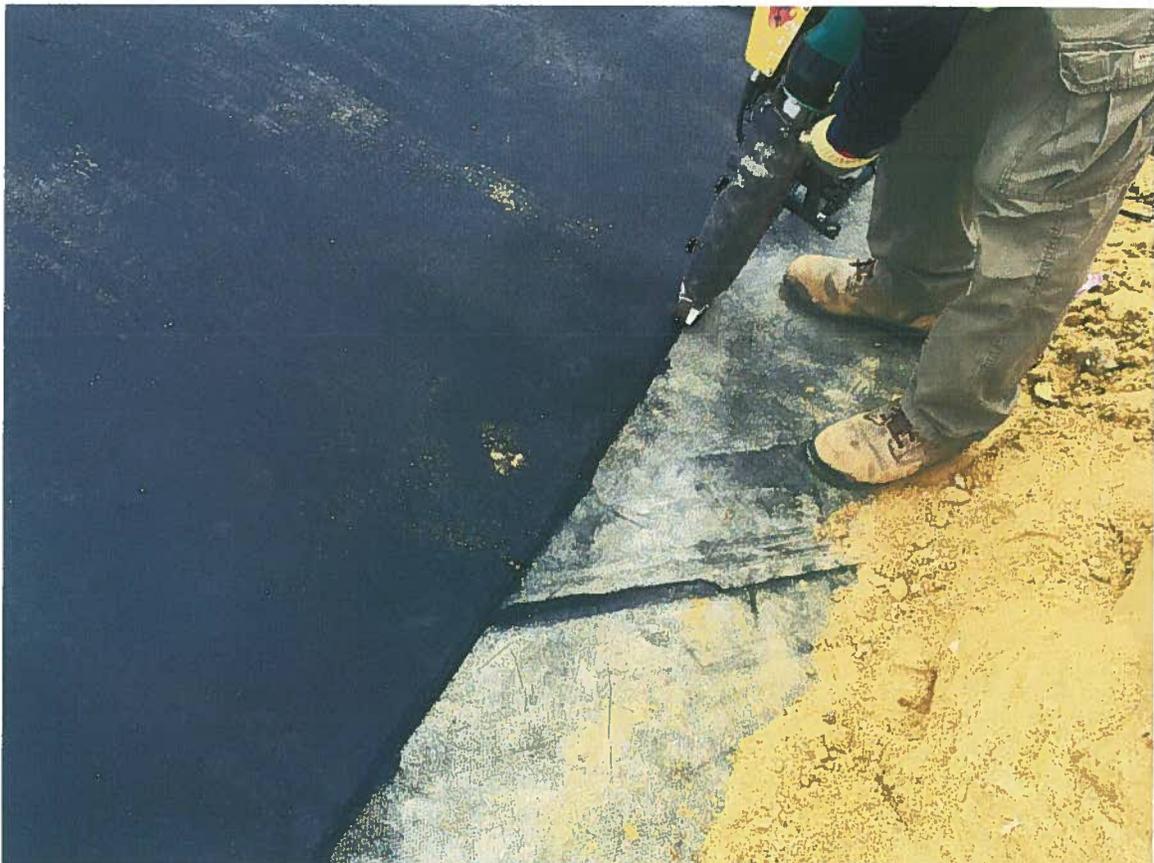
Photograph No. 4: Extrusion welding the geomembrane (FML) repair patch.

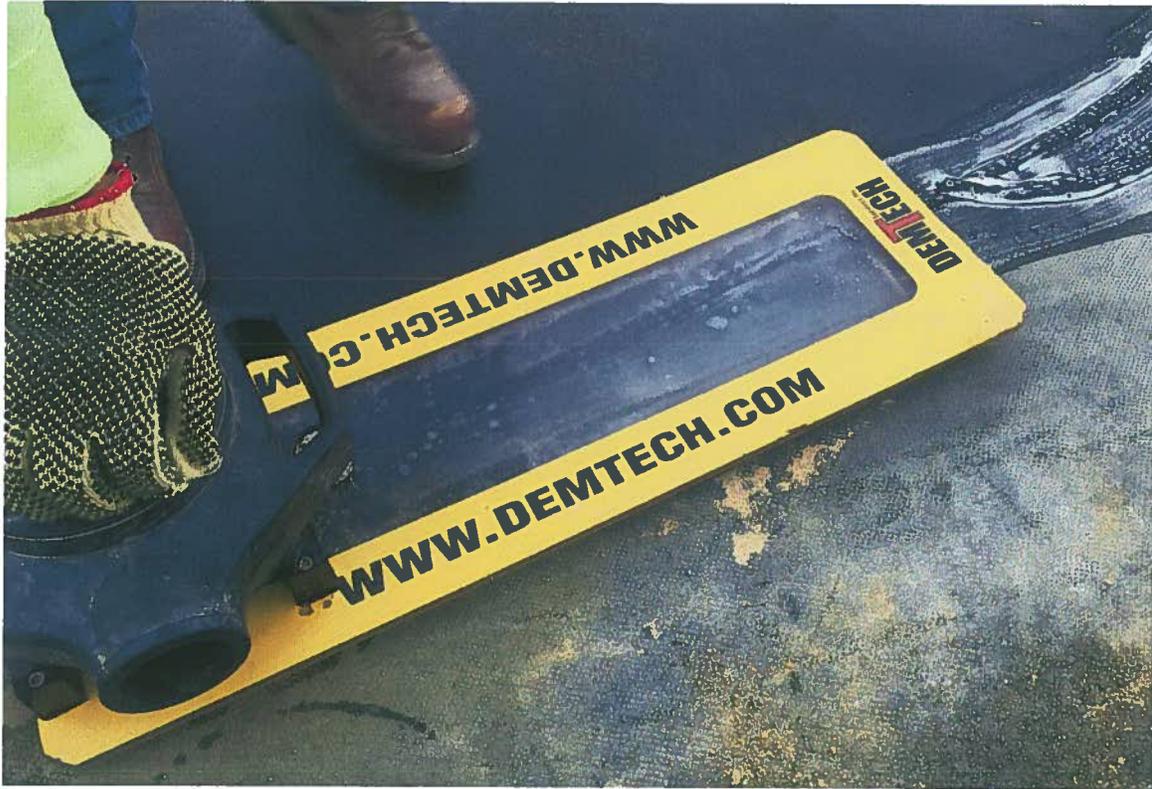
Photograph No. 5: Vacuum box testing the extrusion weld of the FML repair patch.

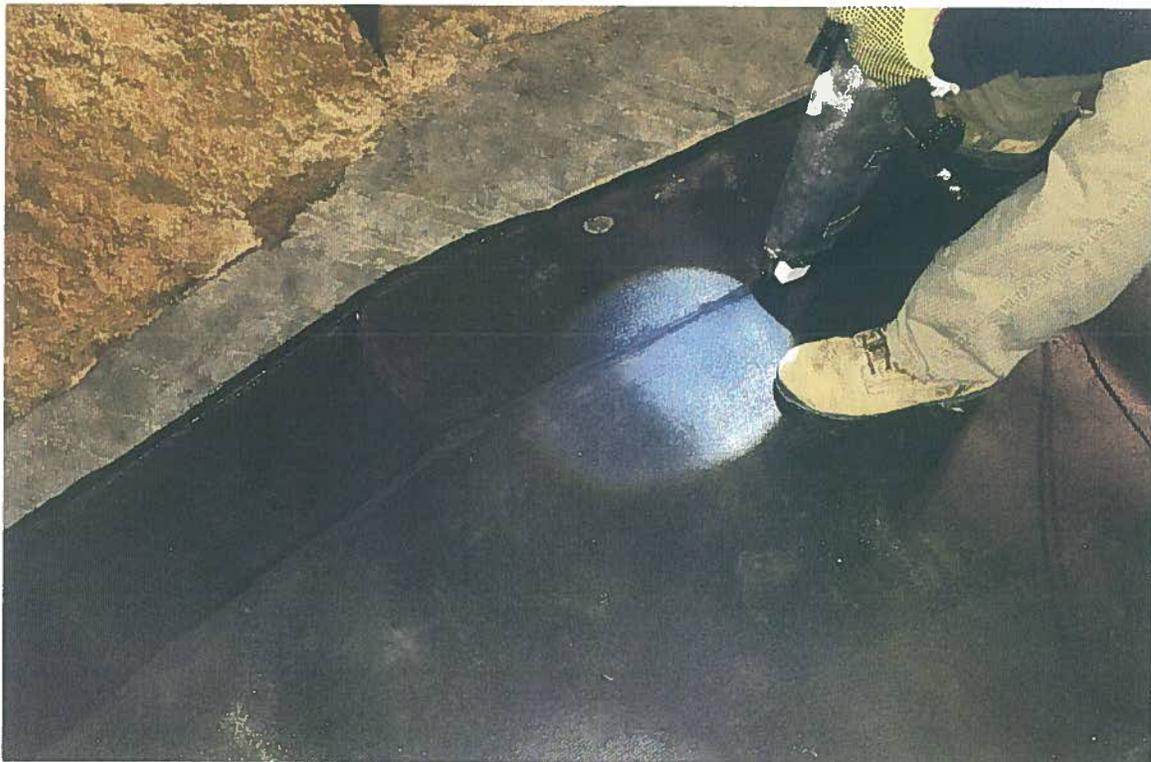
Photograph No. 6: Extrusion welding a geomembrane cap over the new extrusion weld of the geomembrane patch.

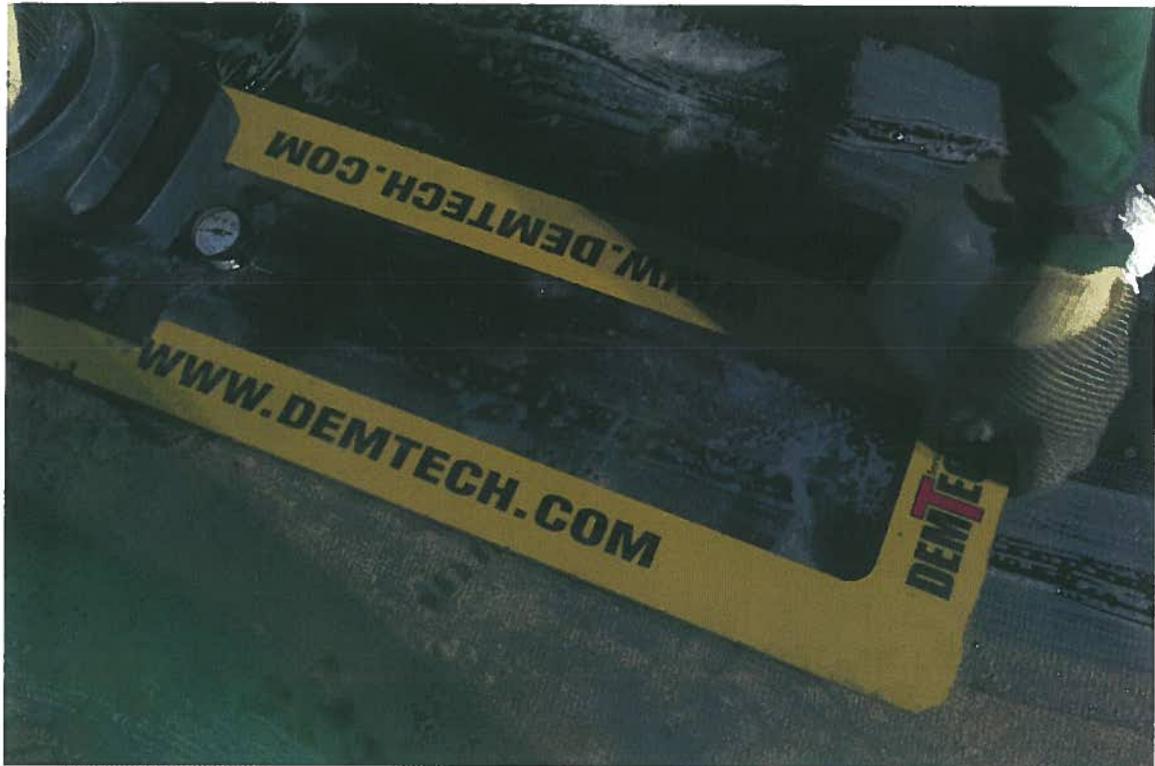
Photograph No. 7: Vacuum box testing the extrusion weld of the geomembrane seam cap over the geomembrane patch.

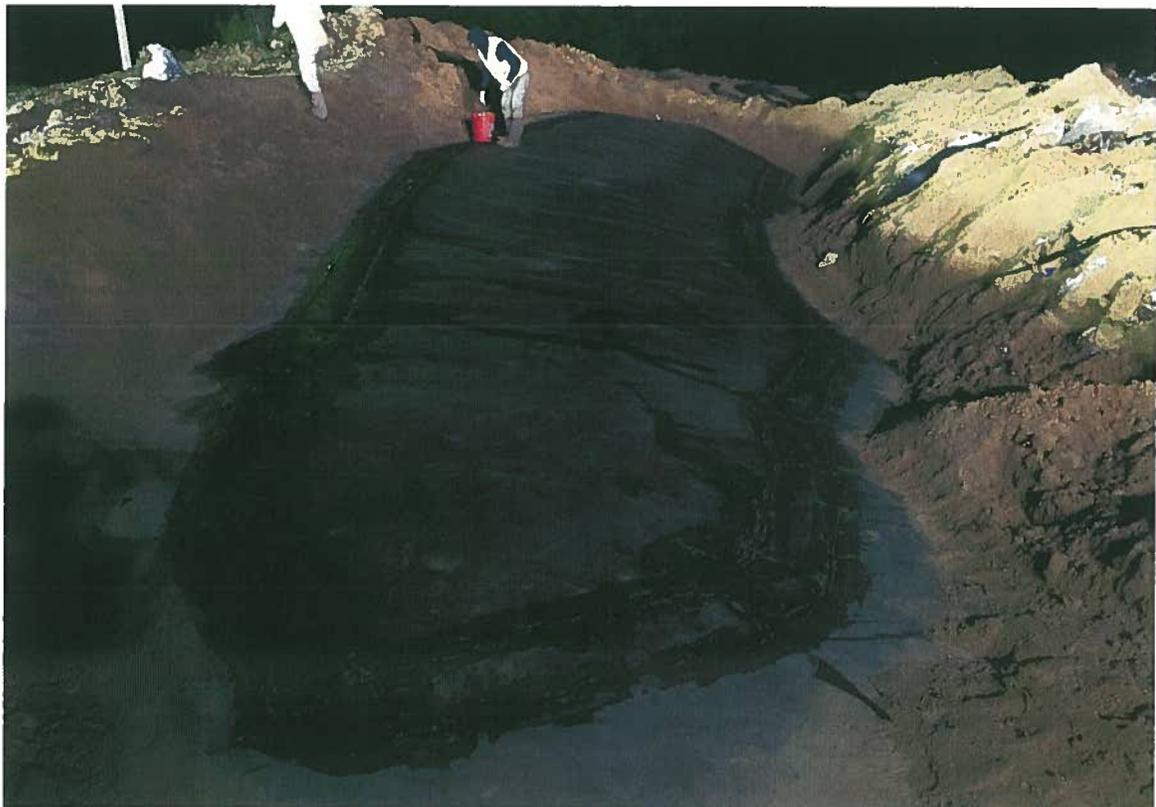
Photograph No. 8: Installed geomembrane repair and seam cap.

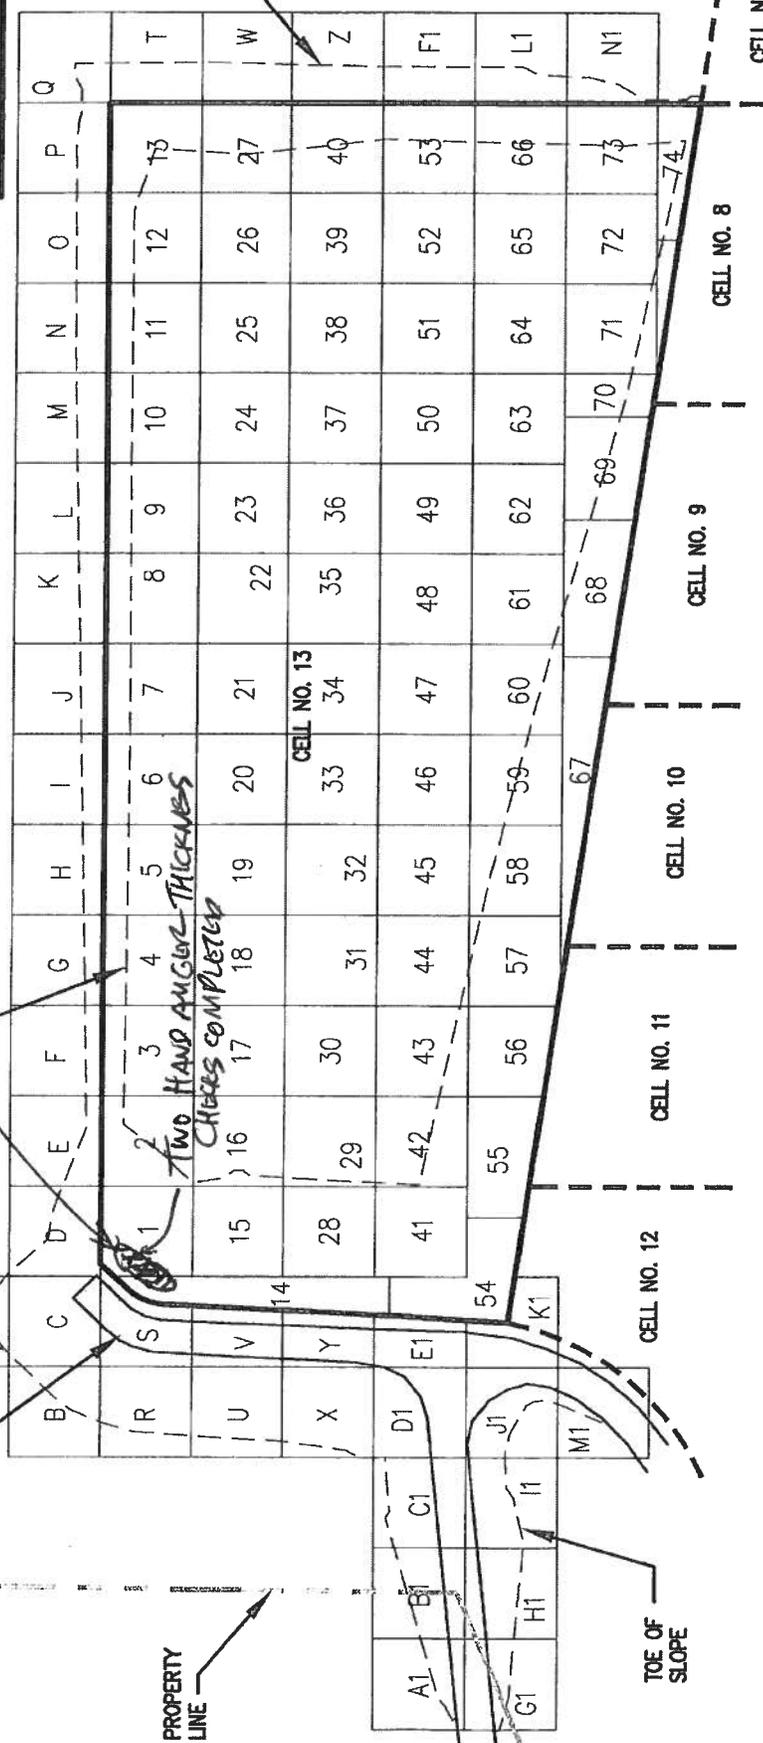
FIGURE **3B**

FML REPAIRS OVER EXISTING PANELS T-168 TO T-171

FIELD SKETCH - CELL NO. 13
EAST CAROLINA LANDFILL
BERTIE COUNTY, NORTH CAROLINA
