**FACILITY COMPLIANCE INSPECTION REPORT**  
**Division of Waste Management**  
**Solid Waste Section**

**Date of Inspection:** 17 February 2016

Carteret County/Coastal Environmental Partnership Solid Waste Transfer Facility  
 800 Hibbs Road  
 Newport, NC

1604T-20160217INSP

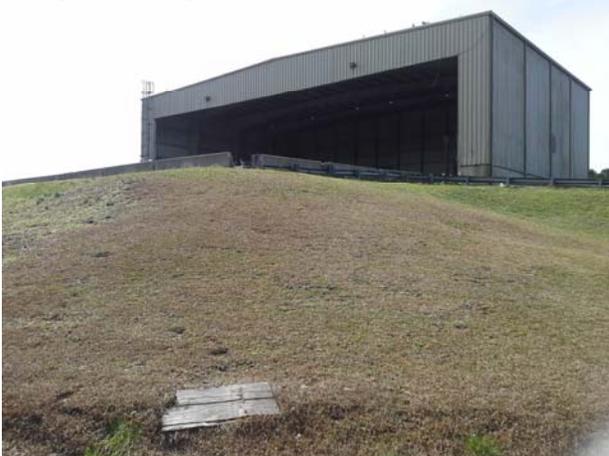
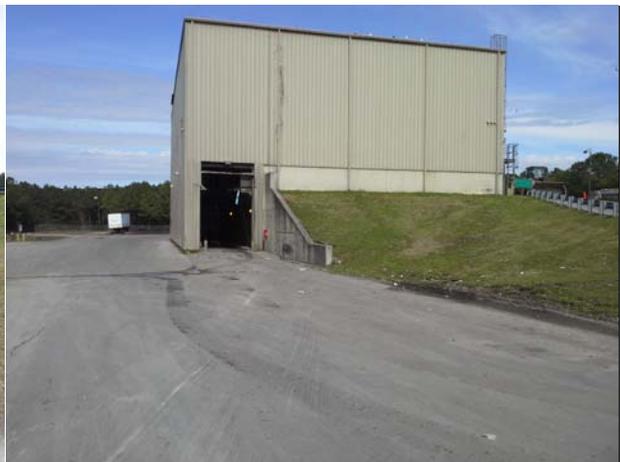
- 9) The Facility access road is of all-weather construction and is being maintained in overall good condition.
- 10) Access around the Facility is generally stable; no areas of erosion were observed during this Facility Compliance Inspection.

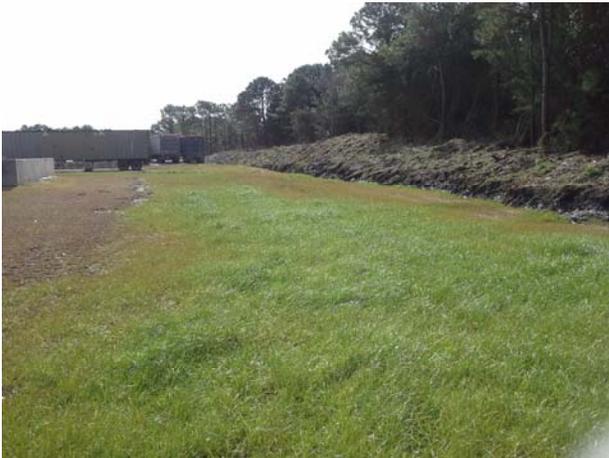
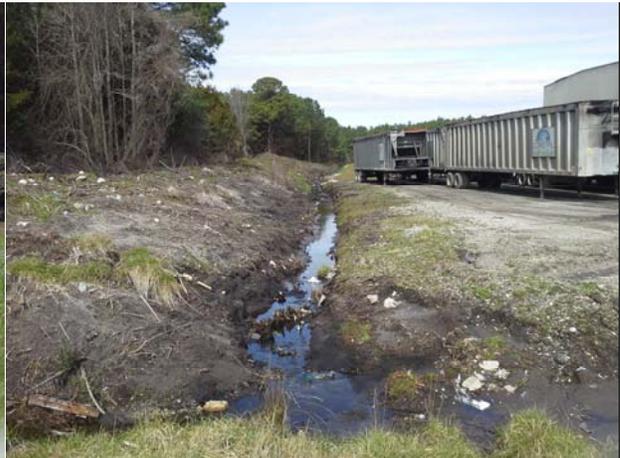
- 28) Scrap tires are collected throughout the week and placed into trailers for direct haul to the Tire Management Facility every Saturday after shutdown.
- 29) Yard waste is collected on site and staged for transport to the Coastal Environmental Partnership Compost Facility, permit #25-09, in Craven County for composting.
- 30) The yard waste storage area has been relocated on the property for better access and maintenance. The previous storage area has been graded and seeded.

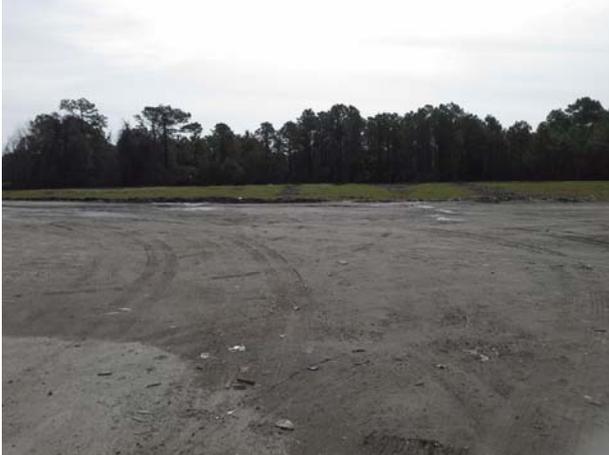
31) The yard waste element appeared well maintained and the volume of waste staged on-site is being maintained in a manageable size at this time.
