FACILITY COMPLIANCE INSPECTION REPORT
Department of Environmental Quality
Division of Waste Management - Solid Waste Section

UNIT TYPE:											
Lined MSWLF		LCID		YW		Transfer	X	Compost		SLAS	COUNTY: Chatham PERMIT NO.: 19-03 FILE TYPE: COMPLIANCE
Closed MSWLF		HHW		White goods		Incineration		T&P		FIRM	
CDLF		Tire T&P / Collection		Tire Monofill		Industrial Landfill		DEMO		SDTF

Date of Site Inspection: February 5, 2016

Waste Management of the Carolinas, Inc. – Chatham County Transfer Station
 361 Waste Treatment Plant Road
 Siler City, NC 27344

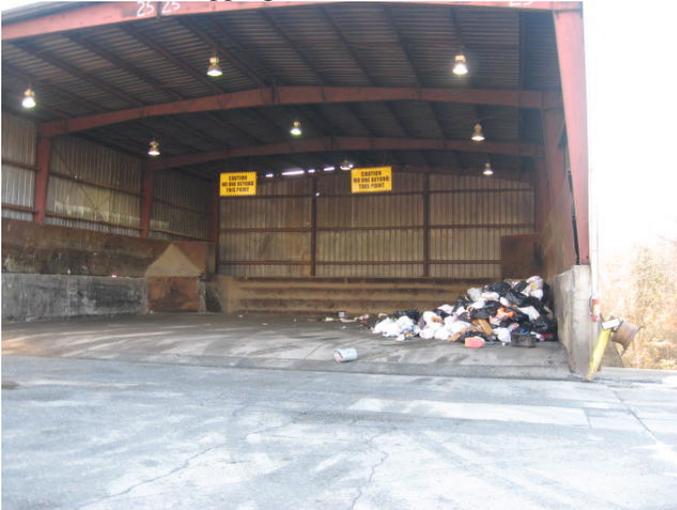
25. The transfer station tipping floor and load-out bay appeared to be routinely cleaned.
26. Ensure the sheet metal on the upper left side of the transfer station building is repaired.

Transfer station tipping floor

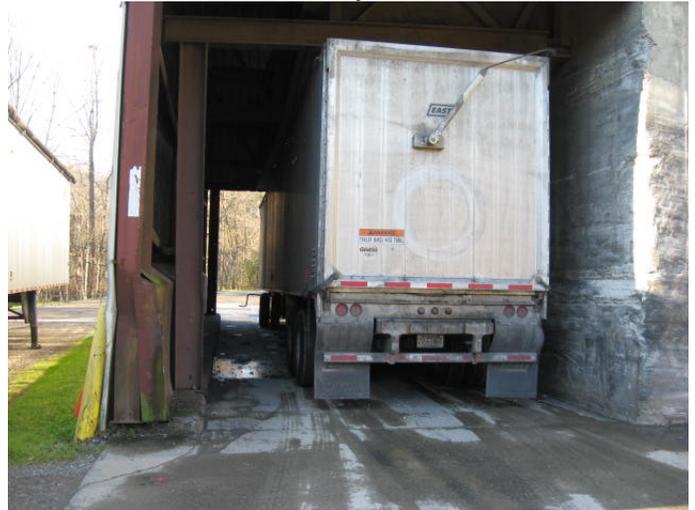
Transfer station load-out bay

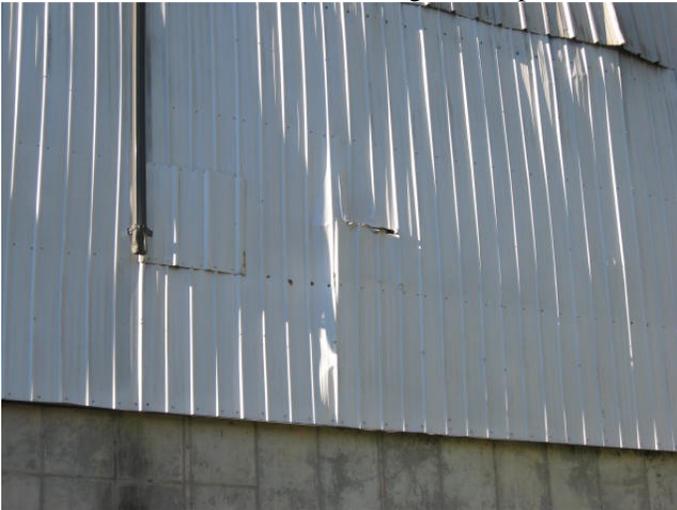
Left side of transfer station building to be repaired

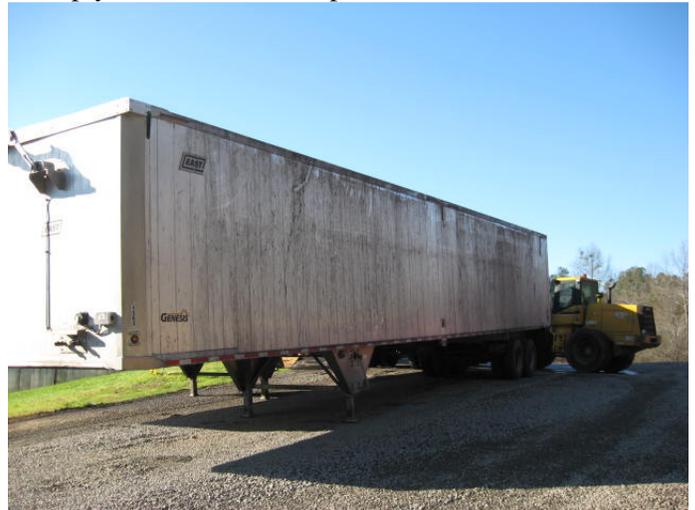
17. Transfer trailers appeared to be in good condition.
18. The materials recovery operation is not conducted (operations plan pg 6, section 4.8 states the procedure if conducted).

Empty transfer trailer - representative
