FACILITY COMPLIANCE INSPECTION REPORT
Department of Environmental Quality
Division of Waste Management - Solid Waste Section

Date of Site Inspection: January 26, 2016

Brooks Compost Facility – Large Type 3 Solid Waste Compost Facility
 1195 Beal Road
 Goldston, NC 27252

Comprehensive Inspection

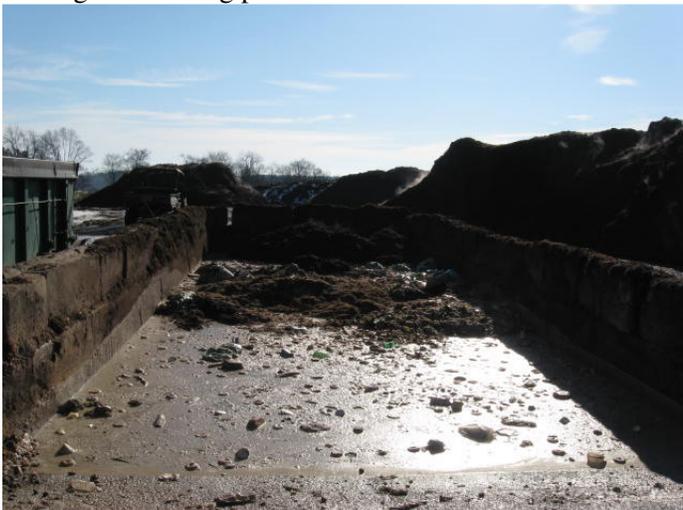
Mixing and bulking pit

7. Liquid material is dumped into a mixing and bulking pit.
8. Solids with a high concentration of liquids are placed on an adjacent concrete pad to drain. Bulking material is added.

9. When liquid material is mixed with absorbent materials, in the mixing and bulking pit, they are placed onto the concrete pad to drain.
10. The concrete pad contains leachate drain grates. Leachate can be directed to the mixing and bulking pit or to two 3,500 gallon concrete storage tanks.

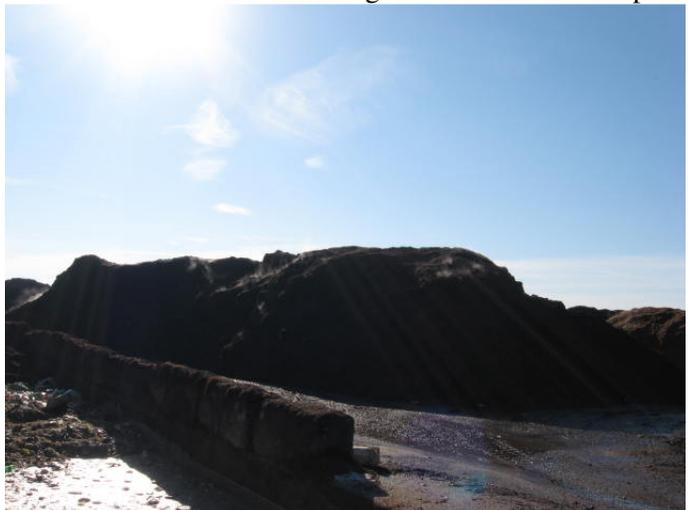
Food waste mixed with bulking material on concrete pad

12. Food waste is placed on the concrete pad upon receipt. It is mixed with bulking materials and placed in windrows.
13. Eggshell/hatchery waste is placed in windrows upon receipt. It is mixed with bulking materials as the windrow is constructed. A layer of uncured compost is placed atop the windrow.

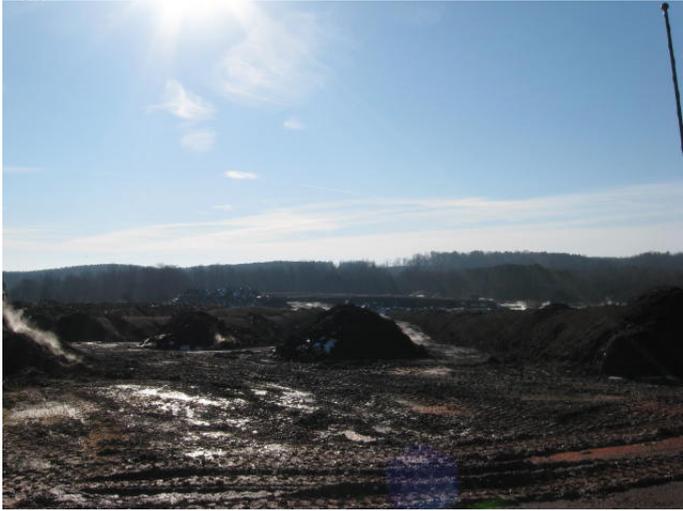
Eggshell/hatchery waste windrows

16. The facility receives leaves during the leaf collection season from the Town of Cary and the Town of Siler City.
17. Active windrows appeared to be within required dimensions. Eggshell/hatchery waste windrows are commonly 350 feet long and food waste windrows 200 feet long.

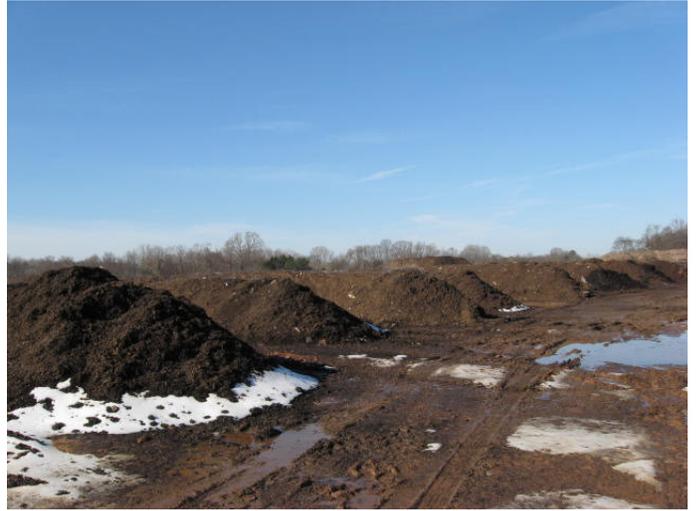
Food waste windrows

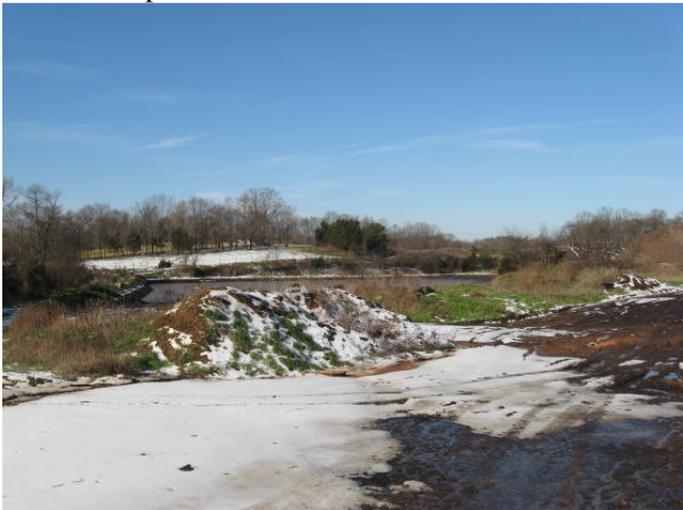
Stormwater pond

39. The facility has a clay-lined stormwater pond. Stormwater is pumped-out for use in the active windrow process and for the irrigation of a nearby 20 acre field [when the irrigation system is constructed]. The facility does not discharge stormwater from the containment pond.

40. Mr. Brooks stated that the stormwater pond freeboard is ~ 8 feet.
41. Ensure the two stormwater pond sediment basins are cleaned-out.
42. The facility has been issued a Division of Water Resources Land Application (Irrigation) of Industrial By Product Compost Leachate and Stormwater Runoff permit, No. WQ0036333, issued: 11/17/14 - expiration: 09/30/18. Ms. Brooks stated that the irrigation system is expected to be constructed during the summer of 2016.

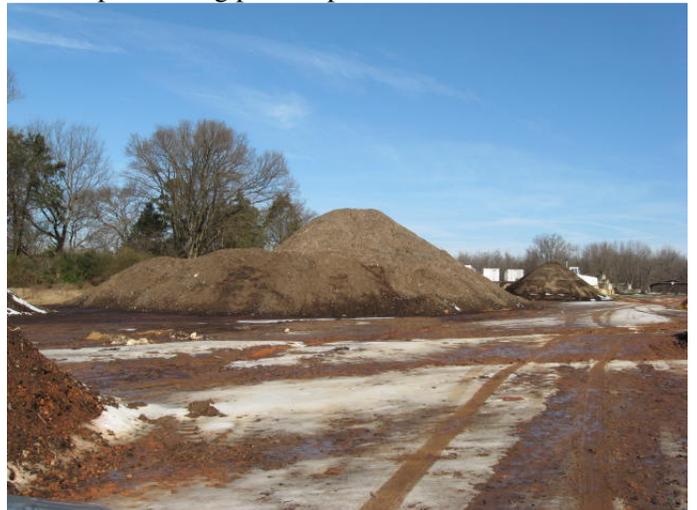
Compost curing pile - representative

21. The facility maintains three curing piles/areas.
22. Cured compost is screened prior to sale – as needed.
23. Stockpiled cured compost is limited to a height of 60 feet.
