FACILITY COMPLIANCE INSPECTION REPORT
Division of Waste Management
Solid Waste Section

Date of Site Inspection: June 17, 2015 Date of Last Inspection: May 18, 2015

Town of Edenton Transfer Station
 118 West Hicks Street
 Edenton, North Carolina 27932

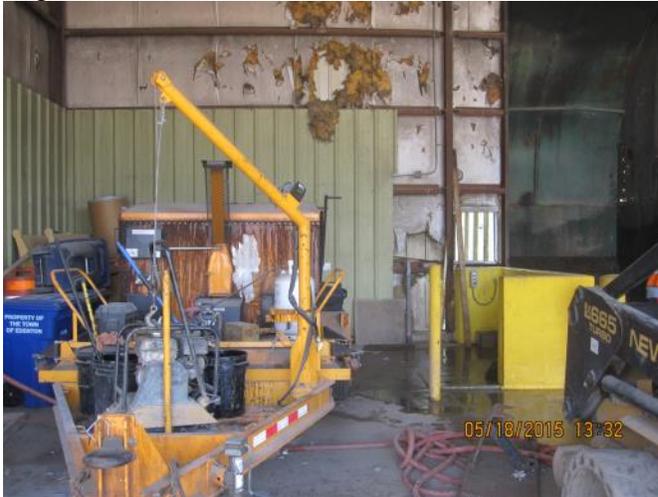
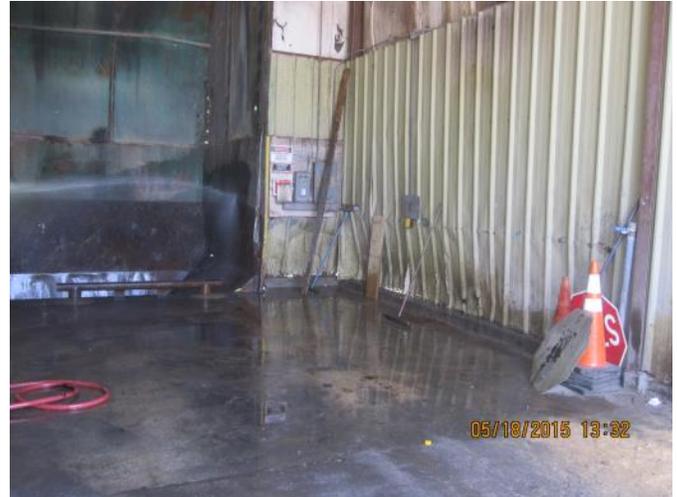
The walls to the facility need repair this damage can allow waste to fall outside the building

- 9) Fire suppression is handled by two freeze proof fire hydrants and a single fire extinguisher mounted on the wall. The extinguisher as charged.
- 10) **The walls need repair in several areas of the building, see photos.**

- 14) **Repairs to the facility are needed.**
- 15) Photos are from the previous inspection conducted on May 18, 2015.

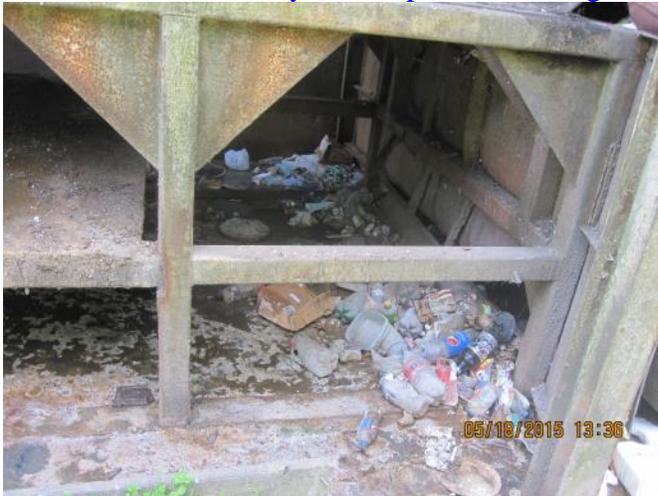
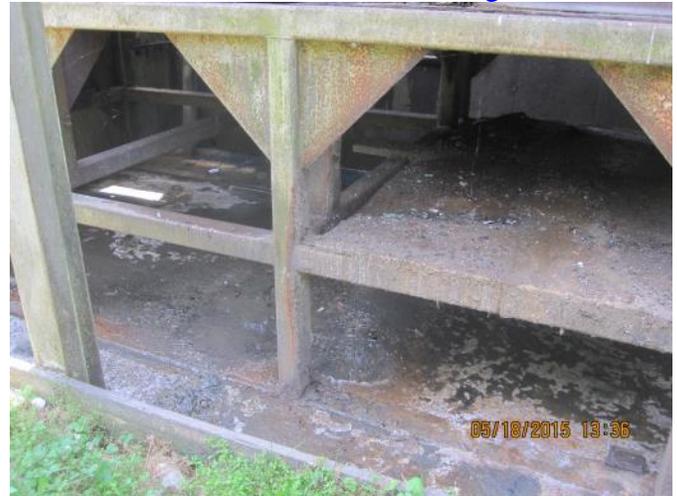
The area beneath the compactor is collecting waste and needs cleaning. The tipping floor was being washed down during the inspection, wash water was running beneath the compactor. It could not be determined if this wash water was draining or ponding and evaporating. **The area beneath the compactor must be kept clean and wash water must be directed to a drain that is kept in a free flowing condition.**

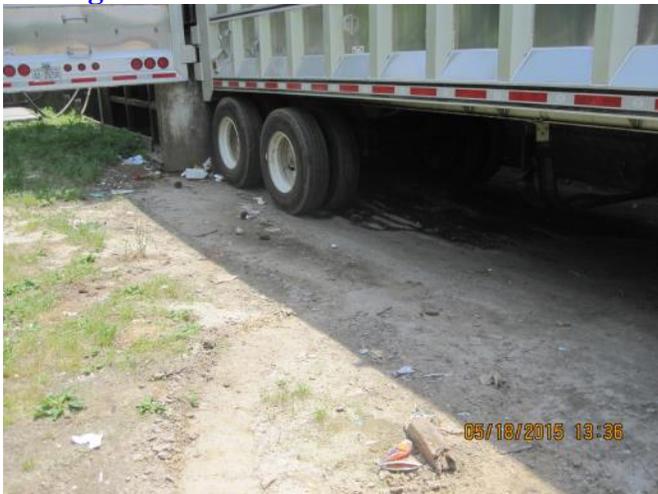
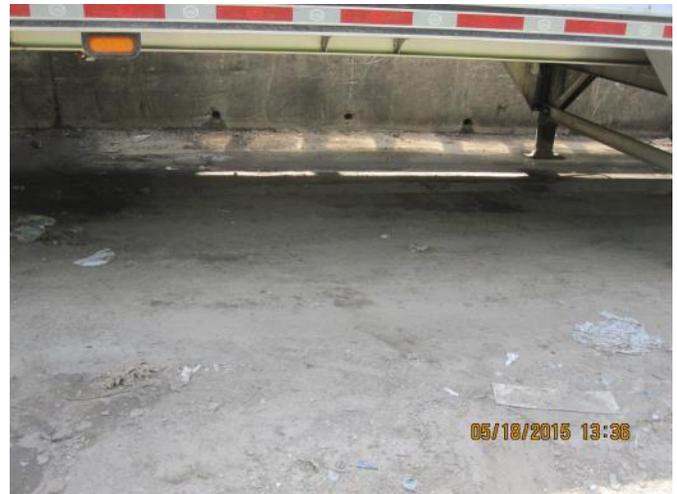
The trailer loading area facility was observed ponding leachate during the last inspection but has been re-graded so that leachate generally should flow more freely.

- 8) The area below the tipping floor has been graded so that runoff flows into a drain but there is still the potential for offsite drainage, see photos.

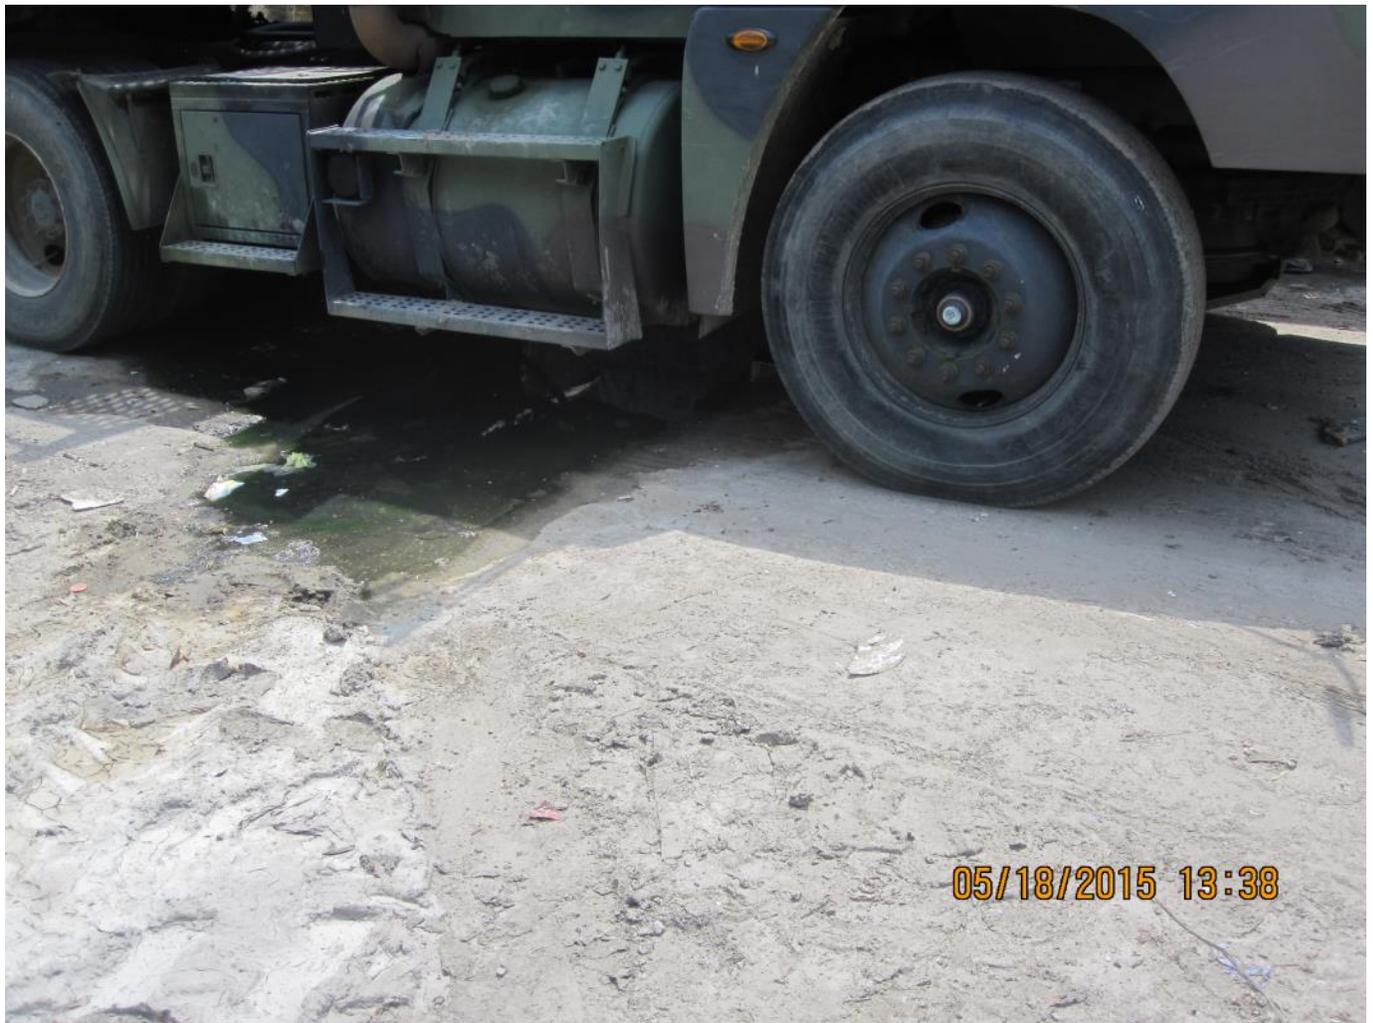
However leachate was still observed ponding beneath the tractor. **The Edenton Transfer must take whatever actions necessary so that leachate does not pond beneath the trailer or tractor and possibly flow off the concrete.**
