FACILITY COMPLIANCE INSPECTION REPORT
Division of Waste Management
Solid Waste Section

Date of Site Inspection: May 18, 2015 **Date of Last Inspection:** January 23, 2013

Town of Edenton Transfer Station
 118 West Hicks Street
 Edenton, North Carolina 27932

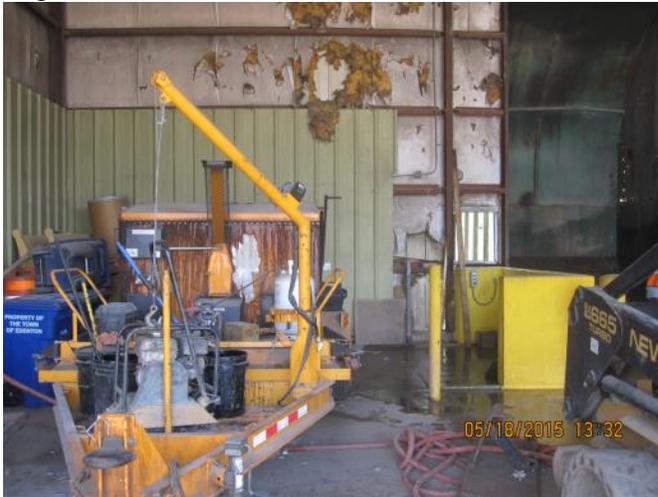
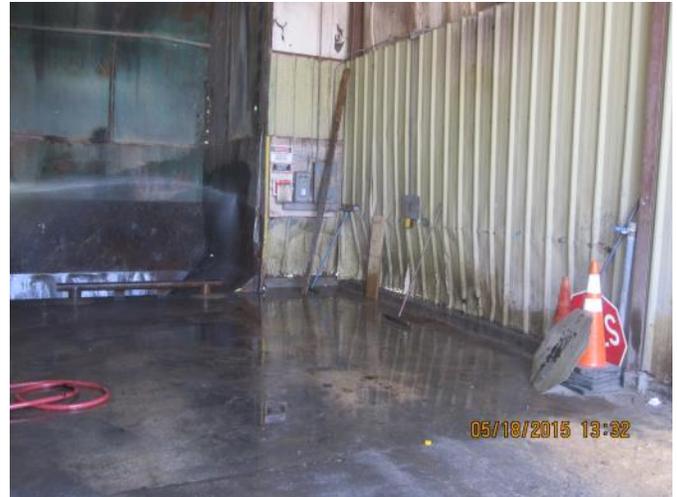
The walls to the facility need repair this damage can allow waste to fall outside the building

- 10) **The walls need repair in several areas of the building, see photos.**
- 11) The tipping floor is in good condition.
- 12) Waste is direct dumped into a compactor, a new compactor has been installed.

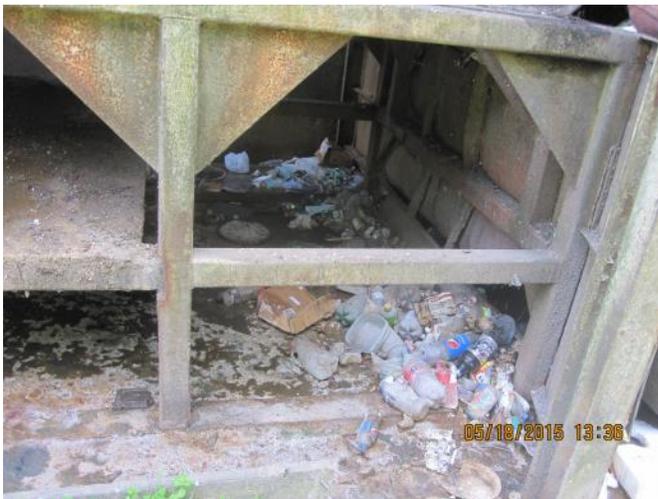
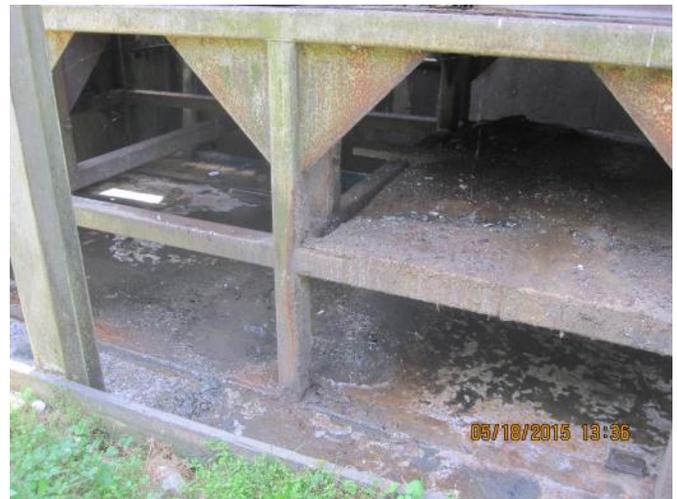
The area beneath the compactor is collecting waste and needs cleaning. The tipping floor was being washed down during the inspection, wash water was running beneath the compactor. It could not be determined if this wash water was draining or ponding and evaporating. **The area beneath the compactor must be kept clean and wash water must be directed to a drain that is kept in a free flowing condition.**

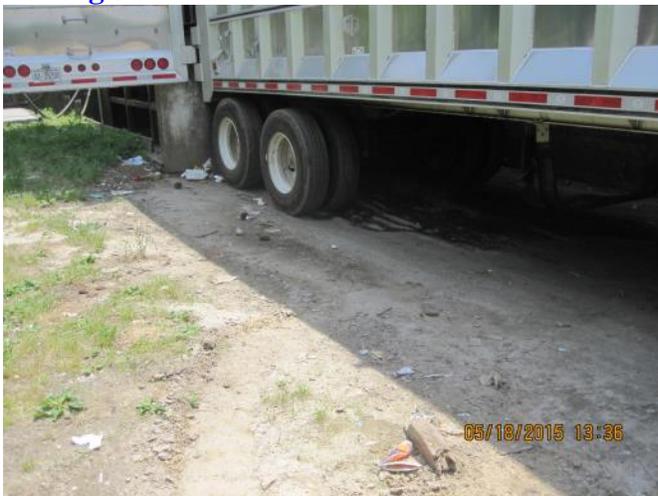
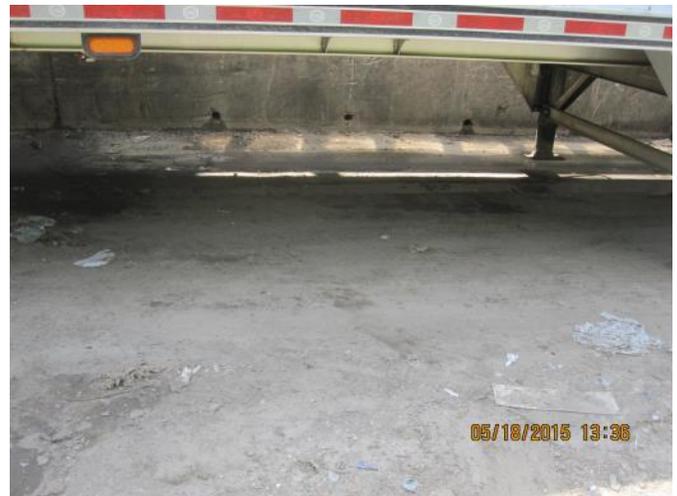
The trailer loading area facility was observed ponding leachate during the last inspection but has been re-

graded so that leachate should flow more freely.

- 8) The area below the tipping floor has been graded so that runoff flows into a drain and not offsite but there are still issues, see photos.
- 9) Fire suppression is handled by two freeze proof fire hydrants and a single fire extinguisher mounted on the wall. The extinguisher as charged.

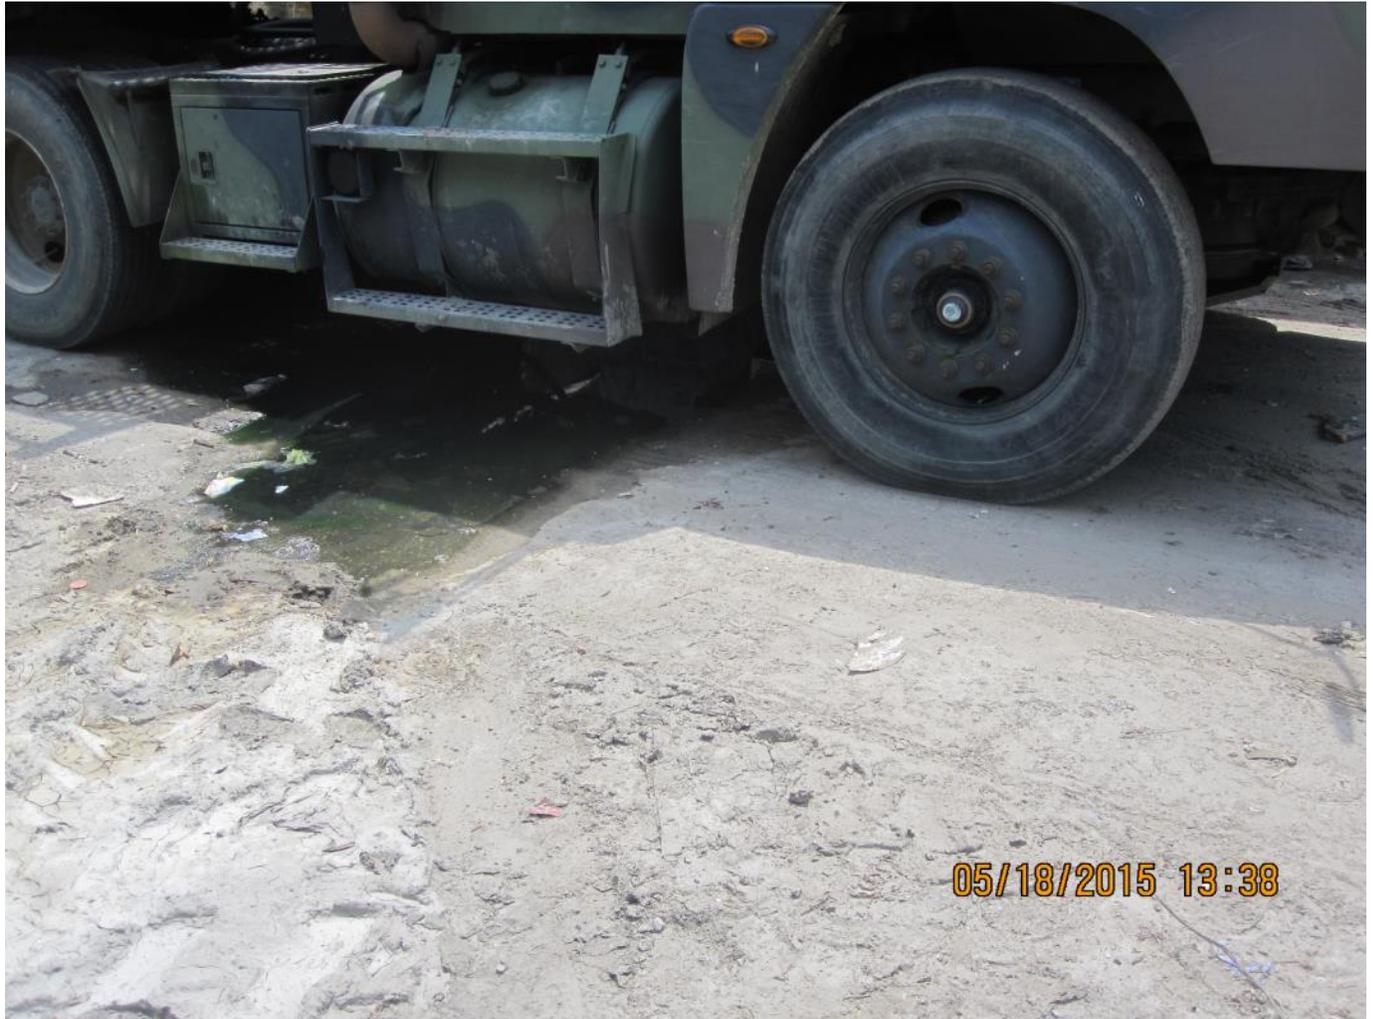
However leachate was still observed ponding beneath the tractor. **The Edenton Transfer must take whatever actions necessary so that leachate does not pond beneath the trailer or tractor and possibly flow off the concrete.**
