FACILITY COMPLIANCE INSPECTION REPORT
Department of Environmental Quality
Division of Waste Management - Solid Waste Section

Date of Site Inspection: January 11, 2016

Veach LCID Landfill
 4261 Old Thomasville Road
 Winston-Salem, NC 27107

Comprehensive Inspection

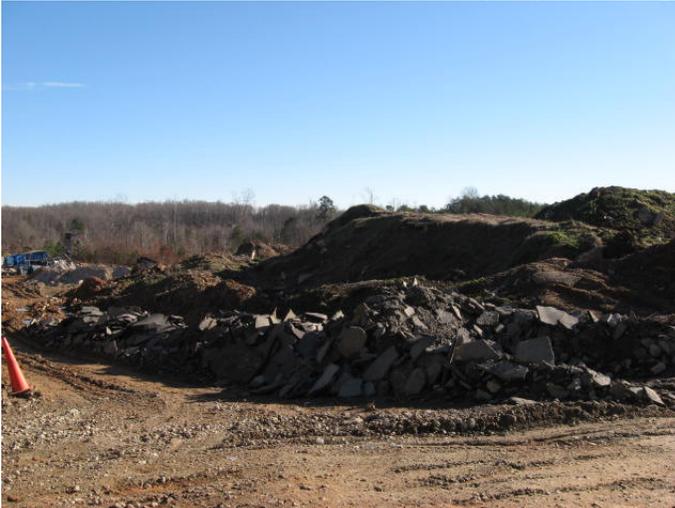
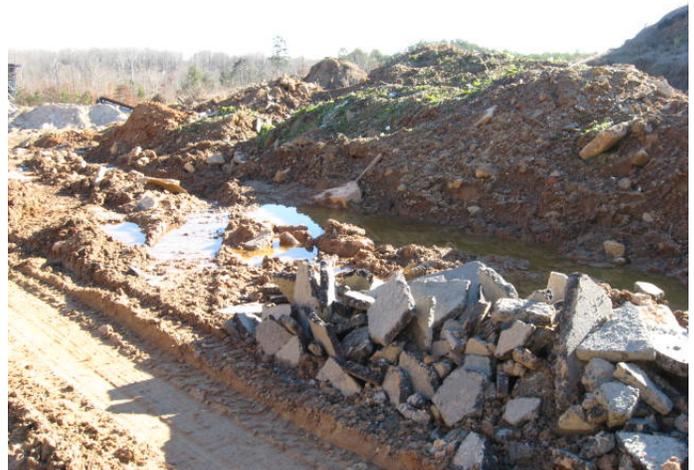
Soil mixed with aggregates stockpile area – water ponding at base of piles

14. Excavation, grading, and fill material side slopes shall not exceed three to one (3:1).
15. Water shall not pond at the base of piled materials. Grade abutting areas to ensure positive drainage.

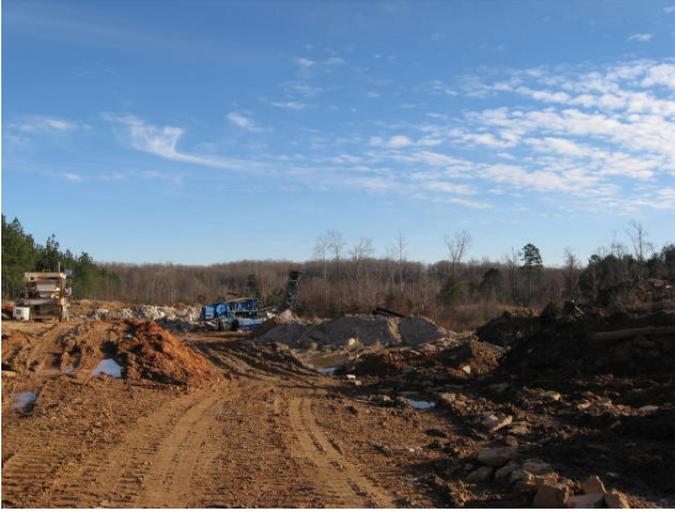
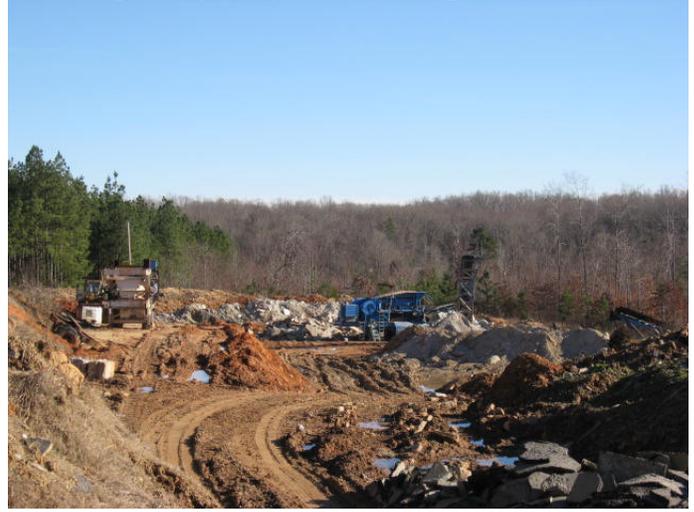
Access road leading to concrete crushing operation – water ponding along roadway and piled materials

24. Access roads are of all-weather construction. Accumulated soil atop the access roads should be removed.
25. The Division of Energy, Mineral and Land Resources – Land Quality Section conducted inspection of the facility in November 2015.

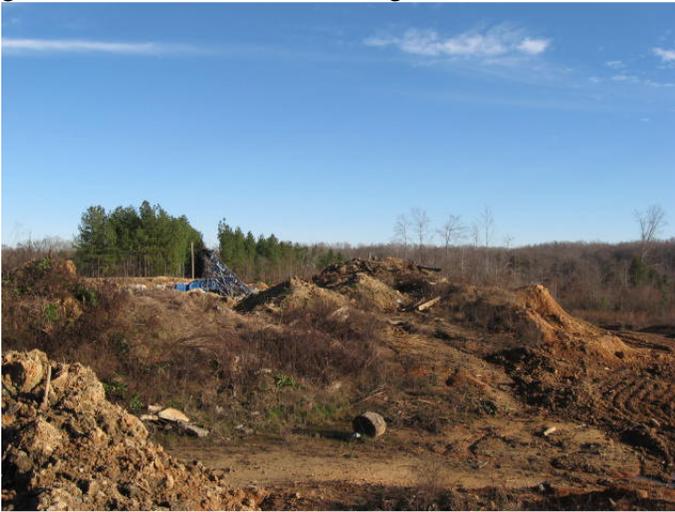
Soil mixed with aggregate stockpiles. Area has LCD – to be graded and defined into a working face and covered with soil

16. Ensure the LCD disposal area is graded accordingly, to include a defined working face and soil cover.
17. Soil mixed with aggregates and inert materials stockpiled for reuse should not be stored at the working face/abutting buried LCD.

18. Inert materials and soil mixed with aggregates accepted for disposal shall be placed at the working face, graded accordingly, and covered with soil.

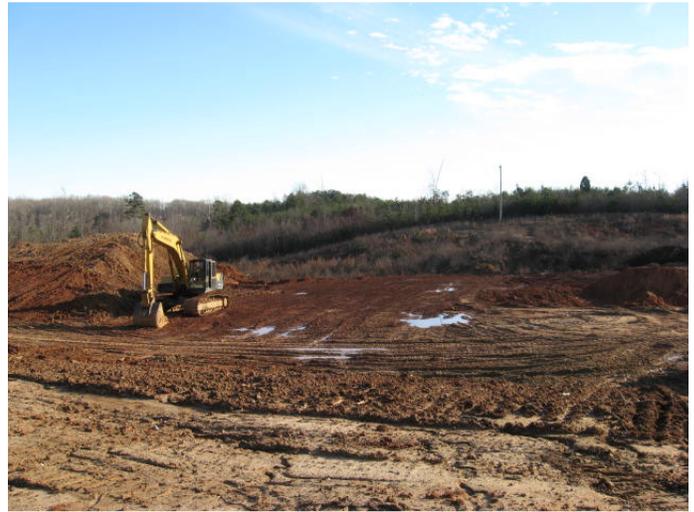
Clean soil stockpile area

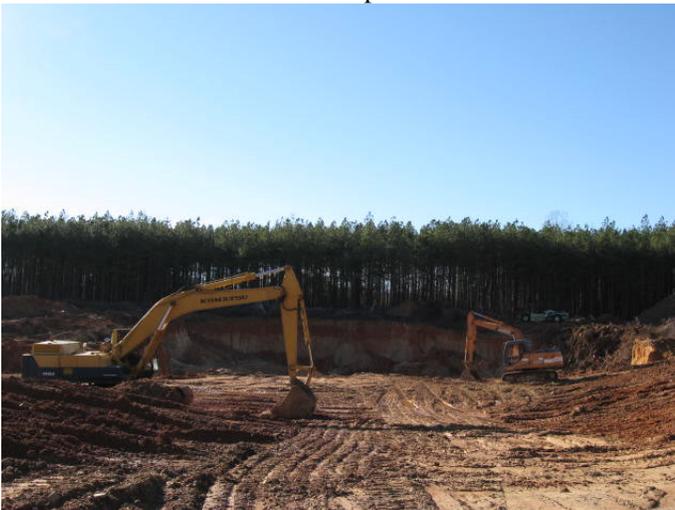
Soil mine area - future landfill phase

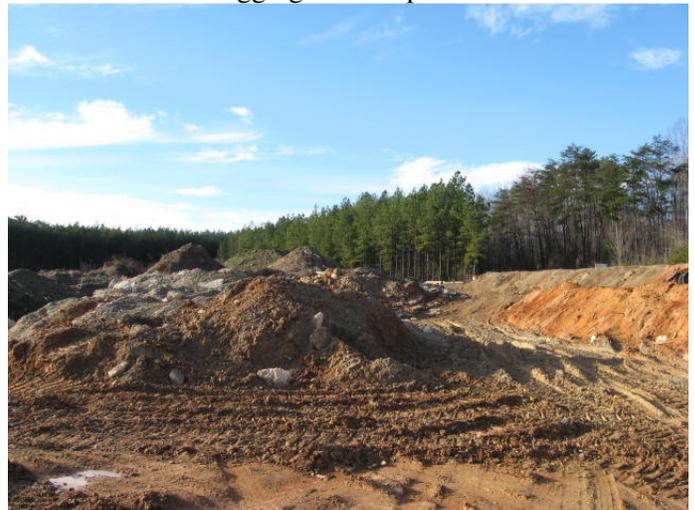
Soil mixed with aggregate stockpile area
