FACILITY COMPLIANCE INSPECTION REPORT
Department of Environmental Quality
Division of Waste Management - Solid Waste Section

Date of Site Inspection: December 7, 2015

Republic Services of North Carolina, LLC
 Bishop Road Transfer Station
 2140 Bishop Road
 Greensboro, NC 27406

Comprehensive Inspection

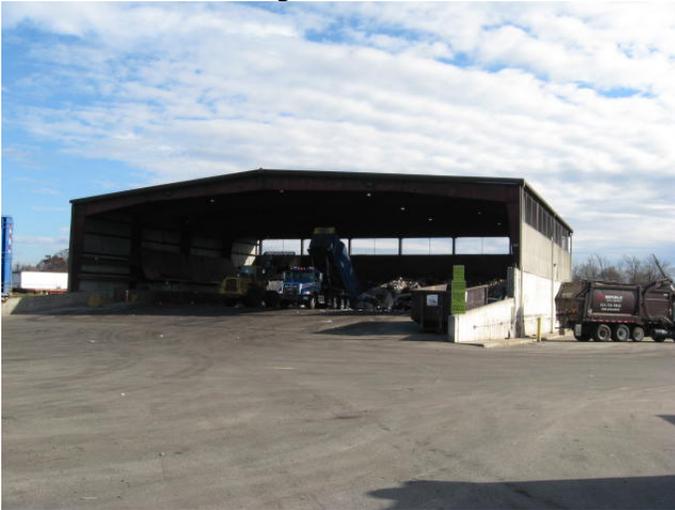
Transfer station building

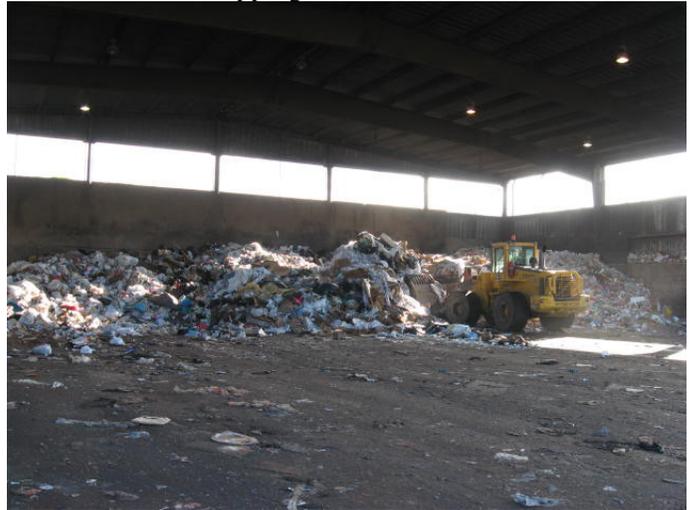
7. The following are facility certified personnel:
 - a. Lenny Bessone, Certified Transfer Station Operations Specialist, TS-2008026, exp. 04/15/17
 - b. Anthony Perez, Certified Transfer Station Operations Specialist, TS-2012057, exp. 06/22/18

31. The transfer station tipping floor is sloped to allow leachate to drain to the load-out bay.
32. Leachate from the transfer trailer load-out bay drains to the leachate holding tank. Mr. McAden stated that the load-out bay floor is an old scale and that the leachate drains along the length of the scale.

Transfer station tipping floor

33. If leachate accumulates on the tipping floor or in the load-out bay it shall be collected with absorbent material and removed at the end of each workday.

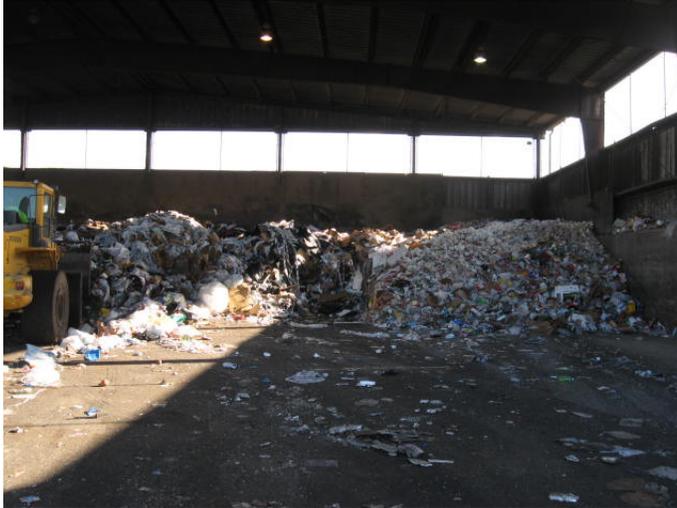
12. The recyclable materials area on the transfer station tipping floor is separated from MSW by a small wall constructed of concrete blocks.
13. During the inspection MSW was piled up along the rear wall of the transfer station building and directly abutted the recyclable materials.

MSW and recyclables abutting, concrete block divider concealed by solid waste [solid waste being relocated]

14. Ensure that MSW does not come in contact with recyclable materials placed on the tipping floor awaiting transfer.
15. It is suggested that additional concrete blocks be added to raise and lengthen the wall separating MSW from the recyclable materials. Additionally, guidance should be provided to the loader operator per the aforementioned.

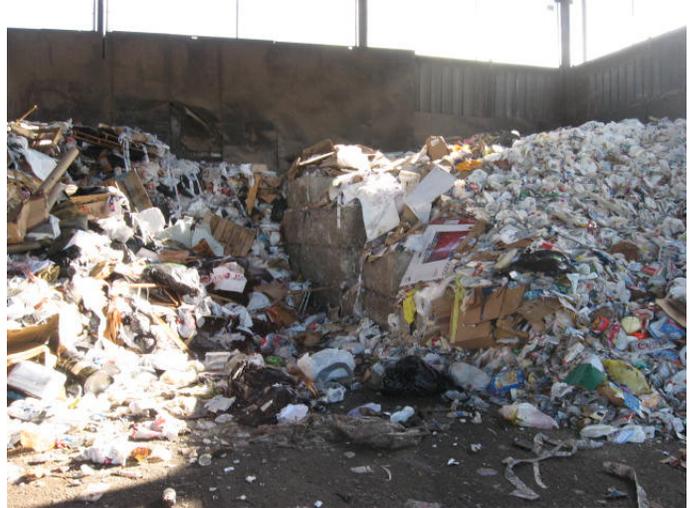
MSW and recyclables concrete block divider

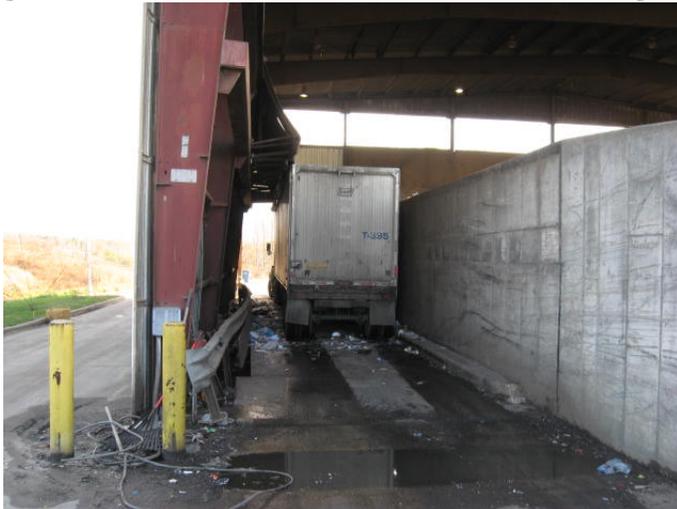
Load-out bay entrance – water accumulated in low area [to be treated as leachate if in contact with solid waste]

34. Water that accumulates at the entrance to the load-out bay (low area) shall be treated as leachate if it comes in contact with solid waste.
35. The facility does not accept scrap tires or white goods.

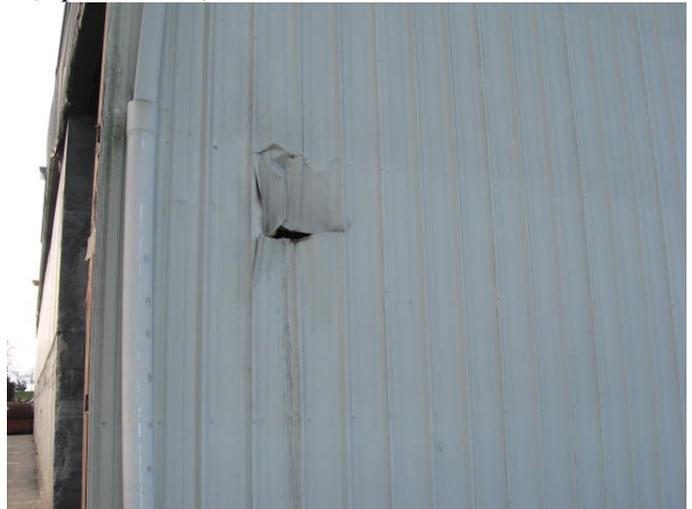
Transfer station sheet metal exterior to be repaired (representative)

29. Ensure that the sheet metal exterior of the transfer station building is repaired such that there are no holes or split seams.
30. The transfer station building tipping floor, approach pad, and load-out bay deflector panels appeared maintained.
