FACILITY COMPLIANCE INSPECTION REPORT
Division of Waste Management
Solid Waste Section

Family Dollar Store #7138
 210 E 2nd St.
 Weldon, North Carolina 27890

CCB structural fill site, no permit required

Comprehensive Inspection

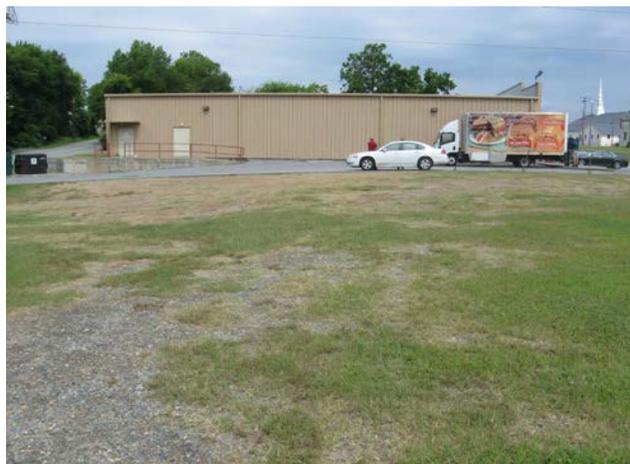
Ground cover must be reestablished

1. Part of the fence that had been put up to prevent vehicular traffic over the area with coal ash, has still not been replaced. **Ground cover must be reestablished in this area.** There does not appear to be any rutting of the soil cover and no coal ash is exposed. **It is strongly recommended that something, i.e. Railroad ties, curbing, concrete barriers, rocks, etc. be put in place to prevent vehicles from going back on the soil over the coal ash.**

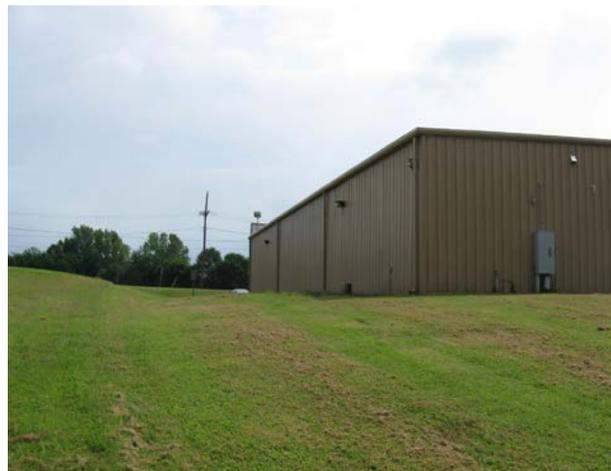
Grass cover good to the back side of the building
