FACILITY COMPLIANCE INSPECTION REPORT
Division of Waste Management
Solid Waste Section

Date of Inspection: 5 January 2016

Carteret LCID
 Community Road
 Morehead City, NC 28557

Comprehensive Facility Compliance Inspection

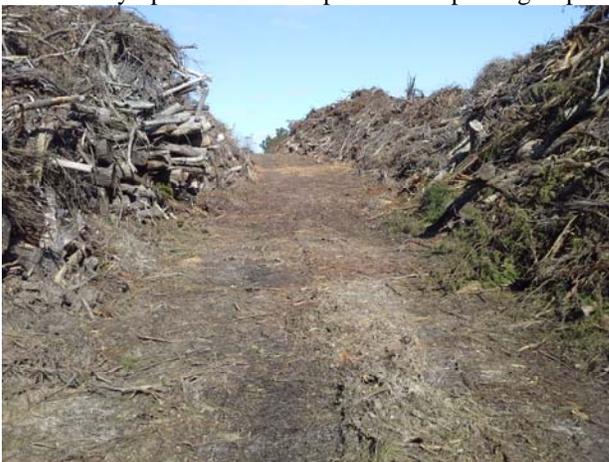
- 12) The Facility operator is in the process of updating/improving the access road to the top lift of the LCID.

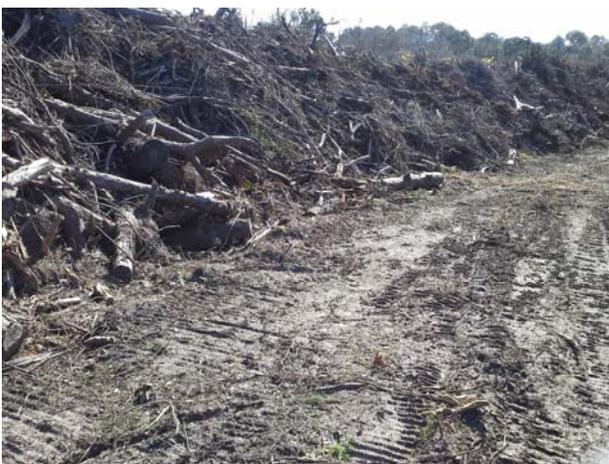
- 13) The Facility operator has been working to regrade some of the interior slopes of the LCID landfill and plans to begin mining and screening topsoil for resale from the oldest areas of the LCID. *Please ensure that all slopes are maintained at a slope not greater than 3:1.
- 14) Interior areas of the LCID have been excavated and vegetative materials are being pulled out for grinding at the Yard Waste Notification.
