FACILITY COMPLIANCE INSPECTION REPORT
Division of Waste Management
Solid Waste Section

Date of Inspection: 25 February 2016

Miller Farm LCID Landfill
 Miller Farm Road
 Morehead City, NC 28557

Comprehensive Facility Compliance Inspection

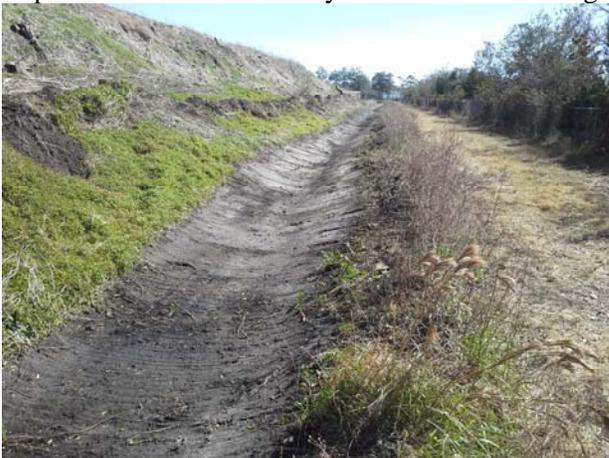
- 10) The perimeter road is well maintained, providing for clear access around the Facility.
 - 11) Improvements to the Facility surface water drainage have recently been completed.

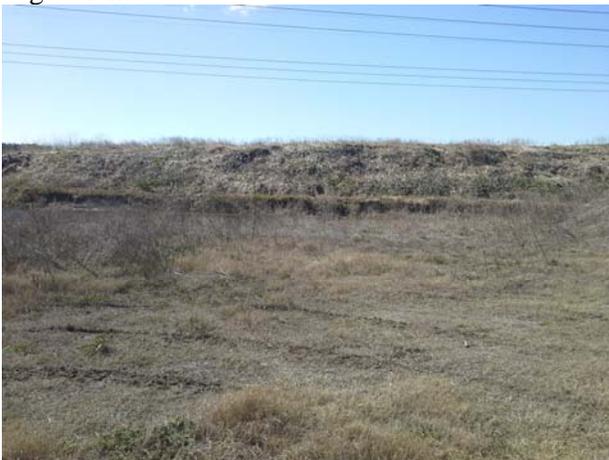
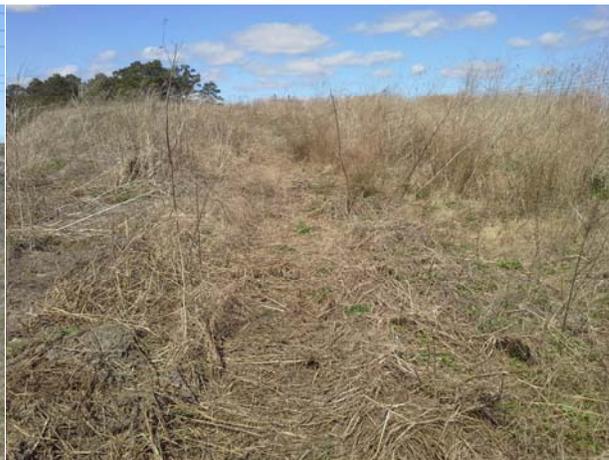
- 12) Soil has been stockpiled in two areas adjacent to the Landfill for use in maintenance and repair.
- 13) *Please continue to fill, compact, and cover all areas of differential settlement to provide for positive drainage of surface water away from the landfill. All sideslopes and repaired areas should be graded at a slope not greater than 3:1 and seeded and mulched to establish a groundcover suitable to prevent erosion.
- 14) Overall, this Facility has a well-established cover crop of native warm season grasses and coppice type vegetation.

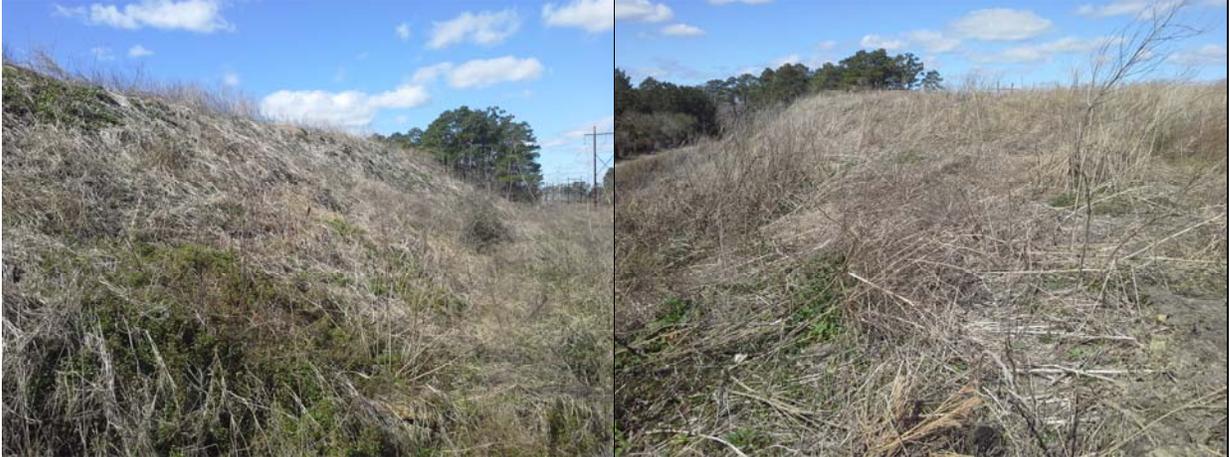
- 15) This Facility is not currently in use.
- 16) Plans are underway for the excavation and screening of all materials in the landfill. The screened soil will be sold and/or re-used. All vegetative material screened from the disposal area will be transported to the Miller Farm LCID #2 for disposal. All inert materials will be staged for grinding and re-use.
- 17) No off-site erosion was noted during this Facility Compliance Inspection.
- 18) No violations were observed during this Facility Compliance Inspection.
- 19) *Corrective actions are needed as a result of this Facility Compliance Inspection.
