FACILITY COMPLIANCE INSPECTION REPORT
Division of Waste Management
Solid Waste Section

Date of Inspection: 15 January 2016

Dixon Pit LCID Landfill
 2628 Hwy 24
 Newport, NC 28570

Comprehensive Facility Compliance Inspection

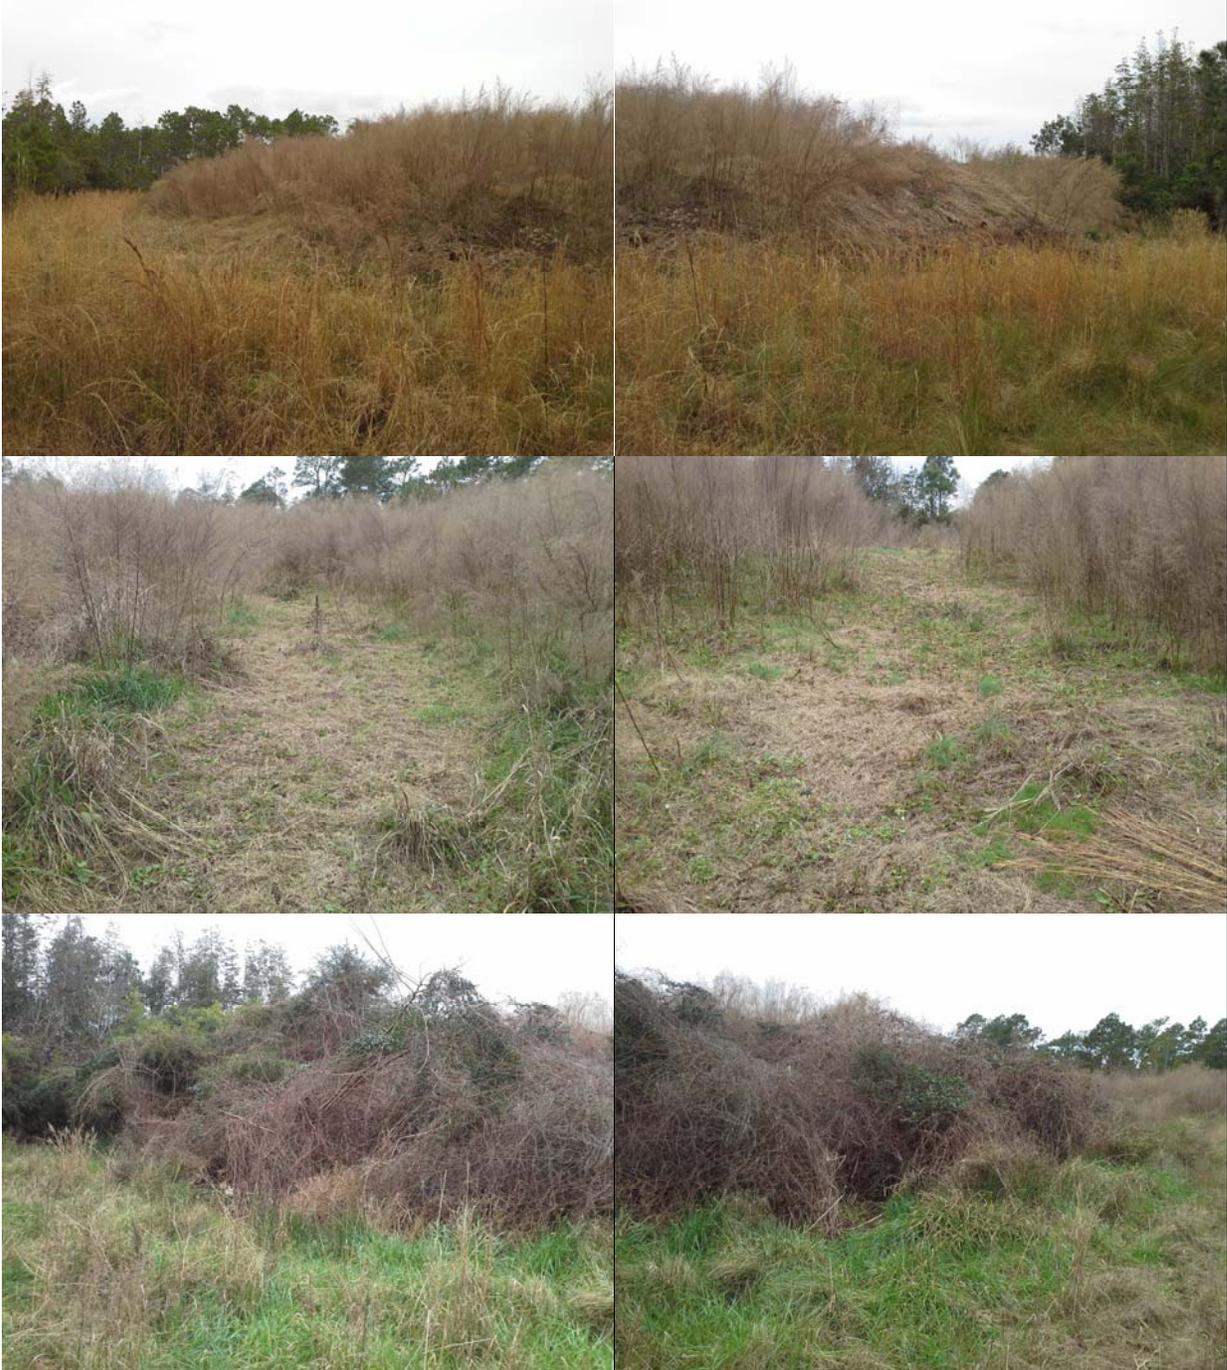
- 9) This Facility has been capped and is currently not receiving waste. The Facility operator wishes to maintain its active status for possible future use.
- 10) A cover crop of native warm season grasses and coppice-type cover has been established throughout the facility. Some brush and woody vegetation has been established on portions of the landfill sideslopes. *Plans need to be underway for the mowing of the landfill cover crop and removal of the brush and other woody type vegetation. After mowing, please ensure that all landfill sideslopes have a groundcover established suitable to prevent erosion of your landfill cap system.

- 11) The Facility Disposal Boundary has been marked with brightly painted wooden stakes delineating the 2 acre disposal boundary. However, several of the markers have been knocked down. *Please re-install and maintain your Disposal Boundary Markers delineating the disposal footprint of the landfill.
- 12) The area around the toe of the slope needs to be mowed to provide for unrestricted access around the toe of the entire landfill for Facility Inspections and maintenance activities.
- 13) No off site erosion was observed during this Facility Compliance Inspection.
- 14) *Corrective measures are required as a result of this Facility Compliance Inspection.
