FACILITY COMPLIANCE INSPECTION REPORT
Division of Waste Management
Solid Waste Section

Date of Inspection: 22 January 2016

Rocky Run LCID Landfill
 Staten Road
 Rocky Run, NC 28560

Comprehensive Facility Compliance Inspection

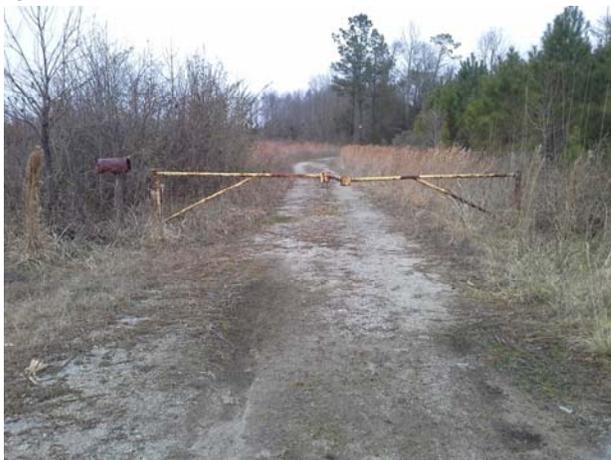
- 7) The signage posted at the Facility entrance has been knocked down. Please re-post the sign clearly displaying the facility contact name and emergency contact number.

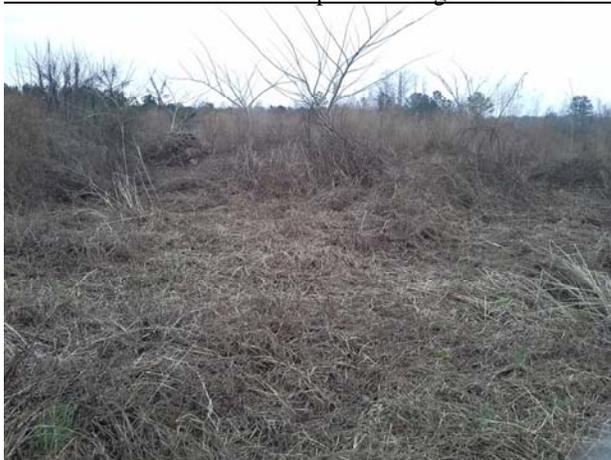
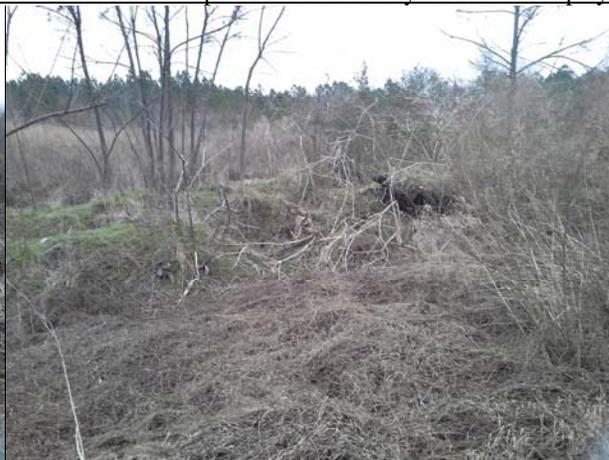
- 10) Brush and woody vegetation has been established on portions of the landfill sideslopes. *Plans need to be underway for the mowing of the landfill cover crop and removal of the brush and other woody type vegetation. After mowing, please ensure that all landfill sideslopes have a groundcover established suitable to prevent erosion of your landfill cap system.

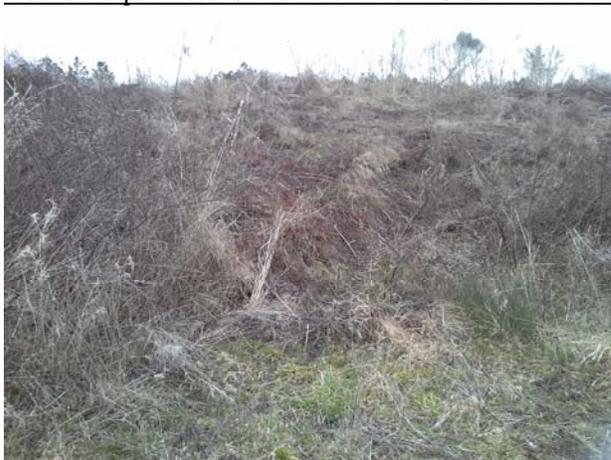
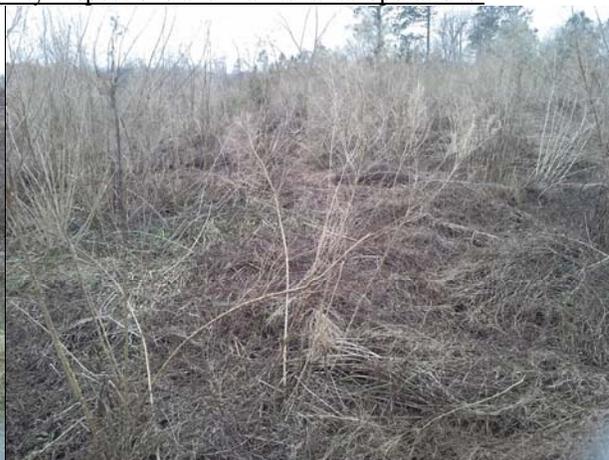
- 11) The access around the toe of the landfill has overgrown with brush and woody vegetation. *Please mow the access around the perimeter of the landfill for more efficient Facility Inspections and maintenance operations.
