FACILITY COMPLIANCE INSPECTION REPORT
Division of Waste Management
Solid Waste Section

FACILITY NAME AND ADDRESS:

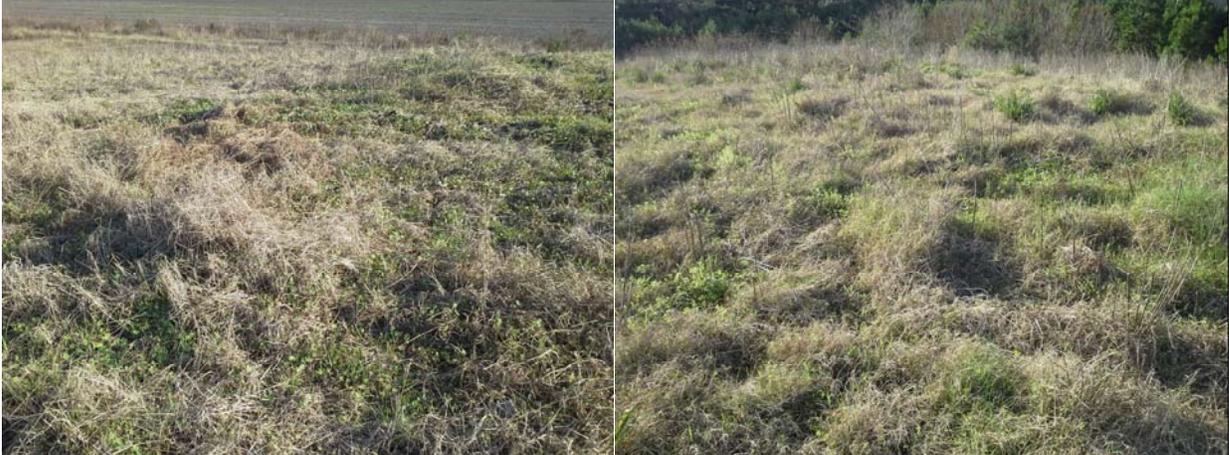
- 9) The access road to the Facility is being managed properly at this time.
- 10) The area around the perimeter of the landfill was clear of brush and woody vegetation during this Facility Compliance Inspection.
- 11) The Facility Disposal Boundary Markers have been knocked down. *Please re-install your Disposal Boundary markers delineating the disposal footprint of the landfill.
- 12) The landfill side slopes have been covered and graded to promote positive drainage of surface waters from the landfill.
- 13) The landfill working face has been covered and compacted. *Please continue to ensure that the active working face is covered monthly or when it approaches one acre in size.

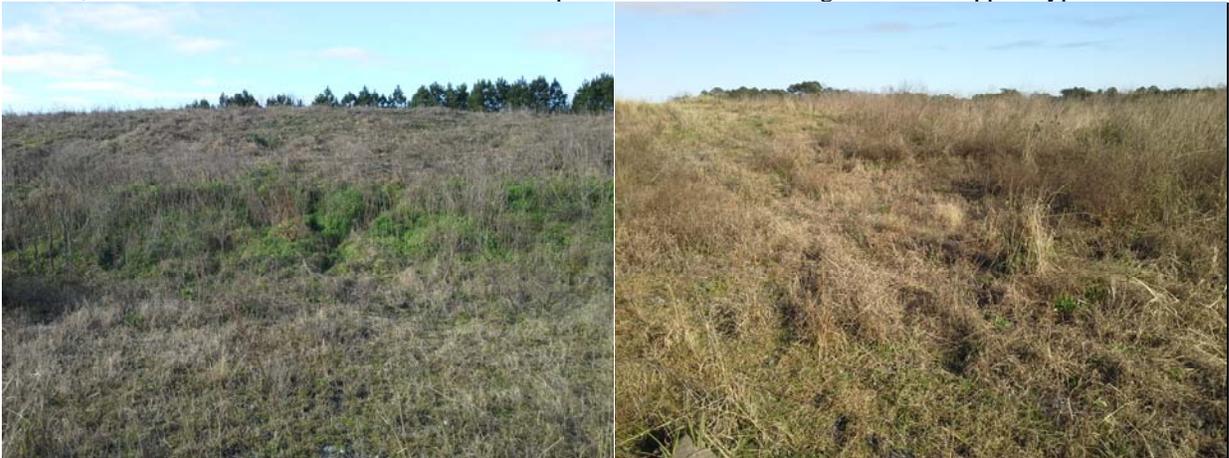
- 14) Overall, the landfill has a well-established cover crop of native warm season grasses and coppice-type cover.
