FACILITY NAME AND ADDRESS:

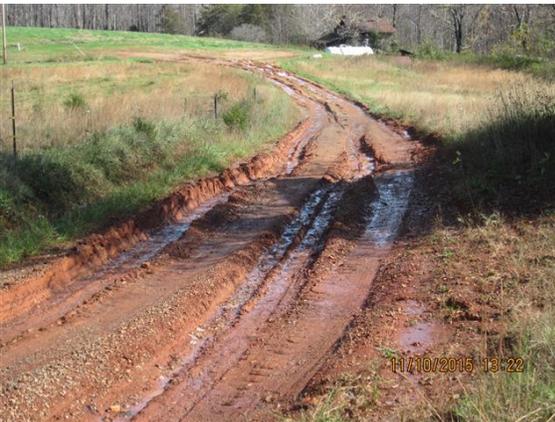
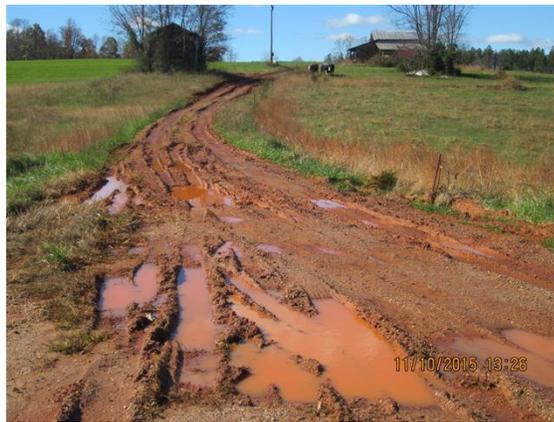
ADDITIONAL COMMENTS

- 1. 15A NCAC 13B .0838 (a) (3) states: "Each site shall have an all weather access road".

B & M Septic Tank, Inc. was in violation of 15A NCAC 13B .0838 (a) (3) because the access road was rutted and impassable.

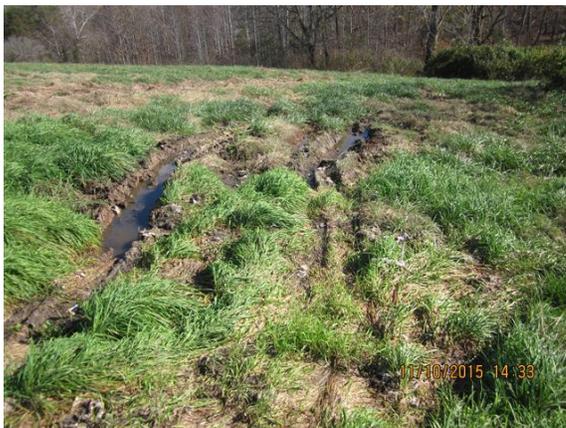
Photo taken near the entrance to Field 3 looking north

B & M Septic Tank, Inc. was in violation of 15A NCAC 13B .0838 (a) (18) because the nutrient management plan for SLAS-85-11 states; "Routine maintenance and cropping practices will be needed to maintain stand of fescue."

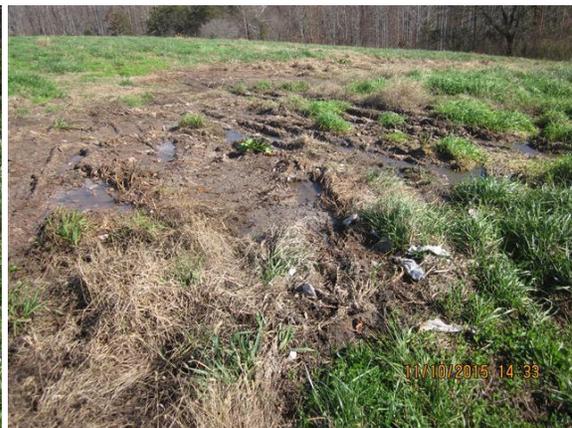
Photo taken near entrance to Field 1 looking northeast
