Closure Report  
20,000 Gallon Diesel Fuel UST  
Draper Corporation  
Hornaday Road  
Greensboro, North Carolina

Prepared By:  
Dan M. Groome  
Triad Environmental Consultants, Inc.  
3519 Clemmons Road  
Clemmons, North Carolina 27012

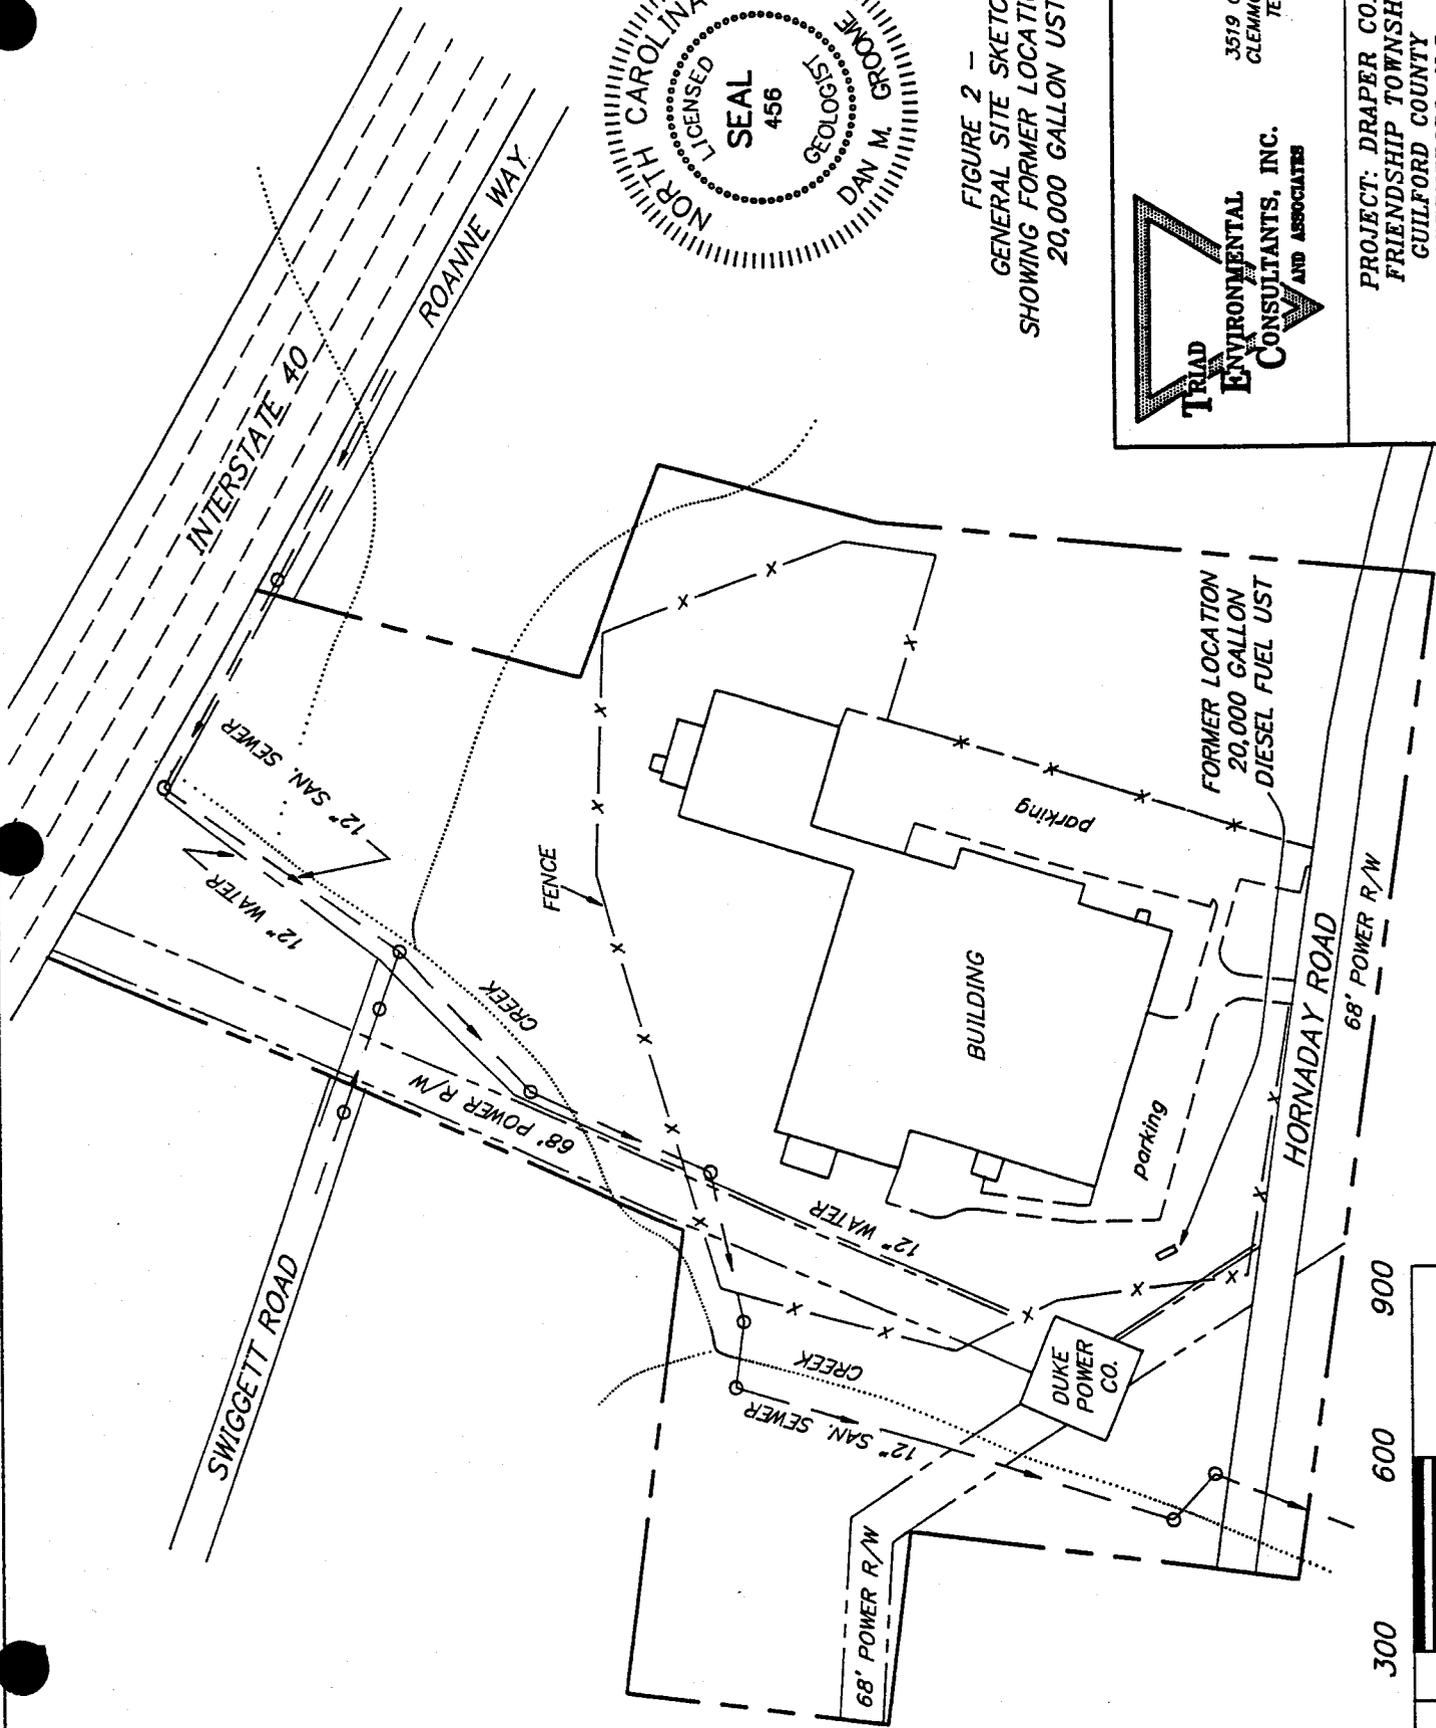
FIGURE 2 -  
GENERAL SITE SKETCH  
SHOWING FORMER LOCATION OF  
20,000 GALLON UST.

A 20,000 gallon steel underground storage tank (UST) was removed from the subject site on December 11, 1992. The location of the site is shown on Figure 1. A general site sketch is shown on Figure 2. The UST had previously been utilized to store diesel fuel. The dimensions of the UST were 10.5 feet in diameter by 31 feet in length. The top of the tank was approximately four feet below the surface. The tank was inerted with dry ice and monitored with an Industrial Scientific Model MX241 oxygen monitor prior to removal. The tank was transported to an approved disposal facility and documentation of disposal is included in this report as Appendix I.

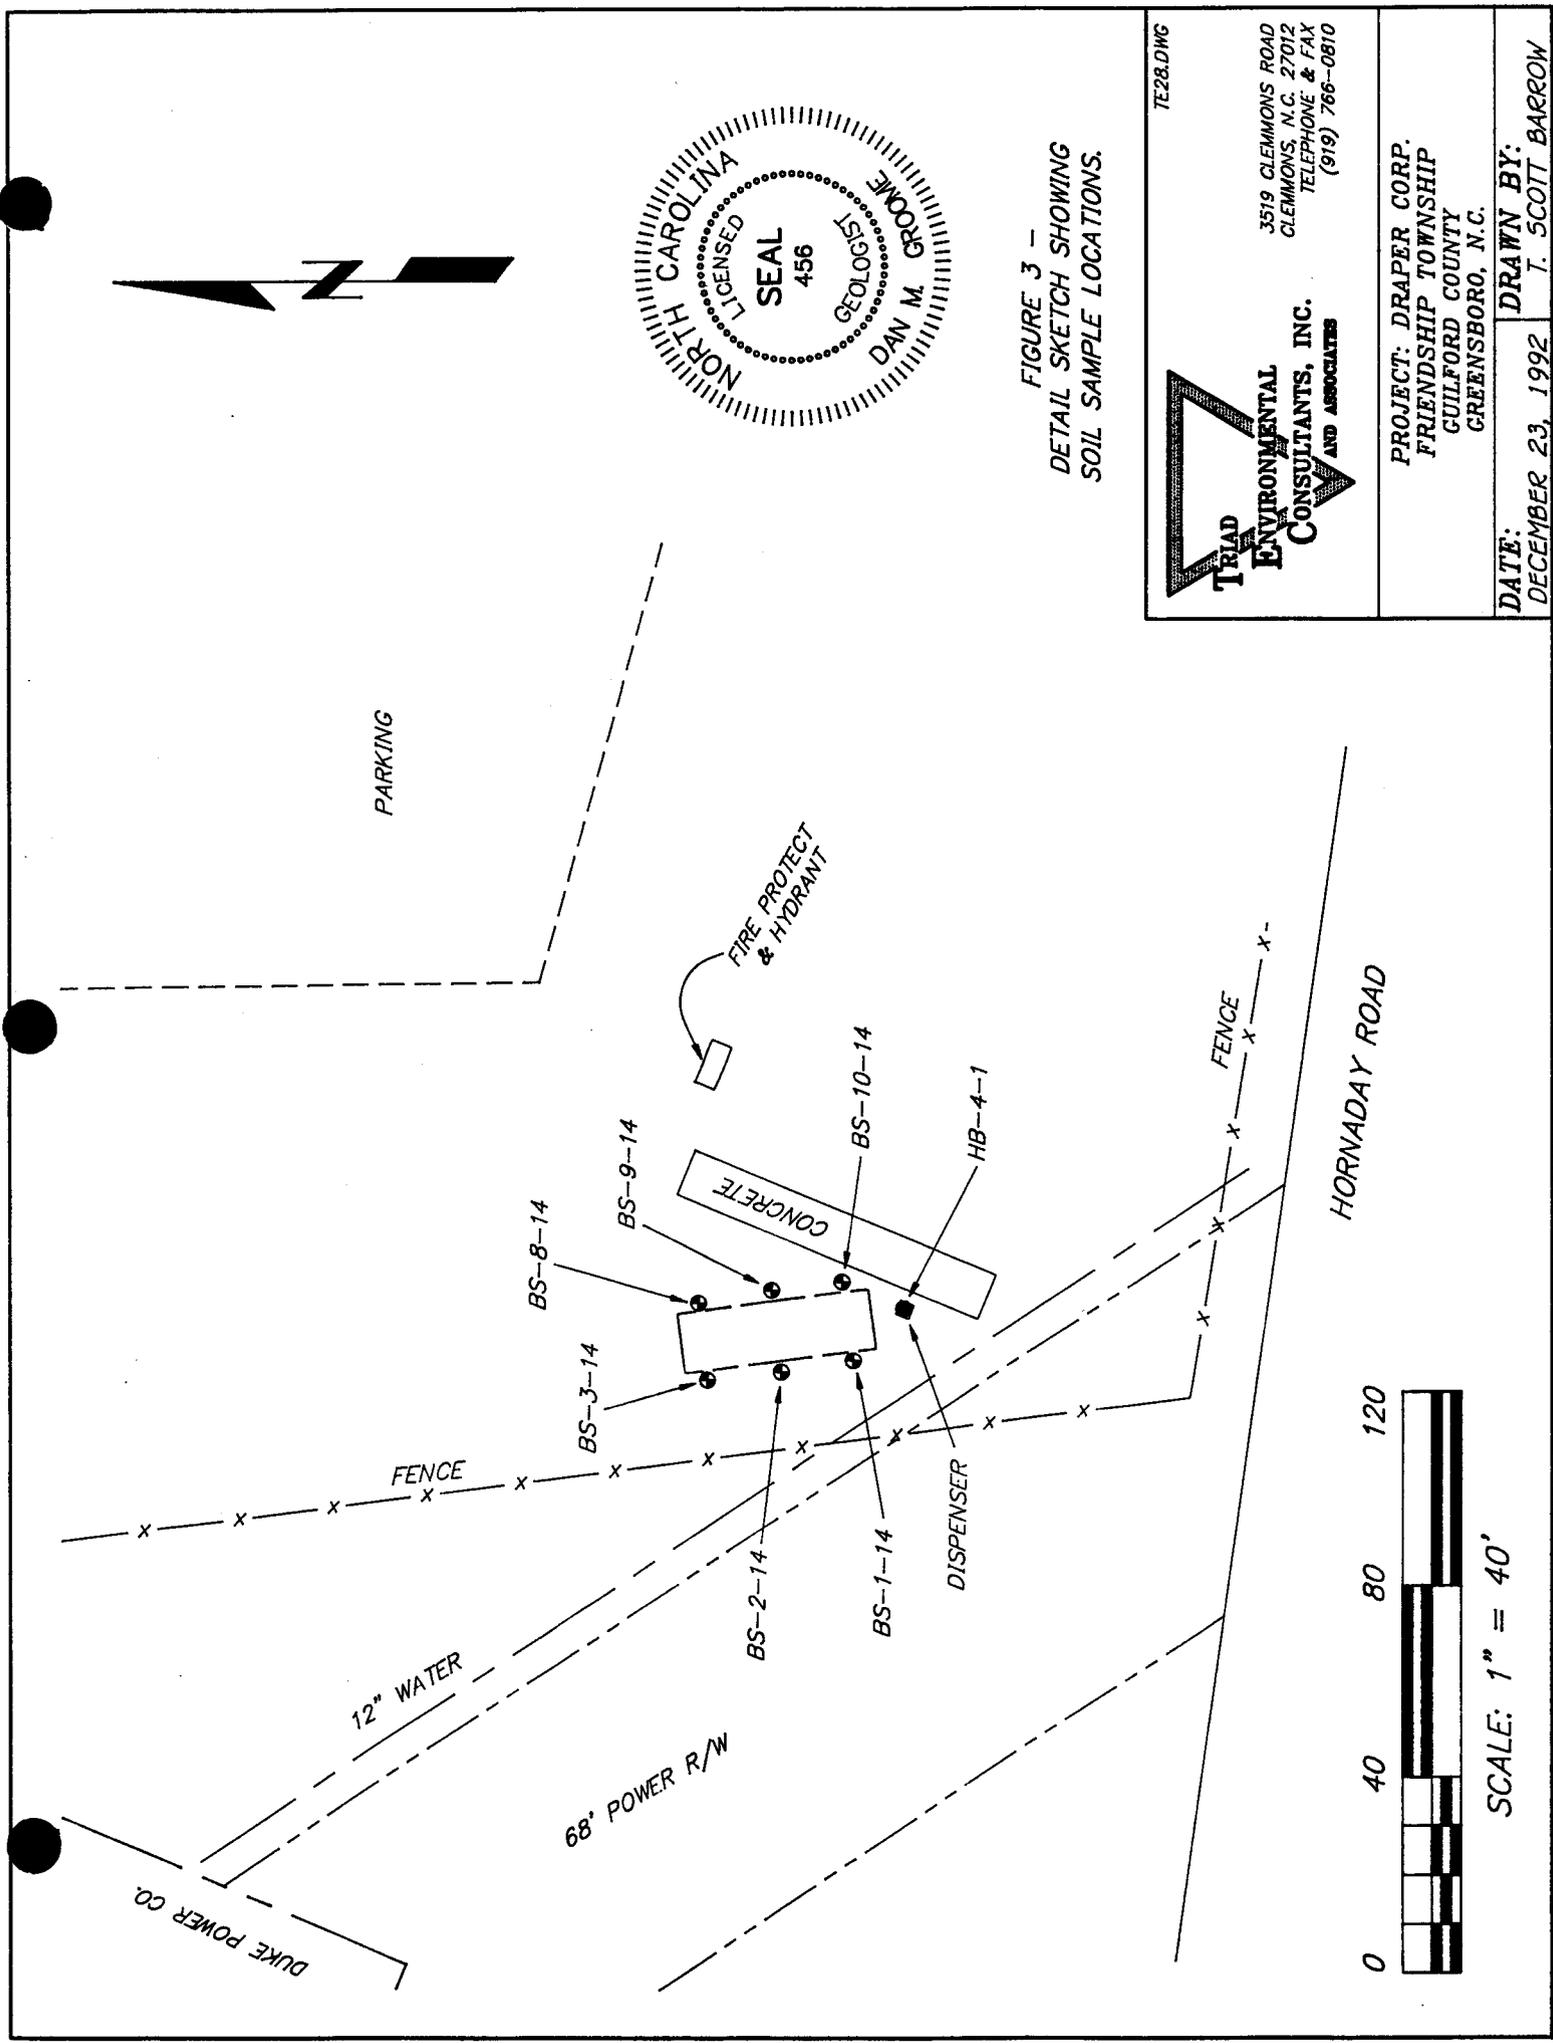
FIGURE 3 -  
DETAIL SKETCH SHOWING  
SOIL SAMPLE LOCATIONS.

Initial excavation was performed on December 9, 1992. During this time it was determined that the UST was mounted on top of a concrete pad. Three (3) soil samples (BS-1-14, BS-2-14 and BS-3-14) were obtained from the native soils adjacent to the edge of the concrete pad at the locations shown on Figure 3. The samples were obtained directly from the excavator bucket. Disposable latex gloves were worn during sampling to reduce the chances of cross contamination. Additionally, a hand auger was utilized to obtain a soil sample (HB-4-1) from the former location of the product dispenser. Three (3) additional soil samples (BS-8-14, BS-9-14 and BS-10-14) were obtained on

December 14, 1992. The soil samples were divided into representative duplicates with one part being evaluated with an Organic Vapor Analyzer (OVA) and the other part placed in new, clean jars for laboratory analysis. The OVA analysis indicated no detection of organic vapors on any of the samples. The soil samples were immediately placed in a chilled cooler after collection and refrigerated while being held at Triad Environmental Consultants, Inc.'s office. Triad Environmental Consultants, Inc.'s standard decontamination and sample handling procedures are included in this report as Appendix II.

The laboratory results indicate that there are petroleum hydrocarbons present in the areas where samples HA-4-1 and BS-3-14 were obtained. However, the concentrations are relatively low, and it does not appear that an extensive release has occurred. Remediation may or may not be required depending on the results of a site sensitivity evaluation. We understand that the guidelines for performing a site sensitivity evaluation and the resulting action levels determined by the site sensitivity evaluation are presently under review by the North Carolina Division of Environmental Management (NCDEM).
