**Soil Assessment and Ground Water
Monitoring Report, and
Corrective Action Plan
Draper Corporation
Greensboro, North Carolina
June 3, 1994**

**Draper Corporation
Greensboro, North Carolina**

**Aquaterra, Inc
Greensboro, North Carolina**

June 3, 1994

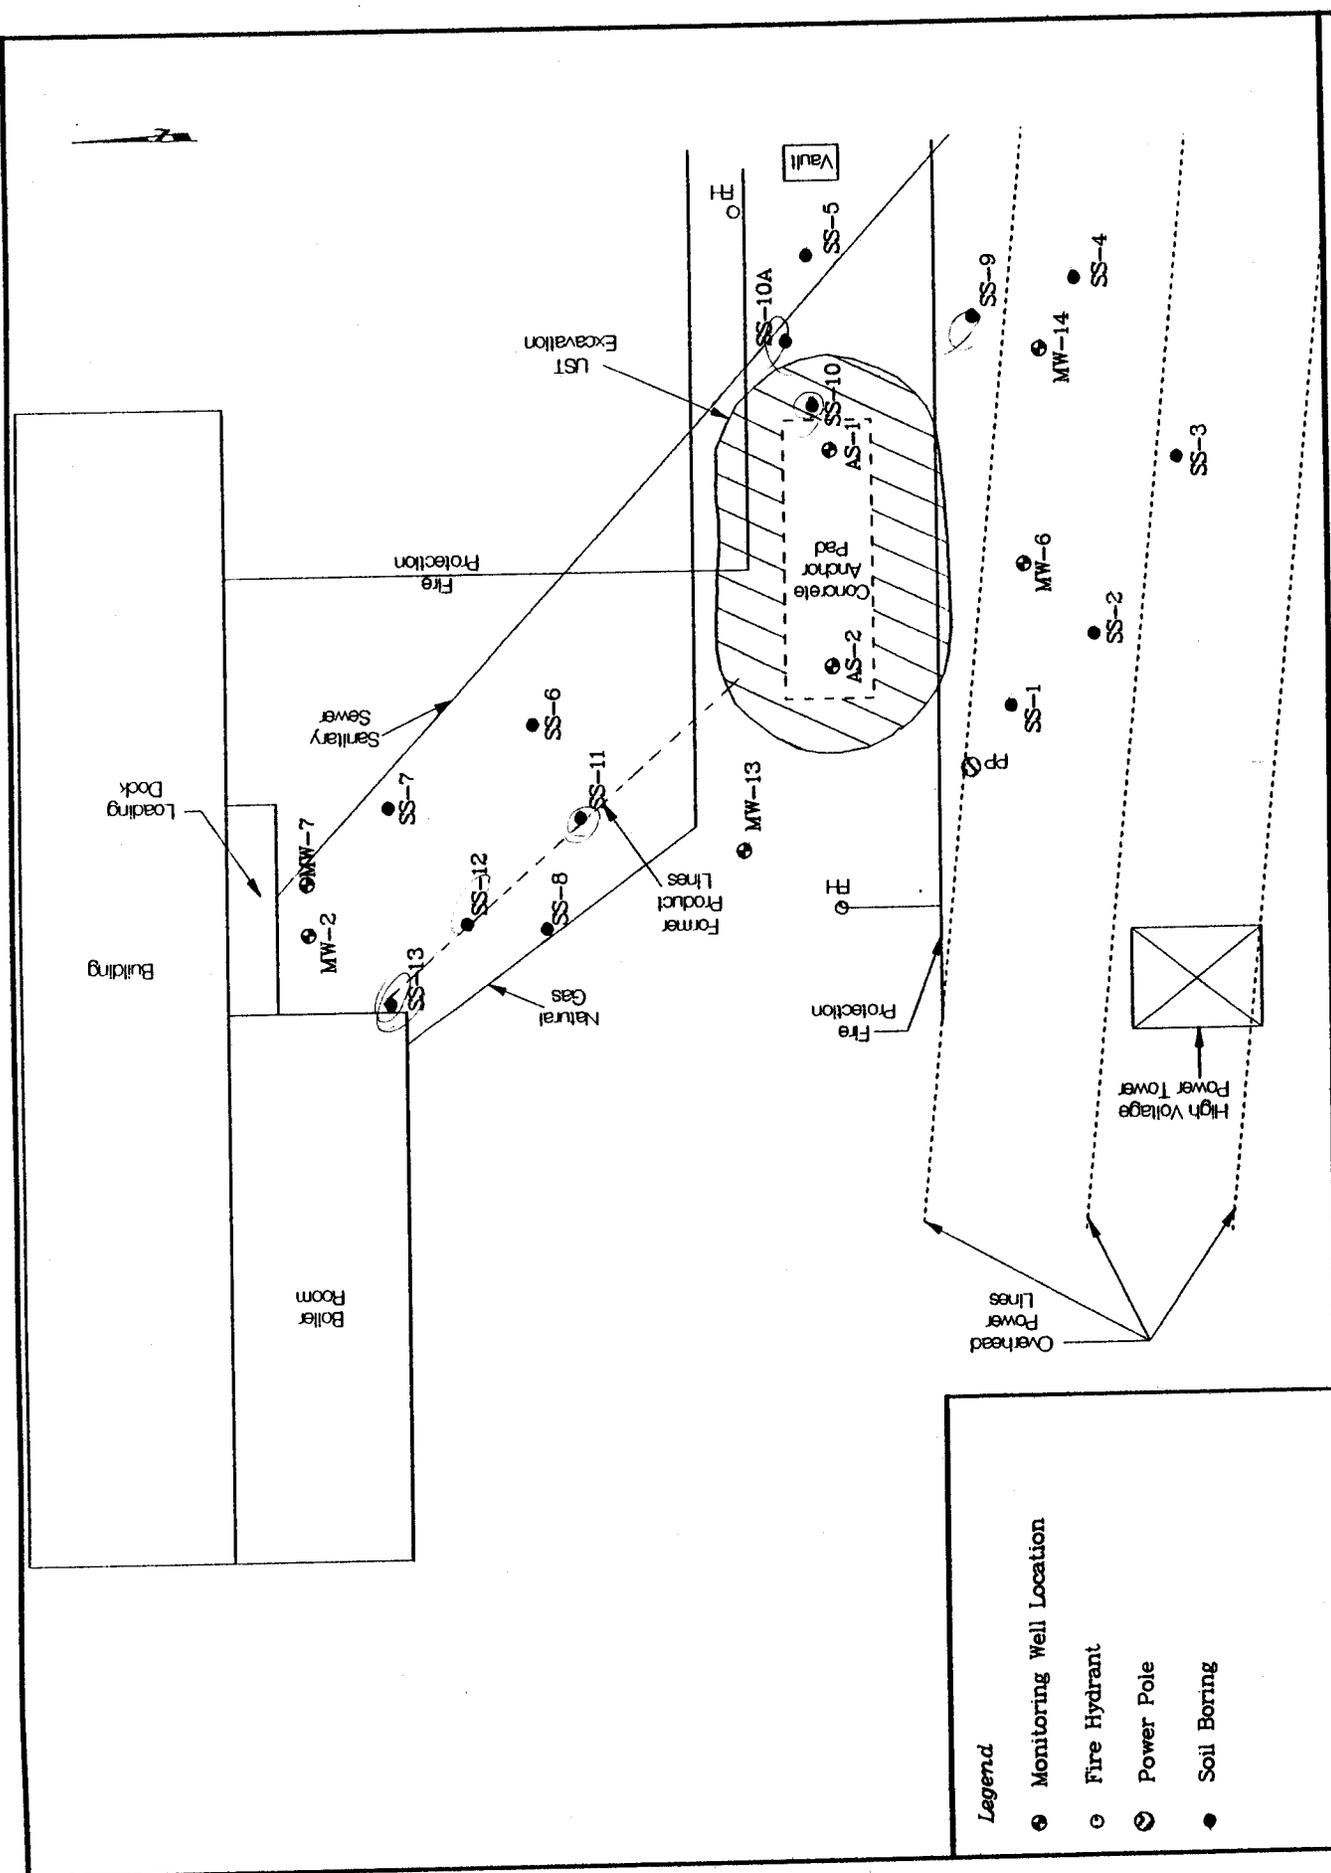
aquaterra A GREAT LAKES CHEMICAL CORPORATION COMPANY		Author JTD	Drawing 43029-1	Layers 0	Date 4-27-94	Title Monitoring Well and Soil Boring Location Map	
		Job No. 4302900	Revision 2	Figure 2	Scale 1" = 30'	Project Draper Corporation Greensboro, North Carolina

Aquaterra used individual, disposable bailers to collect one ground water sample from each of six on-site monitoring wells (MW-2, MW-6, MW-7, MW-13, MW-14, and AS-2)(see Figure 2). Due to physical constraints, a ground water sample could not be extracted from monitoring well AS-1. Per North Carolina Department of Environment, Health, and Natural Resources, Division of Environmental Management (DEM) guidelines, the samples were submitted to Hydrologic, Inc., (Hydrologic) in Morrisville, North Carolina, for analysis of base/neutral extractable compounds, including identification and quantification of the ten highest peaks of tentatively identified compounds (TICs), according to EPA Method 625.

Based on the analytical results and field observations, it appears that a limited amount of soil beneath the transfer piping has been impacted by oil and grease at concentrations exceeding the 250 mg/kg DEM action level. The impact to soils at concentrations above the DEM action level appears to be limited to an area beneath the transfer piping near the boiler room (see Figure 2).

Access to the wells will be maintained during the life of the monitoring period (see Figure 2). Following clean closure of the site, the monitoring wells will be properly abandoned according to North Carolina regulations.

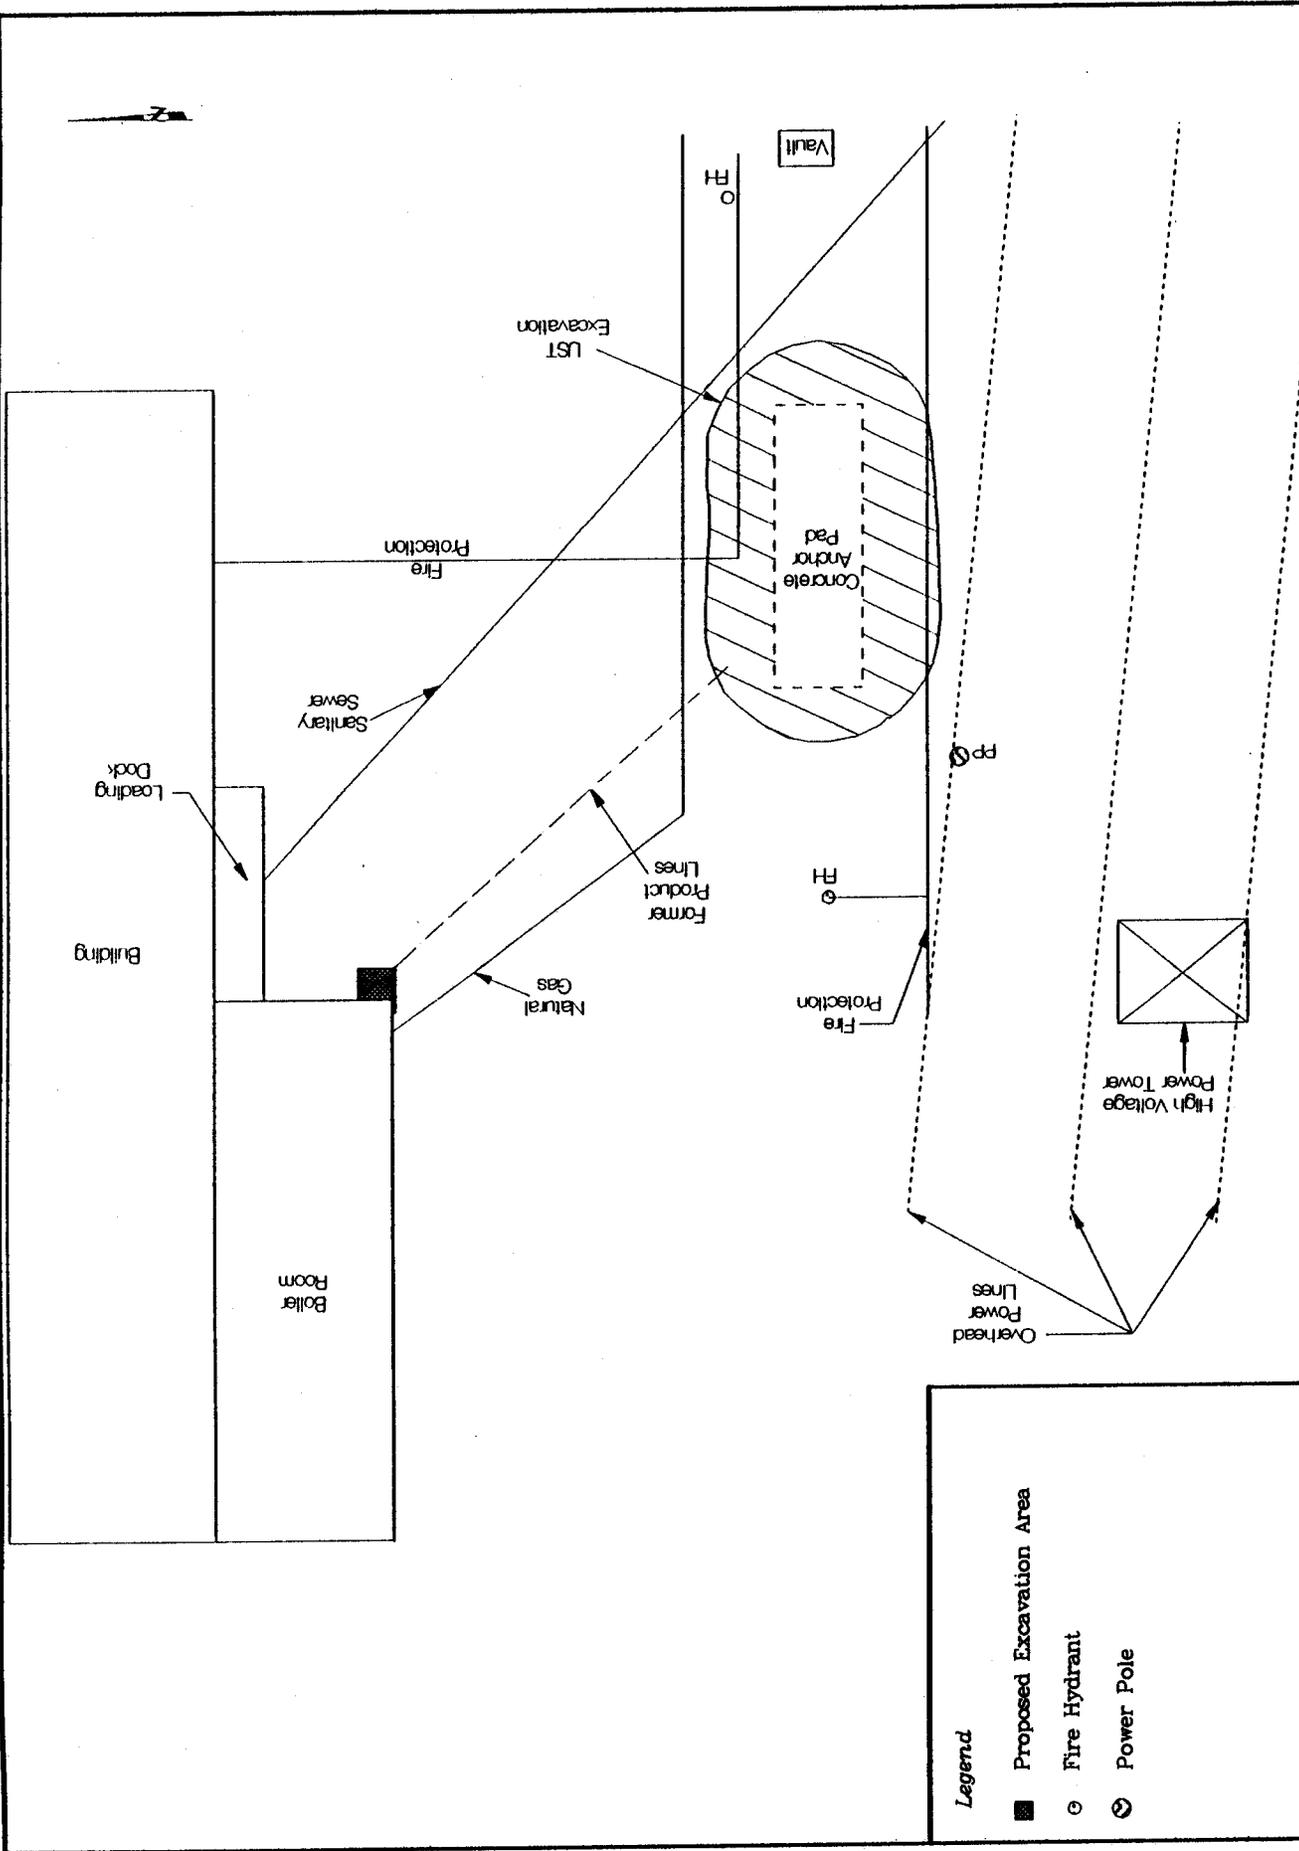
Aqua Terra A GREAT LAKES CHEMICAL CORPORATION COMPANY		Author	JTD	Drawing	43029-1	Layers	0	Date	4-27-94	Title	Proposed Excavation Area
		Job No.	4302900	Revision		Figure	3	Scale	1" = 30'	Project	Draper Corporation Greensboro, North Carolina

According to the most recent analytical results, there is a limited area of soil impact beneath the former transfer line near the boiler room. The sample collected in this area indicated approximately 4,590 mg/kg oil and grease at a depth of approximately 8 feet below grade. Due to the apparently small area of impact, Aquaterra will be using the DEM action level for oil and grease of 250 mg/kg as the target clean-up level.

The soil underlying the site has been impacted by petroleum products apparently from the past operation of a #4 fuel oil UST. As indicated above in Section 5.3.4, Aquaterra recommends excavating the remaining impacted soil. The area to be excavated measures approximately 5 feet long by 5 feet wide and will be continued, depending upon OVA readings, to a depth of approximately 10 feet (see Figure 3). In addition, the excavation activities will be guided by the structural integrity

concerns of the adjacent building. In addition, quarterly ground water monitoring should be conducted to both confirm the earlier results and to ensure that ground water does not subsequently become impacted.
