FACILITY COMPLIANCE INSPECTION REPORT
Division of Waste Management
Solid Waste Section

Date of Site Inspection: March 16, 2016

Bryant Grading LCID Landfill
376 Spence Mill Road
Fuquay-Varina, NC 27526

Comprehensive Inspection

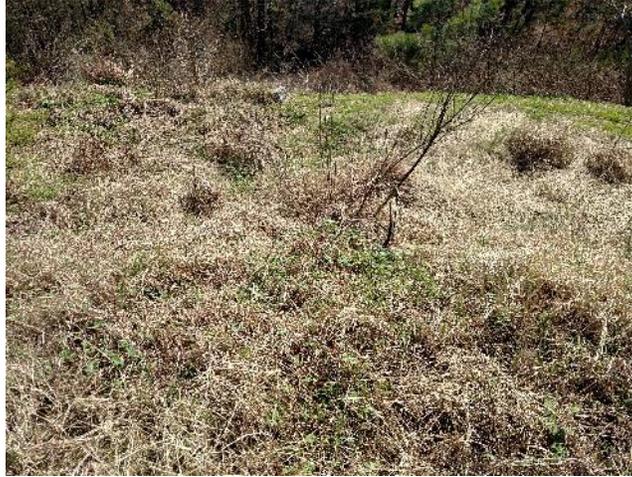
**Per 15A NCAC 13B .0566(14), states “Leachate shall be properly managed on site through the use of current best management practices.”**

**Leachate breakout has occurred on the southeastern slope of the landfill and appears to have flowed to the existing sediment trap which has overflowed into the vegetative buffer.**

The item(s) listed above were observed by Section staff and require action on behalf of the facility in order to come into or maintain compliance with the Statutes, Rules, and/or other regulatory requirements applicable to this facility. Be advised that pursuant to N.C.G.S. 130A-22, an administrative penalty of up to \$15,000 per day may be assessed for each violation of the Solid Waste Laws, Regulations, Conditions of a Permit, or Order under Article 9 of Chapter 130A of the N.C. General Statutes. Further, the facility and/or all responsible parties may also be subject to enforcement actions including penalties, injunction from operation of a solid waste management facility or a solid waste collection service and any such further relief as may be necessary to achieve compliance with the North Carolina Solid Waste Management Act and Rules.

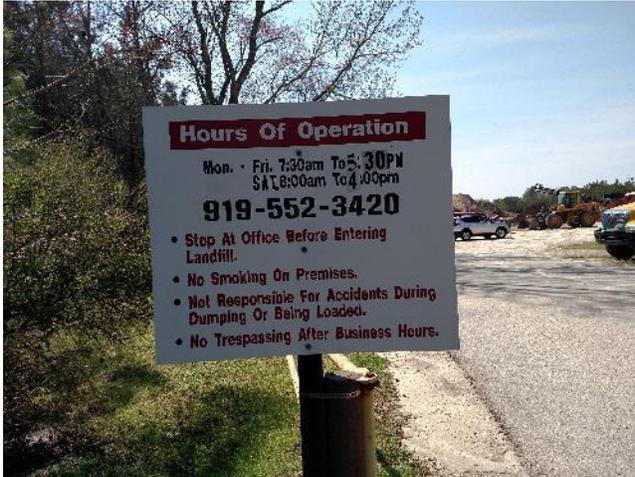
Current facility sign at entrance

1. The facility is a land clearing and inert debris (LCID) landfill.
2. **Per 15A NCAC 13B .0566(4) A sign shall be posted at the facility entrance showing the contact name and number in case of an emergency and the permit number. The permit number requirement is not applicable for facilities not requiring an individual permit. Proper signage needs to be posted within 30 days.**

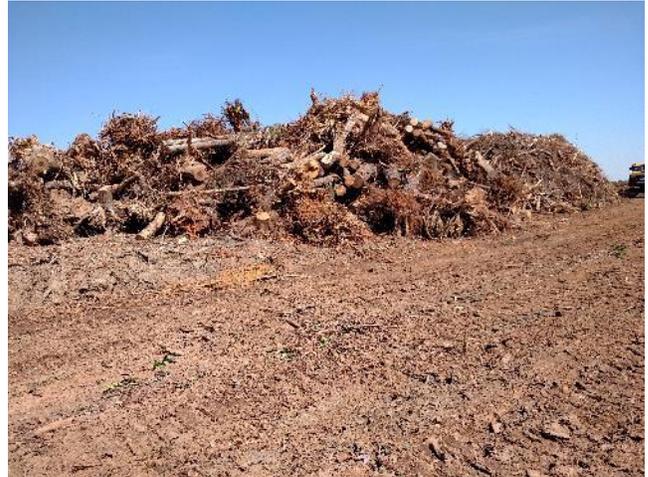
Top of landfill – working face

6. Per 15A NCAC 13B .0566(3), “Solid waste shall be restricted to the smallest area feasible and compacted as densely as practical into cells.”
7. **Ensure the LCD disposal area is graded accordingly, to include a defined working face and soil cover. Excavation, grading and fill material side slopes shall not exceed three to one (3:1).**

8. **Per 15A NCAC 13B .0566(4), “Adequate soil cover shall be applied monthly, or when the active area reaches one acre in size, whichever occurs first.” Based on observations of the site at the time of this inspection, it appears that uncovered waste was exceeding one acre and had not been covered as required by rule. According to #7 of the approved operations plan, the operator will keep the LCID working face as small as possible with a ½ acre maximum size. All areas of waste that are not part of the working face must be covered within 30 days.**

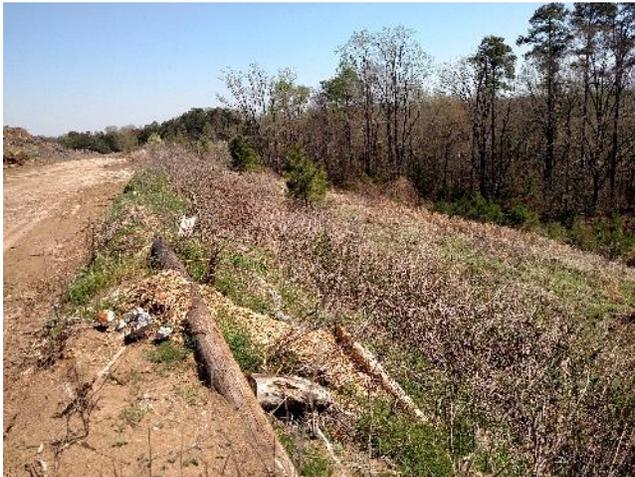
Trees need removing from side slopes

- 15. Trees need to be removed from the side slopes of landfill and drainage ditches cleaned out within 30 days.
- 16. Access roads are of all-weather construction.

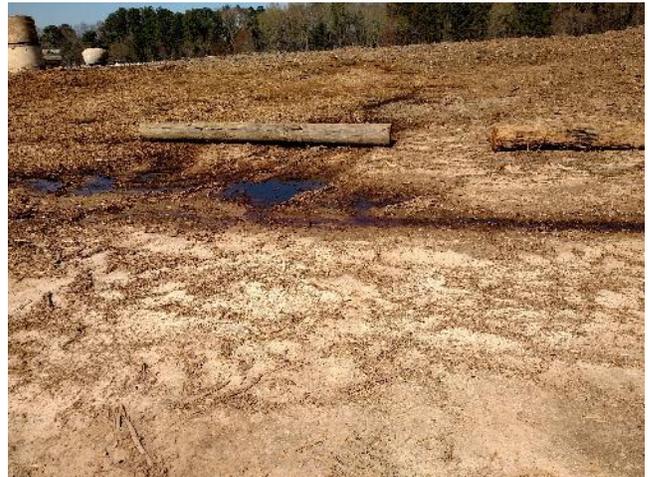
Ponding water on top of landfill

- 10. Per 15A NCAC 13B .0566(10) Surface water shall be diverted from the working face and shall not be impounded over waste.
- 11. Ponding of water observed on top of landfill. Grade top of landfill to ensure positive drainage of surface water off the Landfill within 30 days.

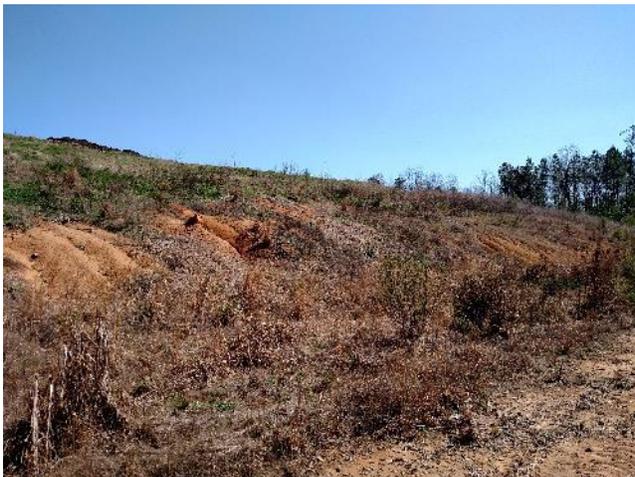
Erosion on side slopes

- 13. Property lines must be marked within 30 days to ensure that waste is not being dumped into the 100' buffer for this facility.
- 14. Erosion on side slopes was noted. Provisions for a ground cover sufficient to restrain erosion must be accomplished within 30 days to prevent further erosion.

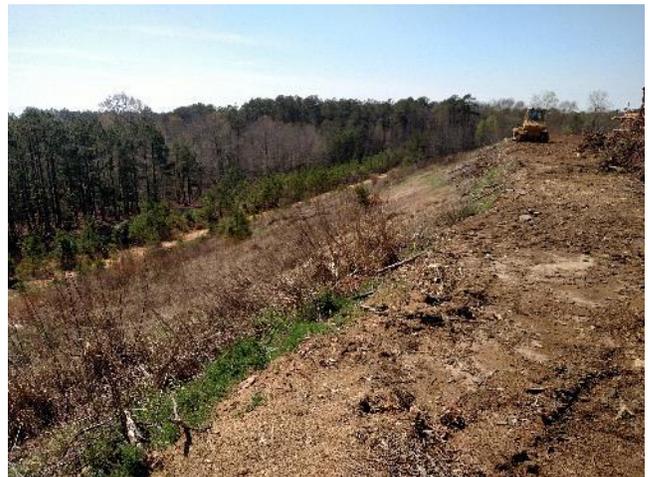
Southwestern side slopes of landfill
